**ARCHEOLOGICAL INVESTIGATIONS  
AT LAKEPORT PLANTATION  
Summary Report, AAS Project 03-02  
May 2003**

**ARKANSAS ARCHEOLOGICAL SURVEY**

# **Archeological Investigations at Lakeport Plantation SUMMARY REPORT**

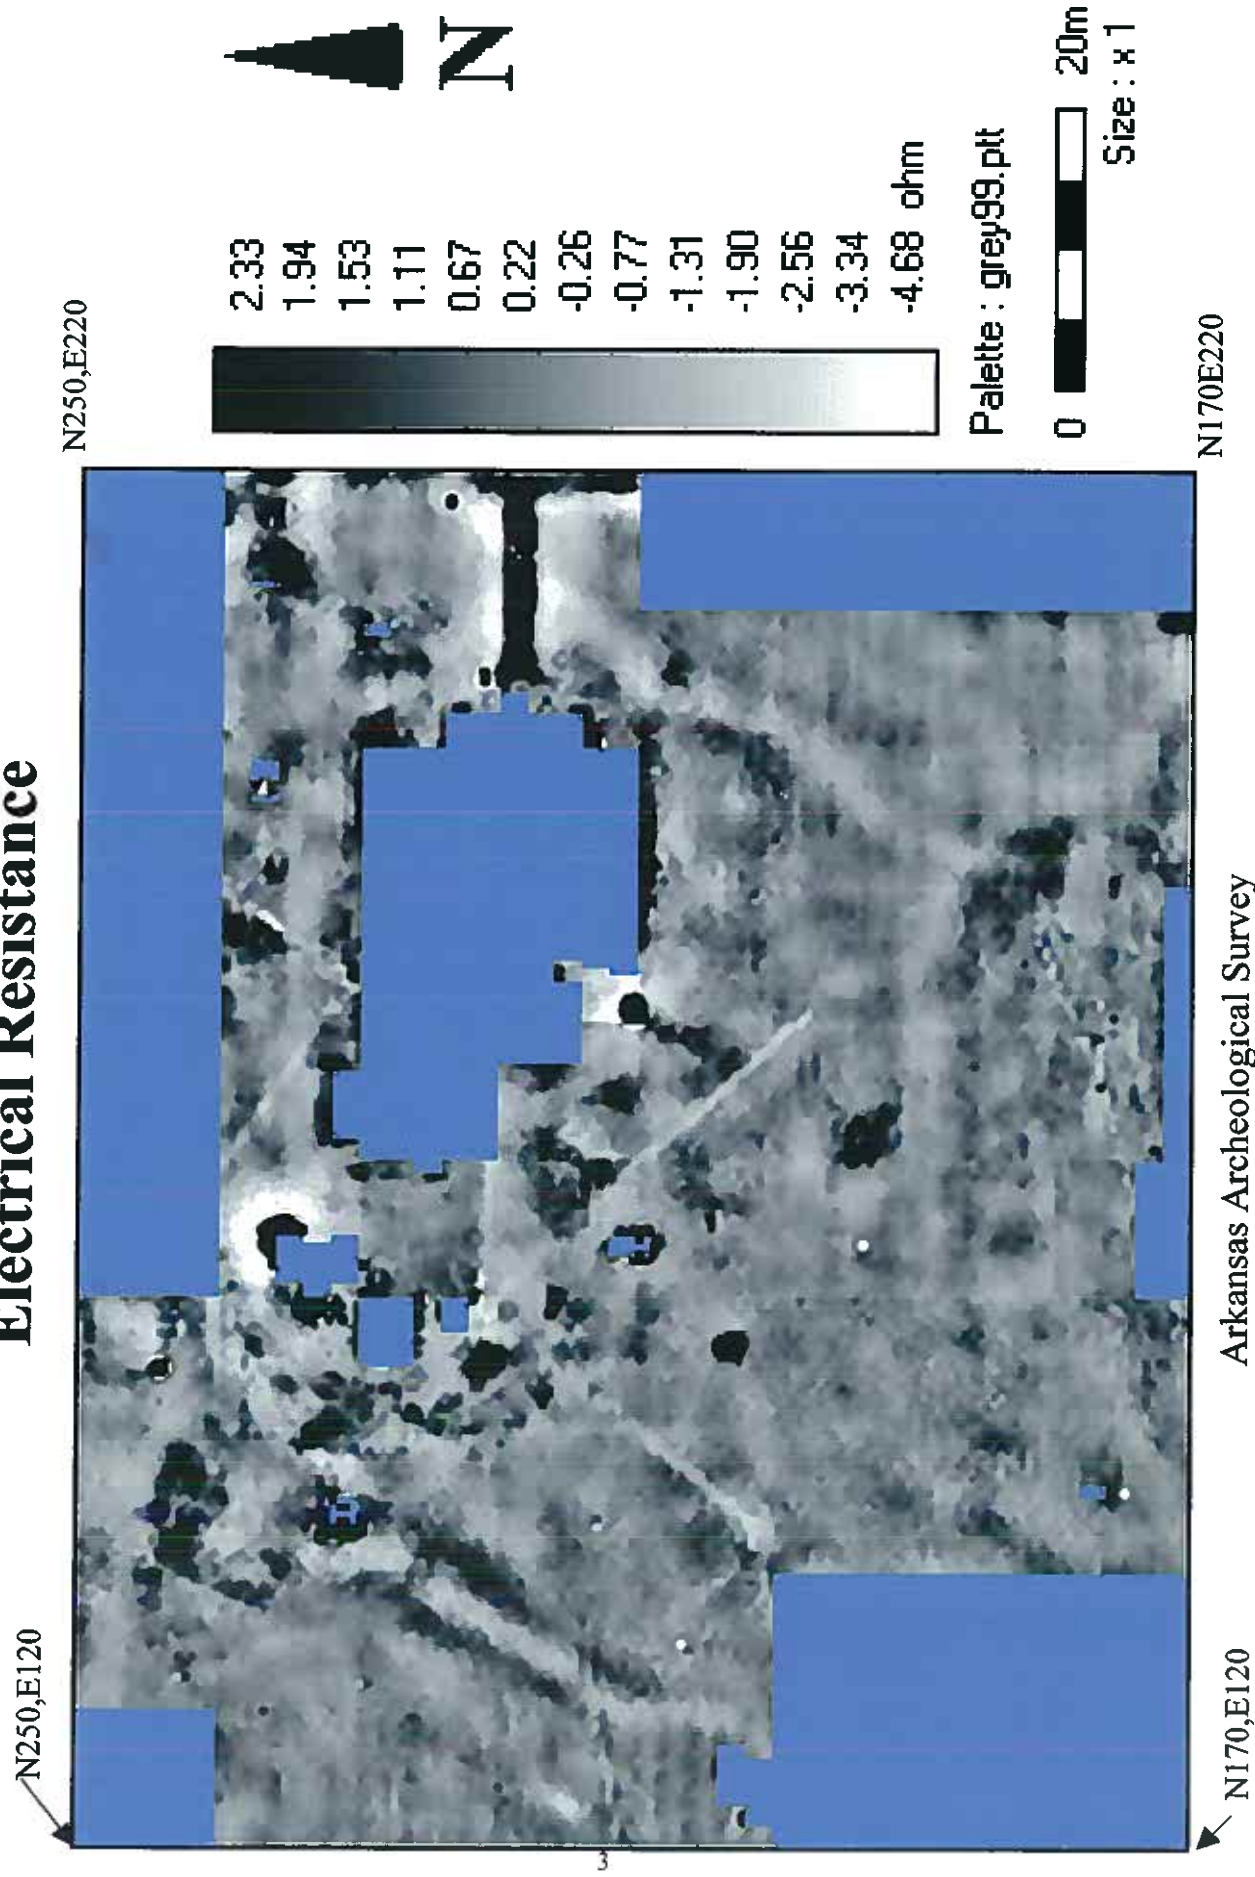
The patterns displayed in Figure 1 are red highlighted in Figure 2. Particularly interesting are the dark indications (markedly high values) adjacent to the south, east, and north foundation walls of the house as well as the dark band running east-west from the front porch at the right side of Figure 2. Stewart-Abernathy's oral history informants identified a brick walkway in the front yard interpreted to be the dark band. Excavation later exposed the walkway. The high values next to the foundation were interpreted as a massive brick footing, but this proved to be an oversimplification. Excavation showed the foundation shadow on Figure 2 was a brick paving skirting the entire house, an unprecedented feature in Arkansas architecture. The density and distribution of patterns behind (west of) and south of the house show an intriguing accumulation of features including possible fence lines, water lines and road ways (linear patterning) and vanished buildings (rectangular patterning). The importance of geophysical data at the outset of the project cannot be over-emphasized; remote sensing data from as large an area as possible allows the identification of the whole plantation complex including vanished structures that now only exist in old photographs or memories. The practical consequences are unintended destruction of features can be avoided, and where that is not possible, future excavation can be targeted to specific anomalies rather than wasting costly field time attempting to locate possible features.

Figure 1. Grey palette image of resistivity values.

The front walkway was highly visible in the remote sensing map (Figure 1) and when scaled measured about three meters wide. We probed across the area of the image and hit a solid surface a few centimeters below the sod measuring 2.9 meters wide. Excavation at the edge of the walkway exposed a narrow brick walkway just under the present surface. Made of highly vitrified bricks laid end to end in a running bond, this narrow walk lay on top of an earlier low-fired brick walkway. The portion of narrower walkway exposed was 35 cm wide and the earlier walkway extended 75 cm wider; both are only partial exposures of the south side of the front walk as identified in the geophysical map.

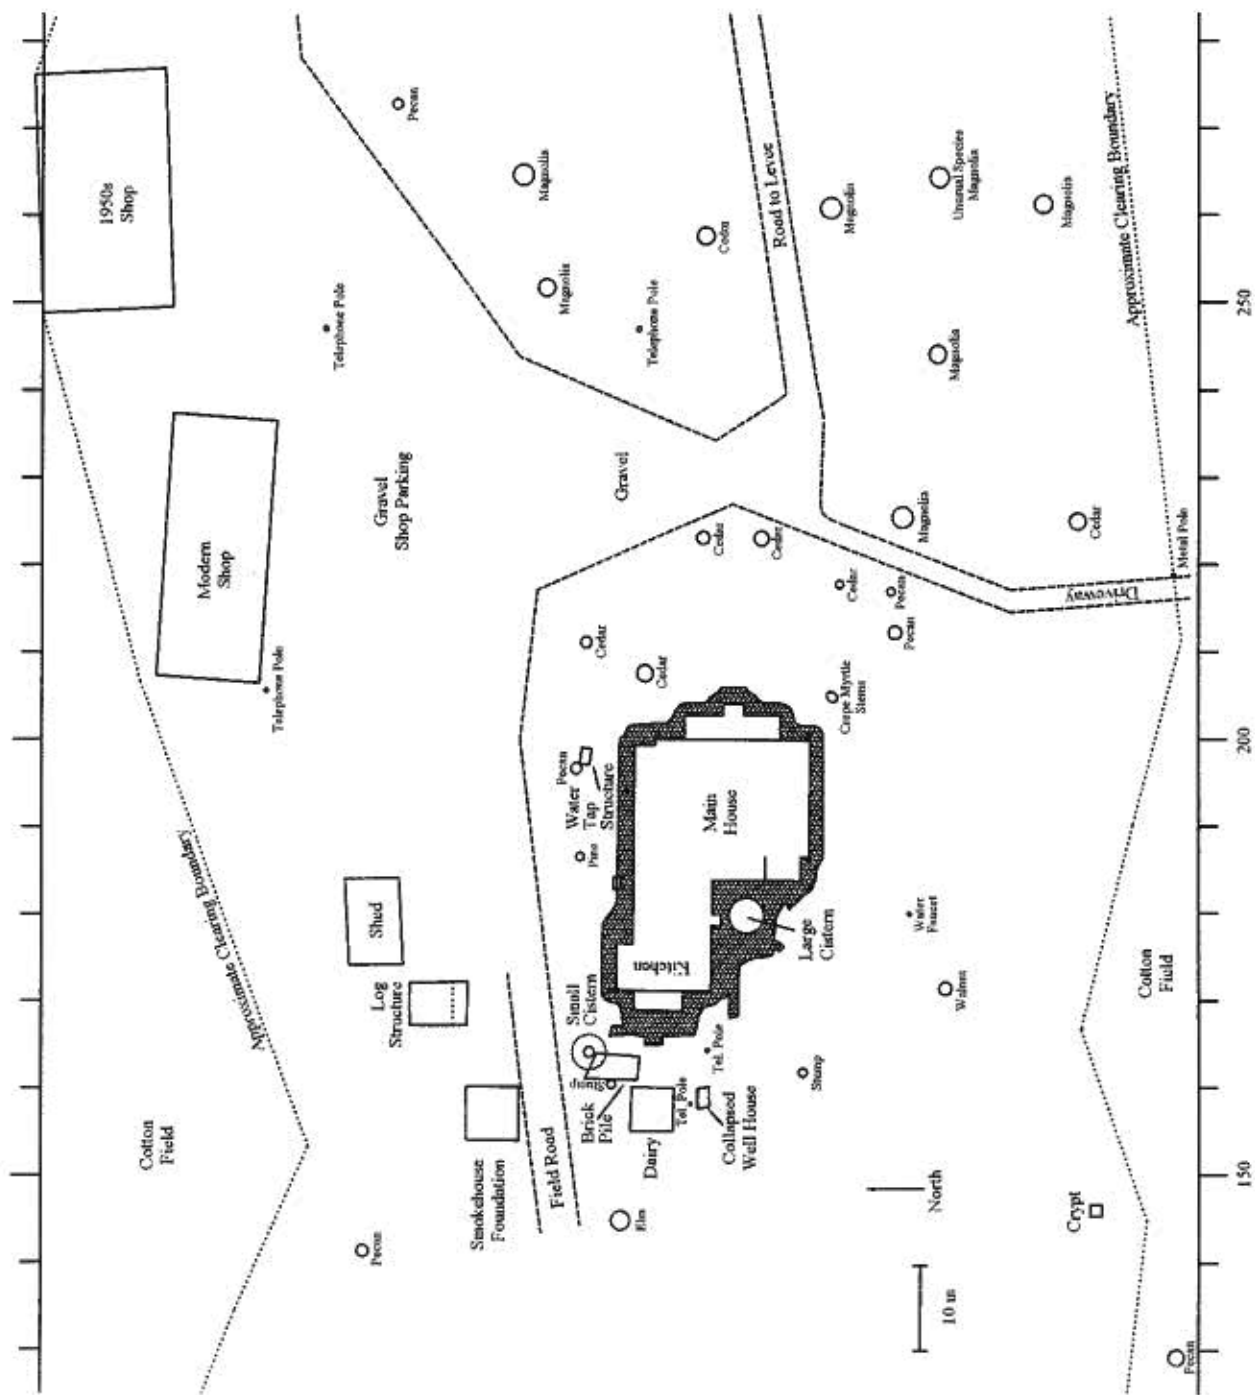
Figure 3. Plan of plantation core area with brick paving mapped.

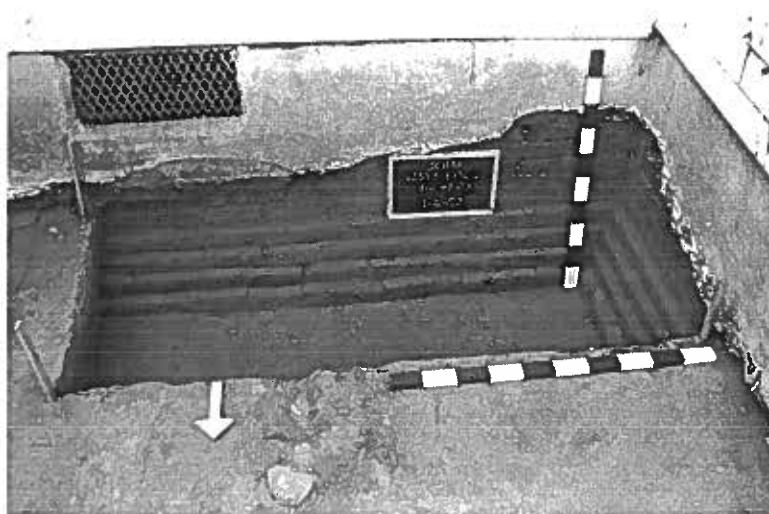
Six 1 x 2 m units were dug to the bottom of the foundation footer at the corners of the main house and kitchen. The footers and foundation walls are massive structures of low-fired, hand-made bricks. The vertical foundation walls sit on footers composed of four courses of bricks, each extending out a half brick width (measured along the long axis) beyond the course above, a brick laying process called corbeling (Figure 4). The thickness of the walls could not be determined, but the corbeling process would result in a 4:1 footer to wall ratio, providing a very wide bearing surface for the two story structure. The elevation of the lowest footer course differed less than six centimeters (2.4 inches) from the mean along the entire foundation indicating the original construction was probably measured with a spirit level or optical instrument.

*Figure 4. Foundation test unit at juncture of east kitchen wall and north commissary wall. Note corbeled footer. (AAS Neg. No. 2002 5333)*

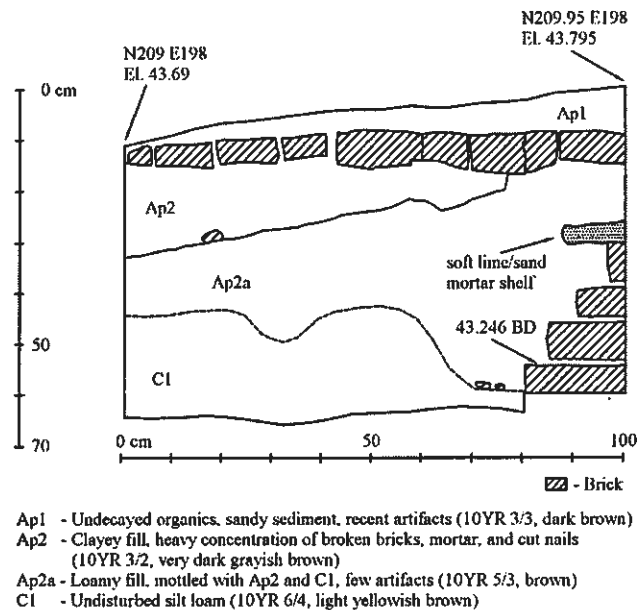
The foundation units were one meter wide, which should have been ample room to expose a builder's trench if present. Rather than a definable trench though, two fill deposits extended across the entire profile (Figure 5). Further, this same fill profile was found in all the foundation units opened around the exterior of the house and in the one chimney base unit under the house. This consistent profile can only be explained by large scale earth moving, rather than the more targeted hand-dug builder's trenches.

Prior to laying out the foundation the top of the ridge apparently was removed, possibly using mule drawn slip scoops well-documented in nineteenth century levee construction. The upper sediments were pulled away down to the undisturbed C horizon, and the footprint of the foundation leveled. Once the exterior foundation walls, porch piers, interior wall foundations, chimney footers and brick drains were built, the interior spaces were backfilled and the exterior spaces next to the foundation partially backfilled (Figure 5, Ap2a horizon) to the top of the corbeled footer. The exterior foundation walls were stuccoed, and the house framed and exterior sided. At some point during construction a very clayey fill was added (Figure 5, Ap2 horizon). This fill contains a heavy admixture of brick fragments, mortar and copious cut nails in all construction use sizes, indicating it was either in place during the most active construction or stockpiled at the edge of the immediate construction area.

Figure 5. Foundation test unit west profile wall, southeast corner of the house.

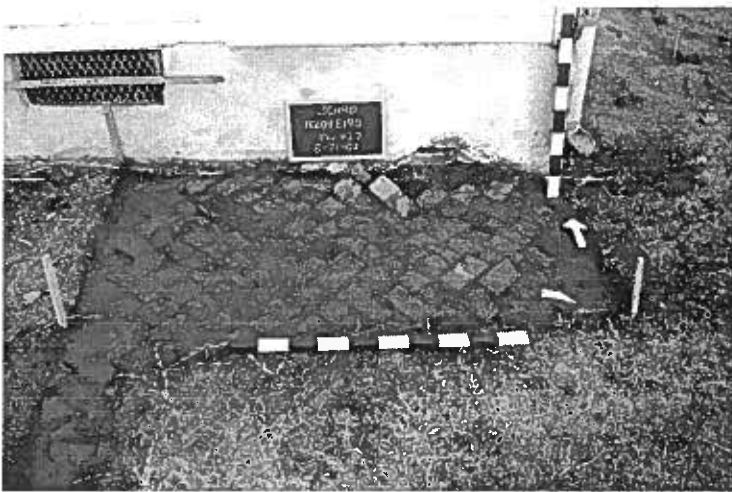
The paving is defined by a soldier course of bricks laid on edge along their long axis at the outside edge. The soldier course was laid in a sinuous pattern from the front walk curving to a straight line parallel to the porch, then curving again through the corner formed by the front porches and the house. It straightens across the front of the northeast porch then curves around the northeast and southeast corners of the house and parallels the length of the house (Figure 3). Behind the soldier course whole bricks are laid flat in a herringbone pattern filling in all the area between the edge and the foundation. Along the north and south facades the width of the paving averages about 1.5 m (Figure 6) and dipped away from the foundation.

It apparently served both an aesthetic purpose and a practical purpose of diverting water away from the foundation, as well as preventing mud from splashing the siding.

*Figure 6. Brick paving at southeast corner of the house before excavation. Soldier course is in the lower left corner. (AAS Neg. No. 2002 5145)*

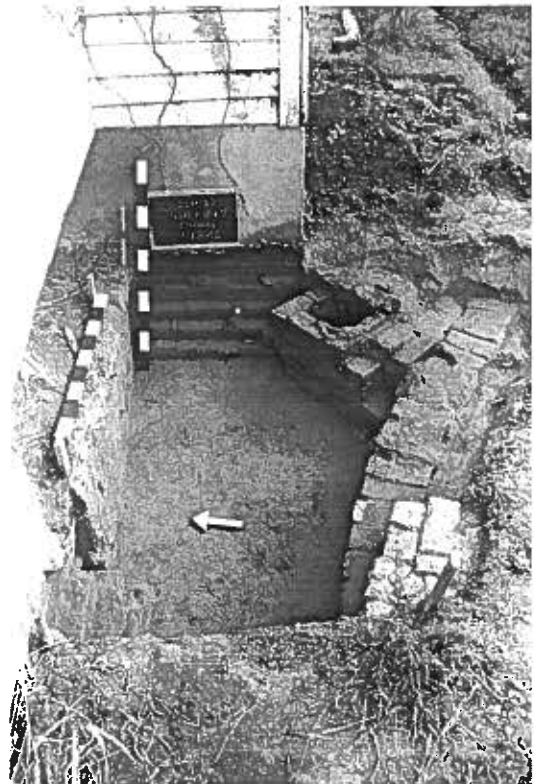
*Figure 7. Excavated box drain and brick drain to large cistern at southwest corner of house. The lighter bricks at the lower right corner are paving bricks. (AAS Neg. No. 2002 5397)*

The large cistern was similarly filled, but by only two drain boxes, one at the southeast corner and one at the southwest corner of the south facade of the house (Figure 7). The box and drain were just below the surface of the paving at the southeast corner of the house, and the drain became deeper as it progressed west under the paving. At the second drain box the drain began curving sharply to the north to clear the butler's pantry pier and enter the large cistern. This prompted a question: why is the smaller cistern filled by three box drains and the larger cistern only two?

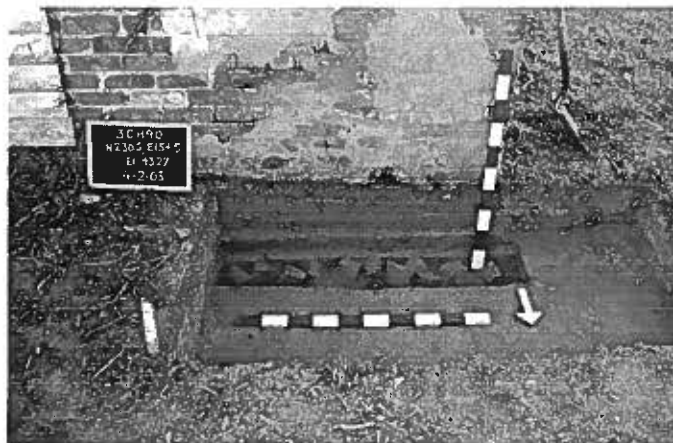
One excavation unit was placed at the northwest corner of standing brick dairy. Three different layers of artifact-laden fill capped the surface. A builder's trench appeared at 30 cm below the surface, measuring about 27 cm wide parallel to the north wall. It did not extend beyond the corner. The builder's trench was filled with  $\frac{1}{2}$  bricks (Figure 8), but no other artifacts were found except a small piece of glass and two cut nail fragments. The footer was comprised of four courses of low-fired bricks, but only the top two were corbeled. The bottom two courses were aligned under second corbeled course.

The profile of the north wall of the unit showed no builder's trench on the west dairy wall. Instead, a thin line (ca. 2 cm) of fill was defined next to the second corbel, but the undisturbed C horizon is in direct contact with the second, third and fourth courses. This means that on the west side the dairy the builder's cut a straight wall into undisturbed sediments and bricks were laid against the dirt wall as a form. The stratigraphic profile exposed at the dairy is a C horizon overlain with three separate fill episodes, none of which correspond to the Ap2 horizons next to the house. The sediments underlying the dairy indicate the site is not part of the large

Figure 8. Builder's trench exposed at the northwest corner of the dairy. Note only two corbeled courses. (AAS Neg. No. 2003 2544)

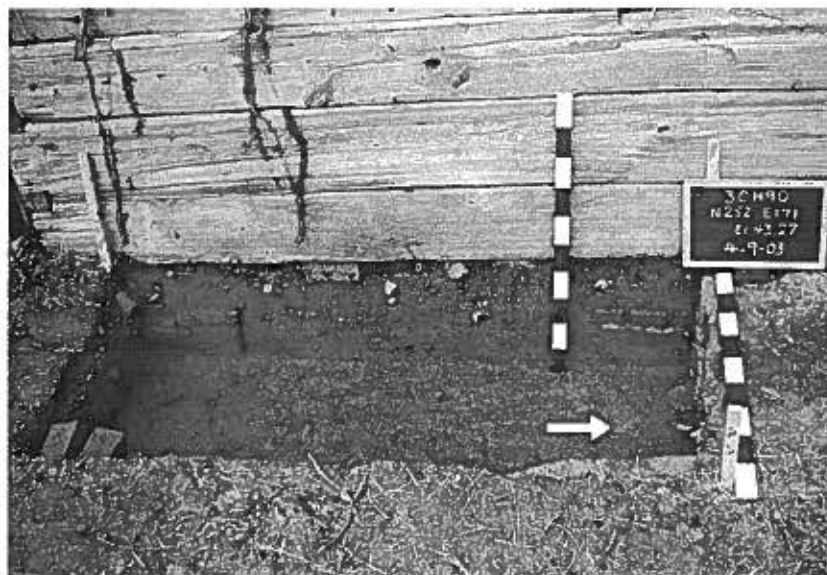
Two excavation units were placed to test an apparently undisturbed area along one wall. One unit was outside the east wall and one was placed parallel on the inside. Two areas of single courses of low-fired bricks were present under the wall at north and south ends of the outside unit. The brick courses were directly under the lowest log at the same elevation, but were 20 cm below the bottom of the log (Figure 9). Low-fired brick fragments and lime mortar fragments were recovered at the same level of the bricks. The two courses of bricks appeared to be the remnants of demolished piers from an earlier structure. A jumble of low-fired bricks was found in the north end of unit. The north pier appears to be resting on bed of mortar in turn resting on an undisturbed B horizon. Artifacts were plentiful, but mainly agricultural, though some cut nails and domestic items could be from a cabin occupation. The inside unit exposed the west side of the same piers. The bricks at north end formed a single course on the same mortar bed. A second jumble of low-fired brick was buried at the south end of the unit, but several were aligned with single course on exterior. This would make the pier about 30 cm (three wythes) wide.

The piers are buried under about 20 cm of fill and do not appear to have supported the present log wall. The north pier appears tumbled down to the east and the south pier tumbled to the west during purposeful demolition. Although the log structure may well be quite old, it was not original to the building site and may have been moved in from elsewhere after the previous structure was removed.

*Figure 9. Two pier remnant brick courses in profile wall under lowest log of cabin. Note mortar bed under the brick at the north end (right side) of unit. (AAS Neg. No. 2003 2604)*
