# Lakeport Plantation Restoration

Technical Report No. 5

## The Shingled Roof

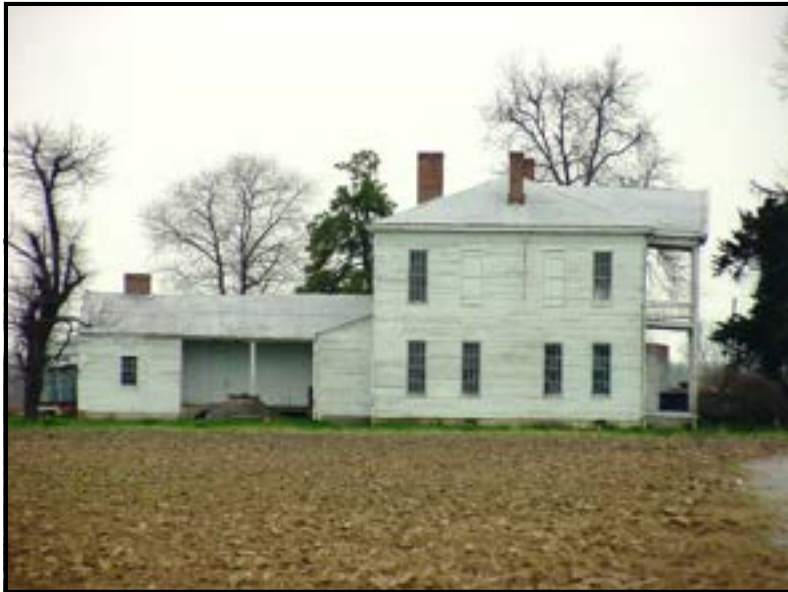
This photo shows the south side of Lakeport Plantation house before restoration began. At that time, the hip roof was covered with a corrugated tin roofing material.

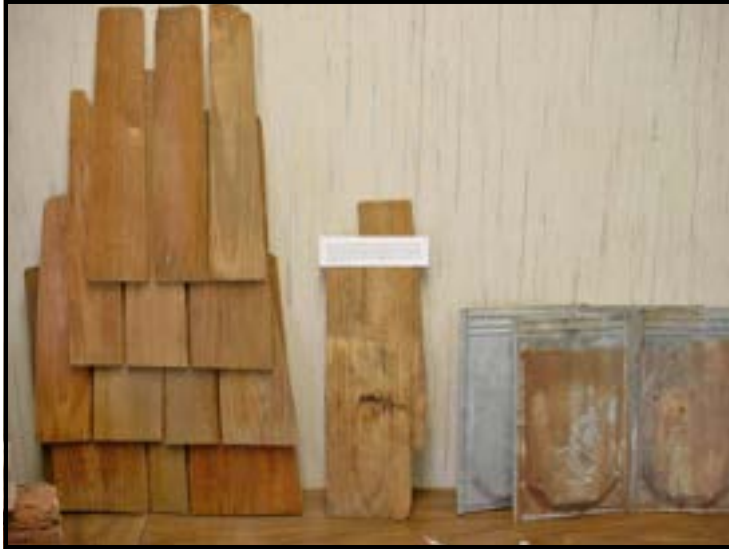
The photo at left shows some of the shingles that were found in the attic of the house when restoration began. The shingles to the far left are hand split cypress shingles that had never been used. The two shingles in the center, also hand split cypress, show signs of use and were probably part of the original roof. The cypress shingles were replaced by the galvanized stamped metal shingles.

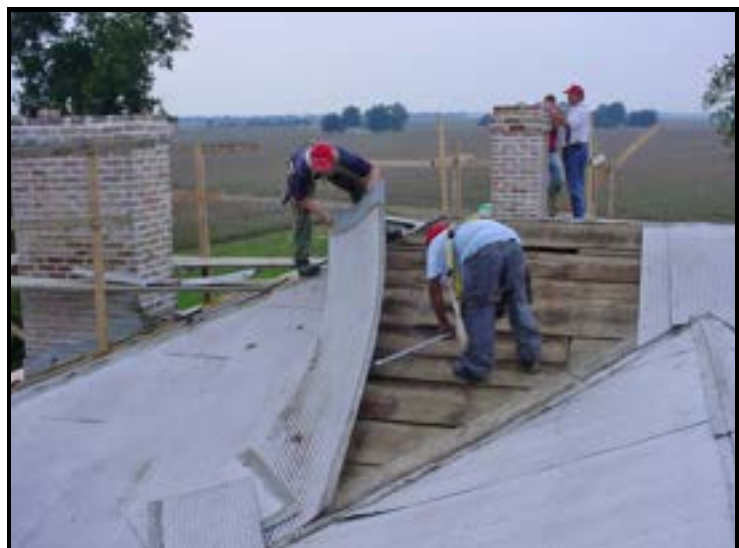
The photo at right shows the restoration crew removing the corrugated metal roofing material from Lakeport Plantation house to get ready for the new cedar shingles to go on.

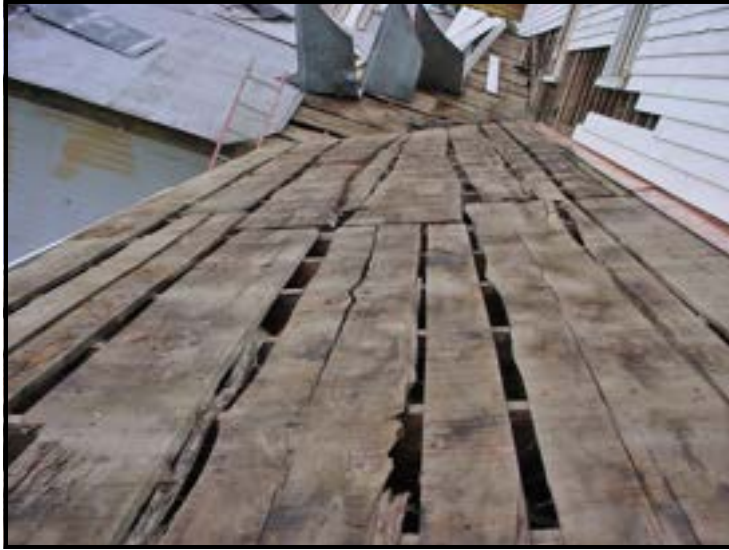
The photo at left shows the original cypress skip sheathing that was exposed when the corrugated metal roof was removed. Crudely cut, many of the boards still have the barked edges and are shaped like the trunk of the trees from which they were cut.

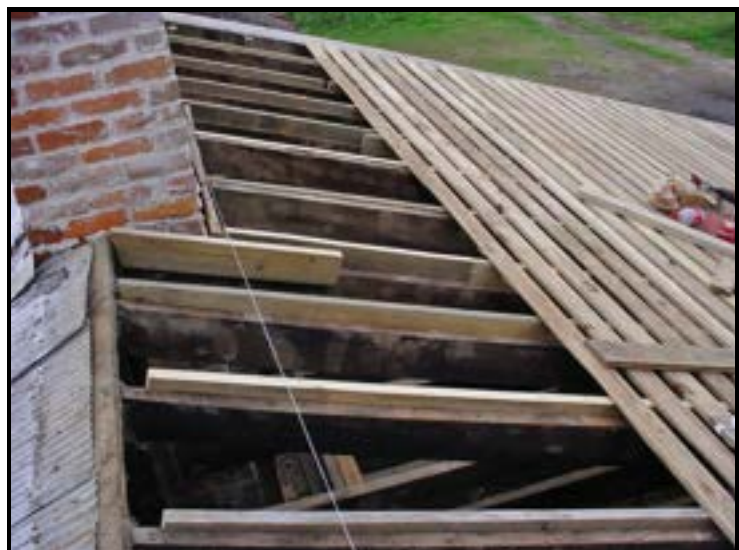
The photo at right shows the roof above the plantation office of Lakeport Plantation house. The roof was deteriorated and the original skip sheathing had to be replaced with new. The damaged rafters shown here were straightened and braced with new materials as well.

The corrugated metal roofing material was removed from Lakeport Plantation house to expose the original rough sawn cypress skip sheathing which was used for the wooden shingles. Skip sheathing are boards that are typically about six to eight inches wide nailed to the rafters. They are spaced about two inches apart. The spaces are left between the boards to allow for ventilation so the shingles, once wet, can dry from both sides. If not allowed to dry thoroughly, the shingles will deteriorate more rapidly, shortening the life of the roof. The original boards used for the skip sheathing on Lakeport Plantation house were wide and crude with many of them still having the cypress bark on the edges. Some of the boards were shaped like the trunk of the tree from which they were cut, wide at the end and then narrowing, as the trunk of a tree would have. The skip sheathing and rafters above the plantation office were badly deteriorated due to moisture infiltration. The sheathing was replaced and the rafters were braced and straightened. The west porch roof also needed new sheathing, along with several smaller areas of the roof.

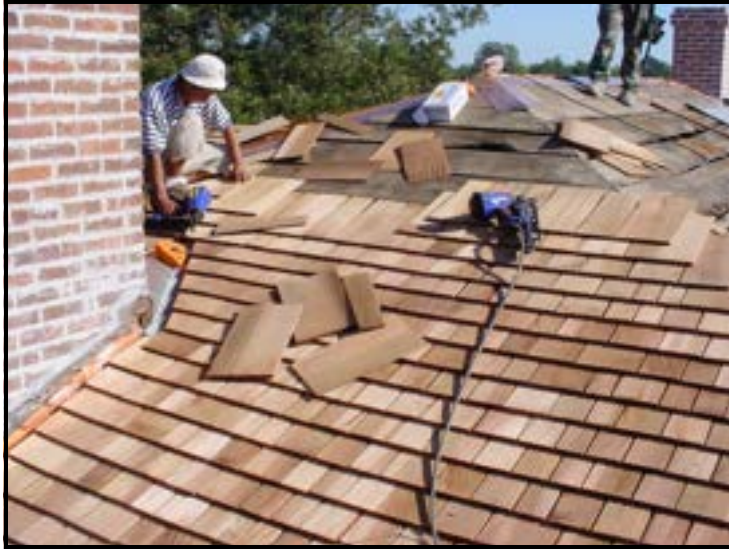
The photo at left shows the new cedar shingles being put on the roof of Lakeport Plantation house. Cedar shingles were used instead of cypress because of the high cost of cypress shingles.

Because the original wood shingles were cypress, it would have been historically correct to go back with the same type of material. Old growth cypress is extremely durable, as well, and the shingles would have lasted for many years. However, the cost of shingles made from old growth cypress was extremely high and, therefore, not feasible to the project. A western red cedar, more commonly used and less costly,

was used instead. Attractive as it ages, cedar turns to a silver-gray color over time. Western red cedar is also rot resistant, which added to its desirability.

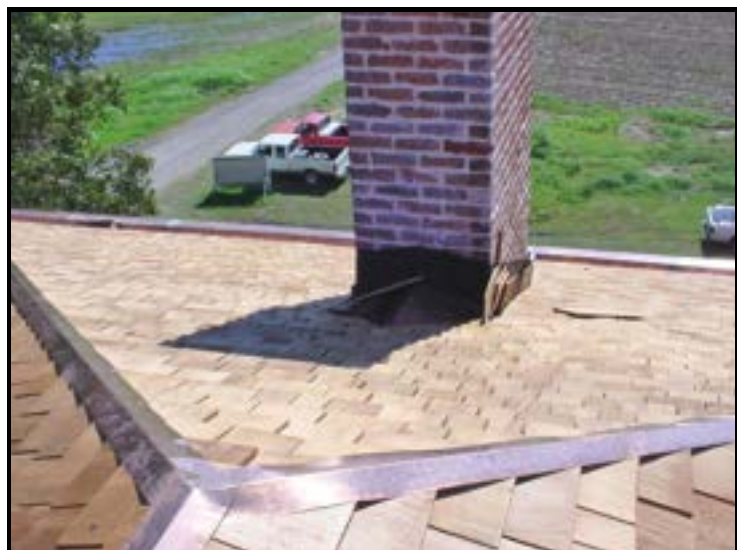
Some of the flashing was also exposed when the metal roof was removed. The flashing was a combination of tin and terne metals and it is uncertain if either material was the original flashing. Terne metal is a metal that has been coated with a lead and tin mixture and can be distinguished from tin by its dull finish.

The photo at right shows the copper flashing covering the ridges of the roof of Lakeport Plantation house. The flashing is used to protect the roof in areas where the shingles cannot; along the ridges, at the hip and in the valleys of the roof.

Tin can last for many years but must be kept painted or it will rust. The flashing serves to protect the roof from water leakage in areas where the roofing material cannot. Flashing lays on top of the roofing material along the ridges and at the hip of the roof. Flashing in the valleys of the roof lays beneath the shingles. A method called step flashing is used where the chimneys protrude from the roof. Metal pieces are cut and shaped to slide under the edge of the shingles and protrude to lay against the side of the chimney. These pieces overlap and run up the roof alongside the chimney in a stair step fashion and protect the roof from leaking around the chimneys. The metal flashing was replaced with copper flashing. Copper material does not rust and will also last for many years.

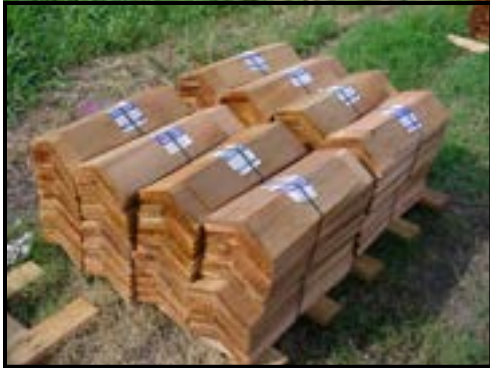
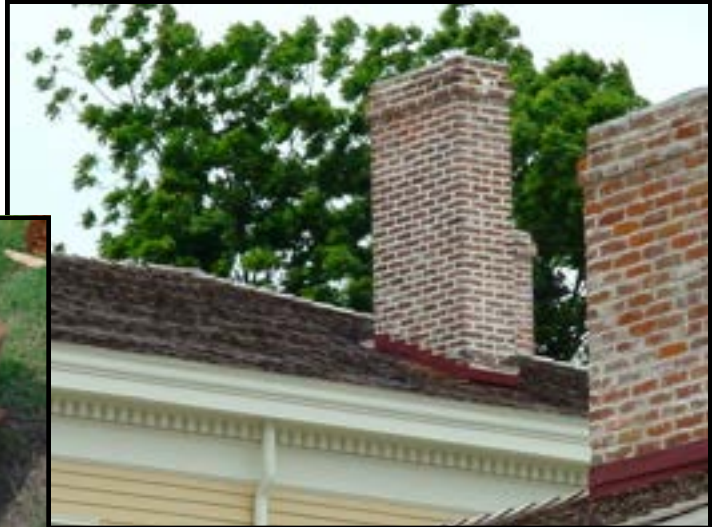
The photo at right shows the roof after completion. The ridge caps cover the exposed ridge flashing and give the roof a finished look. In this photo the cedar shingles have begun to change their color. The photo below shows an up-close view of the cedar ridge caps ready for installation.

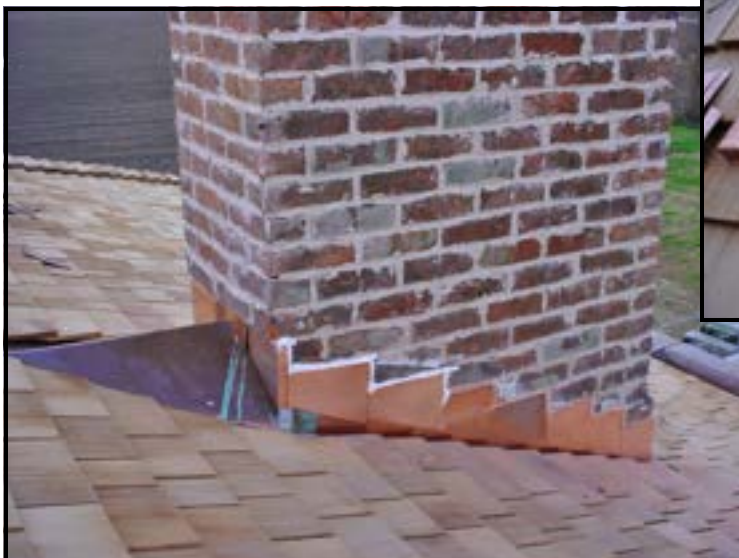
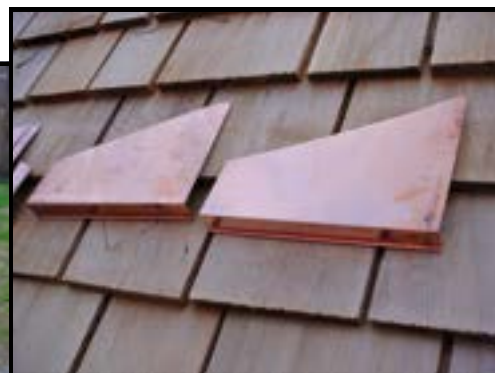
The photo at left shows the step flashing after it was installed on one of the chimneys of Lakeport Plantation house. The photo above shows individual pieces of the step flashing before being installed. The bent ends slide underneath the wood shingles and the rest of the flashing lays against the side of the chimney.

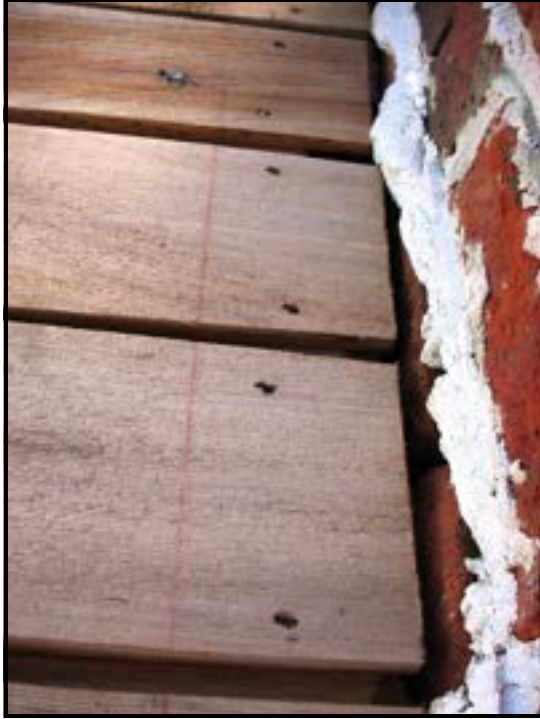
This photo shows some of the wood shingles where the roofing nails were driven with a nail gun to below the surface of the wood. Many of the shingles were cracked and damaged during installation, resulting in several leaks in the new roof. The first roof was completely removed and replaced with a second roof which was installed correctly.

It is important that roofing contractors use craftsmen who are experienced in historic preservation and restoration when replacing or repairing a historic roof. The restoration crew that installed the shingles on Lakeport Plantation house were not knowledgeable about wood shingles and their application. Nail guns were used to apply the wood shingles, and the nails were driven below the surface of the shingles,

damaging the wood, and cracking the shingles. Nail guns are not recommended for use with wood shingles. As a result, the roof began to leak with the first rainfall. The new roof had to be completely removed and replaced.

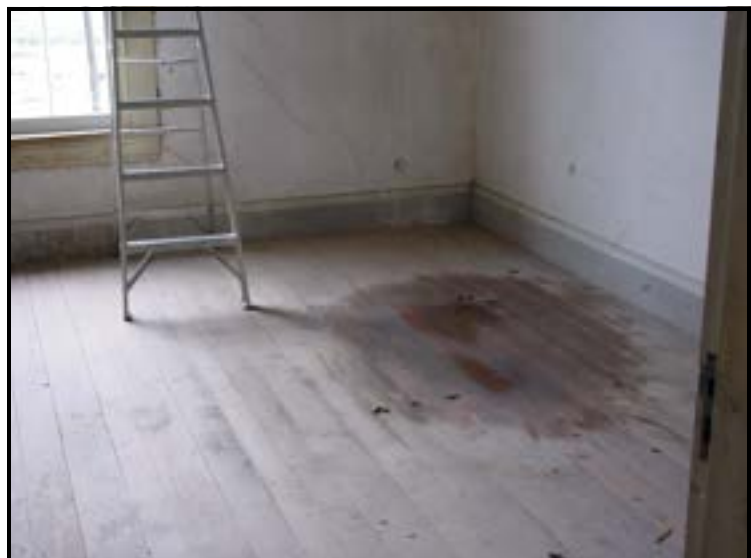
The photo at right was taken after the new roof was installed on Lakeport Plantation house. The water laying on the floor is from a leak in the roof above the nursery. This was only one of several leaks.

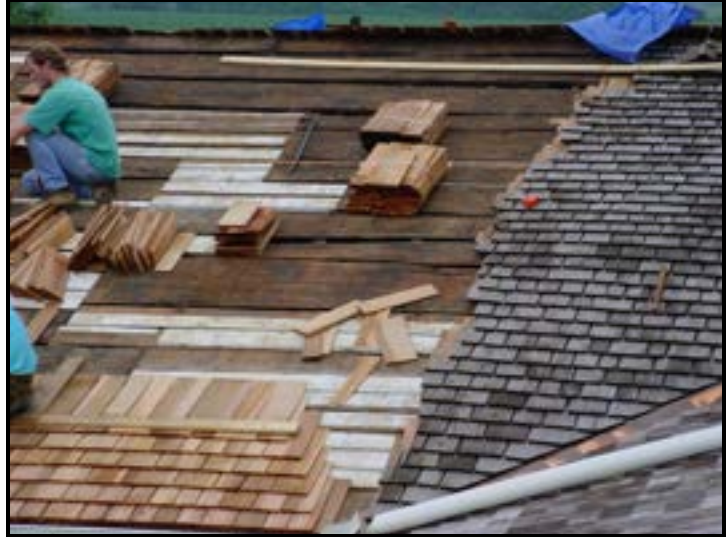
The photo at right shows the first set of shingles as they are being removed from the roof of Lakeport Plantation house and the second set being installed.

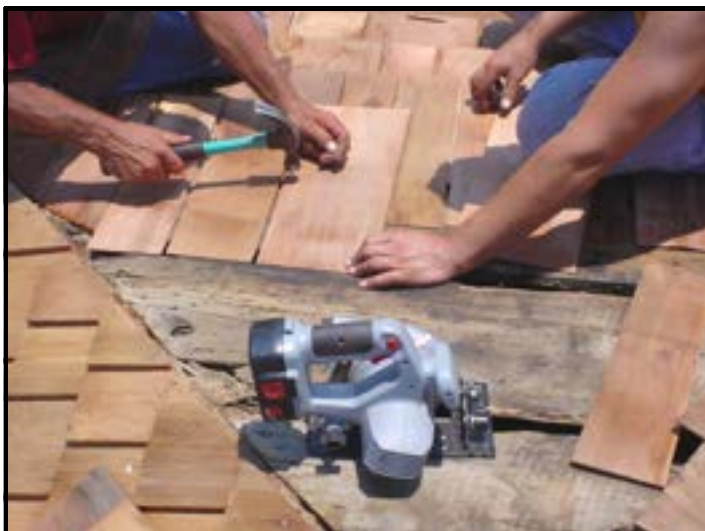
The photo at left shows the correct method for installing wood shingles. The shingles should be placed approximately one-half inch apart to allow for the shingles to expand when wet. Using a hammer, the nails should be nailed flush with the shingle to keep from damaging the shingle.
