# Lakeport Plantation Restoration

Technical Report No. 8

## Lakeport Porches

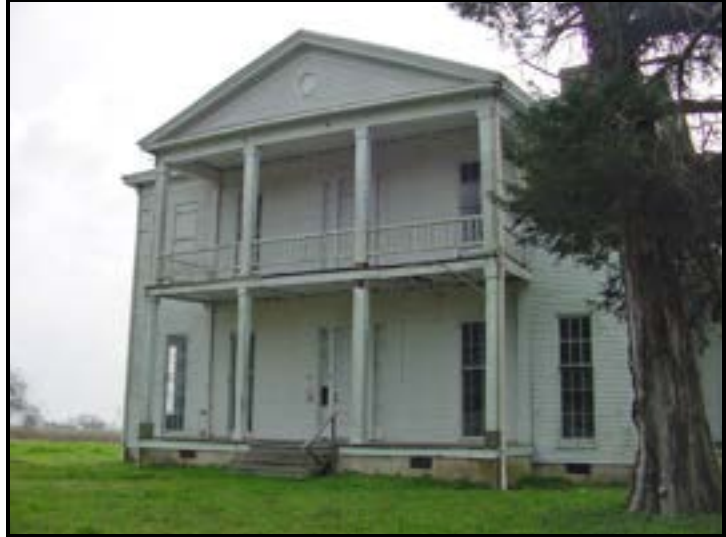
At the time that restoration began, all of the porches on Lakeport Plantation house were in poor condition. Past repairs were evident but only served to cover up the deterioration. Once exposed, it was evident that the front porch was on the verge of collapse. Support beams for the large pediment were badly deteriorated as well as support columns on both floors. The support columns on the outside perimeter of the first floor were deteriorated to the point that only a sliver of wood remained to provide support for one column. The floor joists on both floors were also badly damaged.

Extensive structural damage to the front porch of Lakeport Plantation house was discovered when restoration began in March, 2003.

Temporary bracing was used to support the pediment as the deteriorated porch components were removed. During this time the brick porch foundation was rebuilt and deteriorated floor joists were replaced. When the original floor joists were exposed, it was discovered that they had been built to set slightly higher than the supporting beams. The purpose of this was to allow air to flow underneath the porch decking to prevent moisture deterioration. This same type of construction was used when replacing

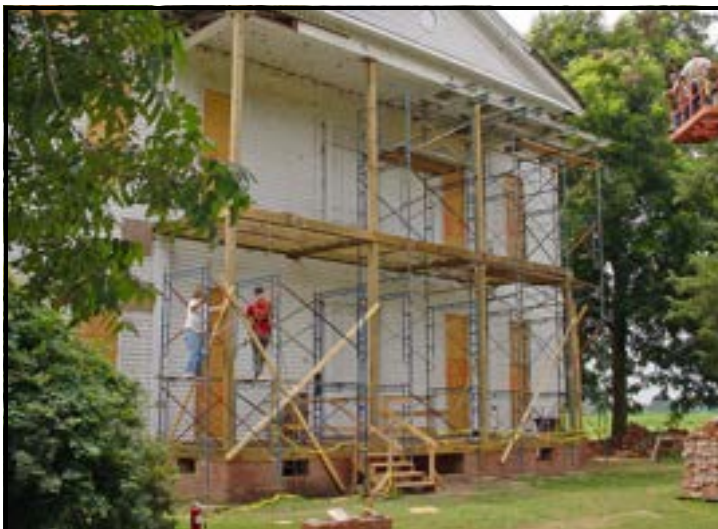
In the photo at left the bracing is being removed from beneath the front porch pediment of Lakeport Plantation house. The bracing was used to support the pediment as deteriorated porch components were removed and new porch framing was constructed.

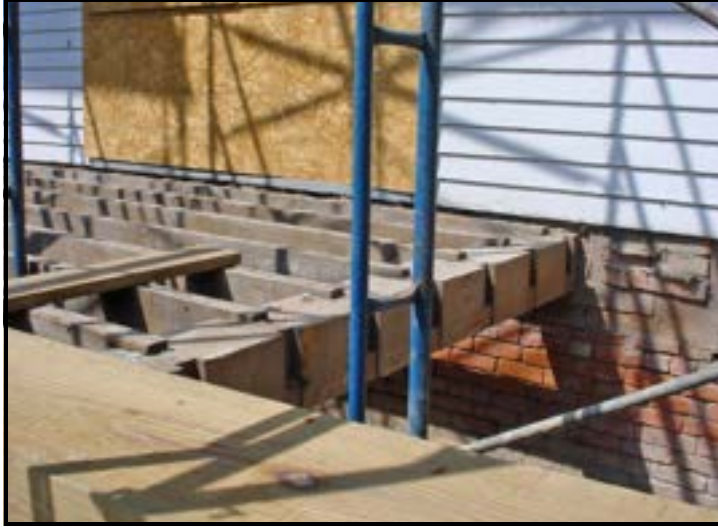
The photo at left shows original floor joists exposed during the front porch restoration. The original floor joists were built to set slightly higher than the supporting beams. The purpose of this was to allow air to flow underneath the porch to prevent moisture deterioration..

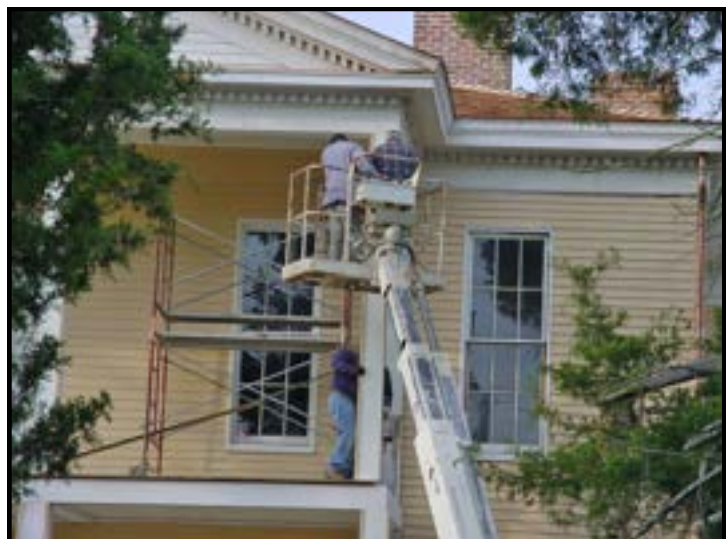
The front porch columns were not original to the house. The original columns would have been square in shape and slightly tapered with capitals at the top and they would have matched the original pilasters. New columns were built to match the existing pilasters. The new columns were constructed using sinker cypress material.

The photo at right shows a newly constructed column being set in place. None of the existing front porch columns were original to the house when restoration began. The deteriorated columns were all removed and replaced with new columns built to match the existing pilasters

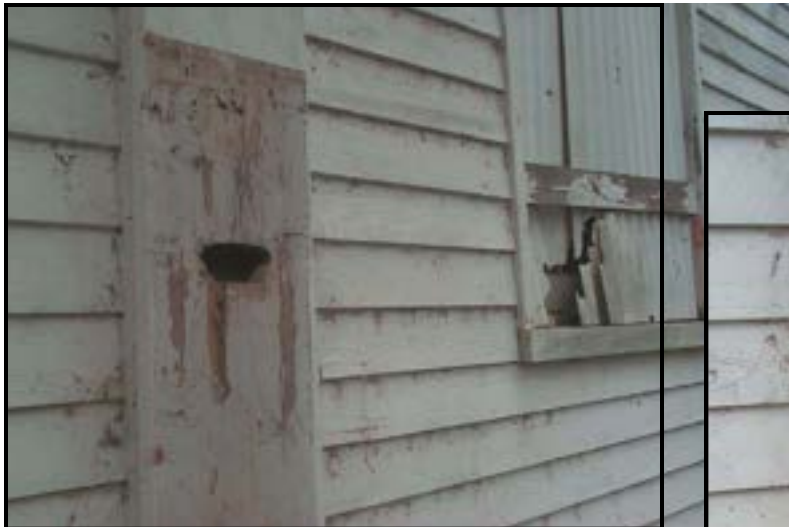
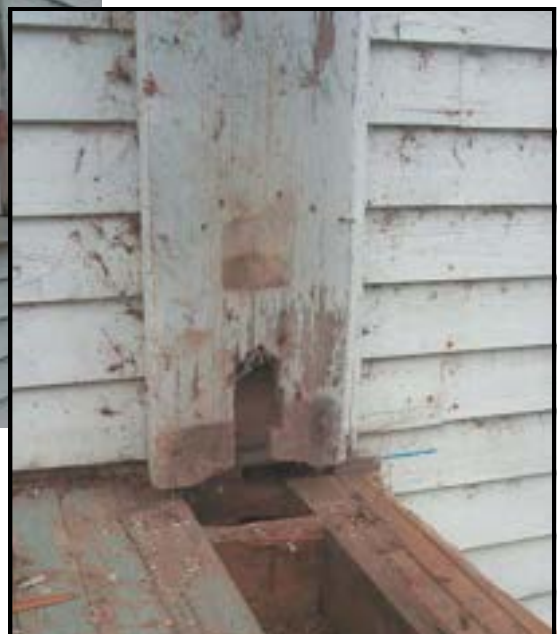
The original front porch balustrades were missing from both floors. The second floor did have a simple balustrade that had been built to replace the original. Mortises of the original handrail and foot rail were uncovered when pieces of sheet metal were removed from the pilasters. This gave information about the shape of the railings as well as the height and how they were attached to the pilasters. Two of the original balusters were found on top of the commissary shelving, providing a model for their exact replication. The porch balustrades were constructed using old growth cypress material that had been salvaged from old industrial buildings in Greenville, Mississippi.

The photos above and at right show profiles of the original handrail and foot rail for the front porch balustrade. These were discovered underneath pieces of sheet metal that were removed from the front porch pilasters. These photos were taken from the Lakeport Plantation Historic Structures Report.

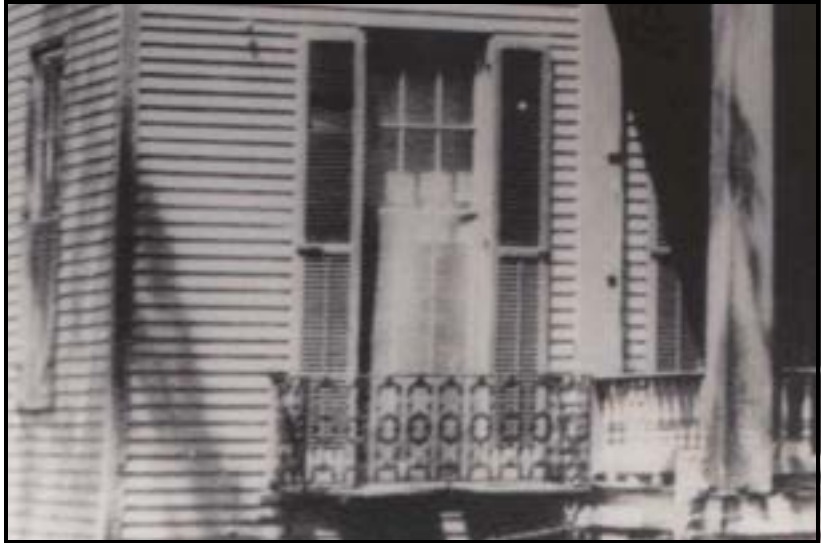
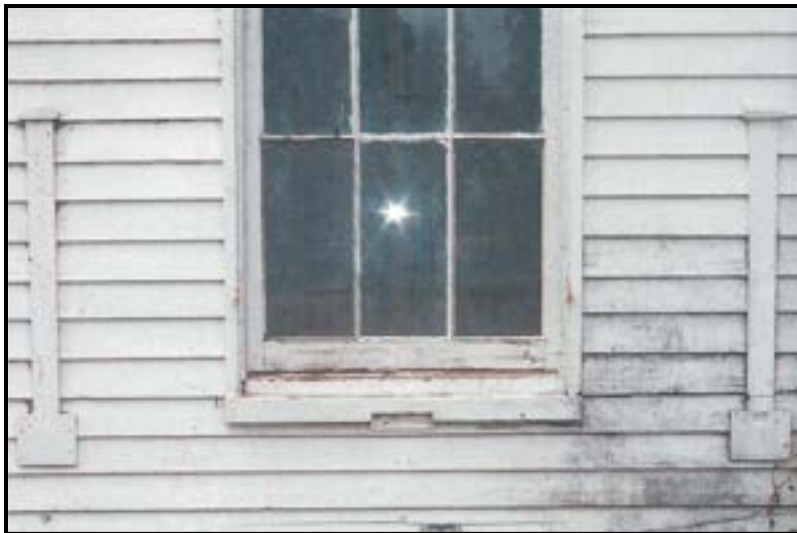
The only remaining evidence of the balconettes, which set on each end of the front porch, was vertical wood supports attached to the siding and a rectangular shaped cut-out below each window. The decorative cast iron was missing. It was discovered that the original cast iron had been removed in previous years and installed on a house in Lake Village, Arkansas. The ironwork was recovered and historic photos were used in the reconstruction of the balconettes.

In the photo at left, evidence of a balconette can be seen in the vertical wood supports on each side of the window and the rectangular shaped cut-out below the window. The photo below shows one of the original balconettes after restoration.

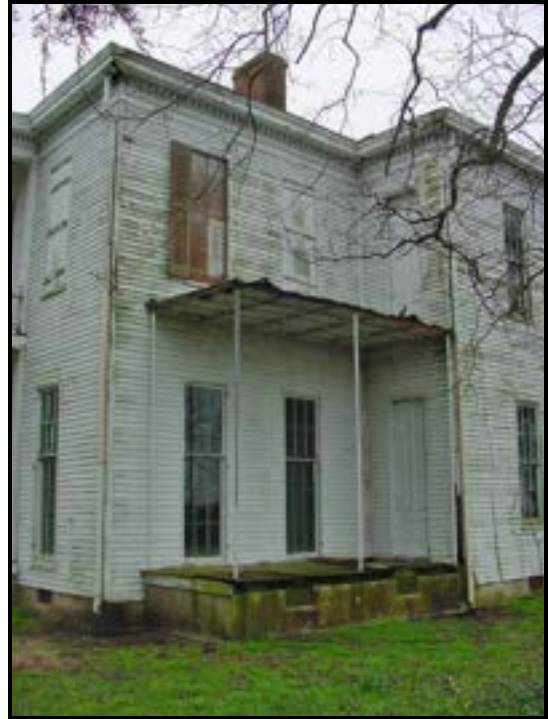
**When** restoration began on the ornamental iron porch, the decorative cast iron columns and balustrades were also missing. All that remained of the original cast iron was the frame, which had been left in place when the rest of the ironwork was removed. The brick foundation walls and floor joists were original but in poor condition and had to be removed and replaced. The existing flooring was not original to the house. It was in poor condition as well and was removed and replaced with a pressure treated pine material. The existing roof was a corrugated tin that had been put

The photo at right shows the ornamental iron porch before restoration began. The decorative cast iron had been removed, the porch foundation and flooring were deteriorated and the original roof had been replaced with corrugated tin. In the photo below the ornamental iron porch has a new foundation and the deteriorated floor joists have been replaced. The cast iron porch framing seen in this photo is original.

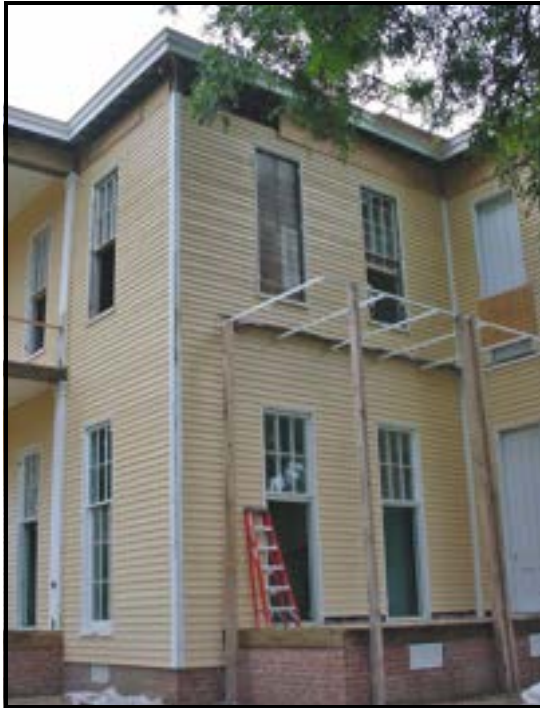
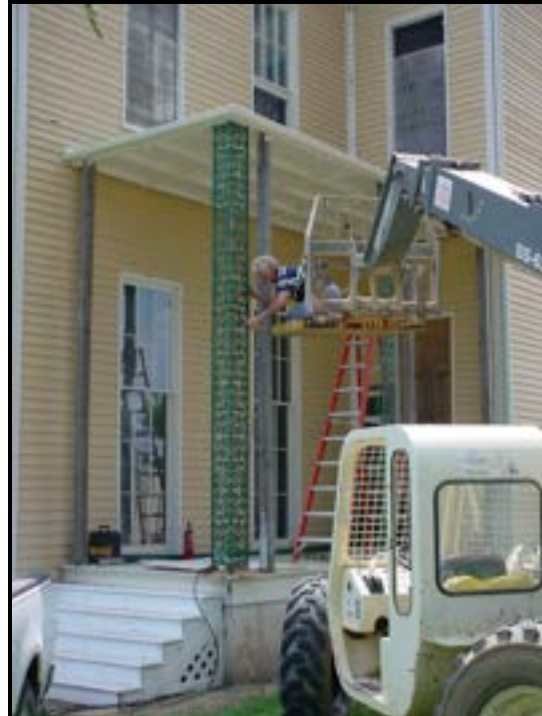
The photo at right shows a cast iron column being returned to its original location on the ornamental iron porch. In the photo below, a restoration sheet metal worker is soldering together the copper for the flat seam copper roof of the porch.

on in the 1950's. From evidence found during restoration, it is believed that the original roof was a traditional flat seam metal roof. Copper was used for the new roof because of its durability. The original cast iron columns and balustrades were recovered from the same house in Lake Village that had acquired the balconettes. The ironwork was restored and, through paint analysis, was returned to its original green color. Once restored, the decorative ironwork was returned to its original location.

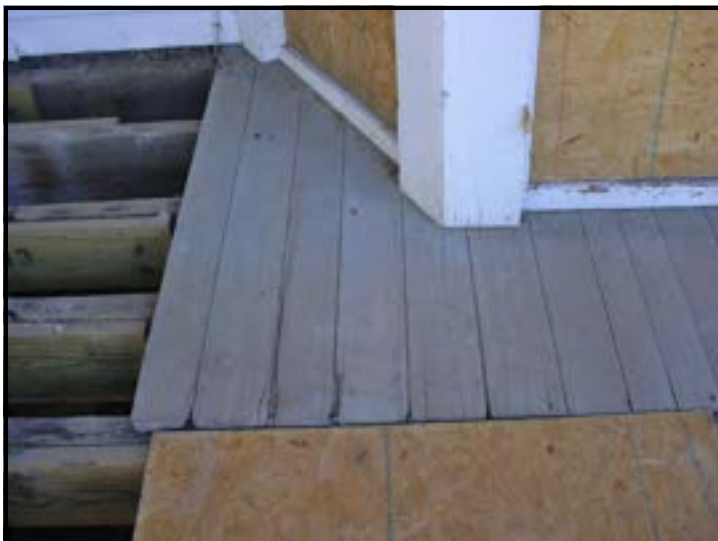
remained when restoration began. Most of the flooring was replacement and in poor condition. All of the flooring was replaced except a small area of the original in front of the bay window. When the floor joists were exposed, about half were deteriorated and in need of replacement. Floor joists for the ell porch were built in the same manner as the other porches, with the joists setting higher than the supporting beams. Deteriorated floor joists were replaced using this same technique. The original brick piers that supported the ell porch were removed and replaced.

The photo at left shows the original tongue and groove flooring that was left around the bay window area of the ell porch.

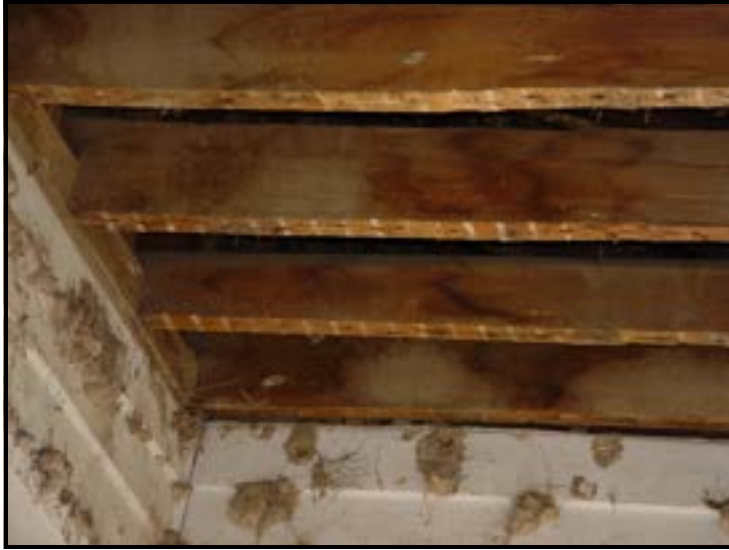
The ceiling of the ell porch was a beaded board that was believed to be original. Poor installation and deterioration required its removal during restoration. When the ceiling material was removed, it was discovered that this was not the original ceiling. Surprising evidence showed that the original ceiling was constructed of lathe and plaster. It was concluded that the lathe and plaster ceiling had failed rather early as the beaded board ceiling construction was dated to sometime between the 1870's and the 1890's. A new lathe and plaster ceiling was built to replicate the original ceiling, using a modern cement based plaster. A cement based plaster is much harder and more durable for exterior use than the soft, lime-based plaster that would have been used originally.

In the photo at left marks left by the original lathe and plaster ceiling can be seen. Evidence of the lathe and plaster ceiling was discovered when the second ceiling was removed from the ell porch.

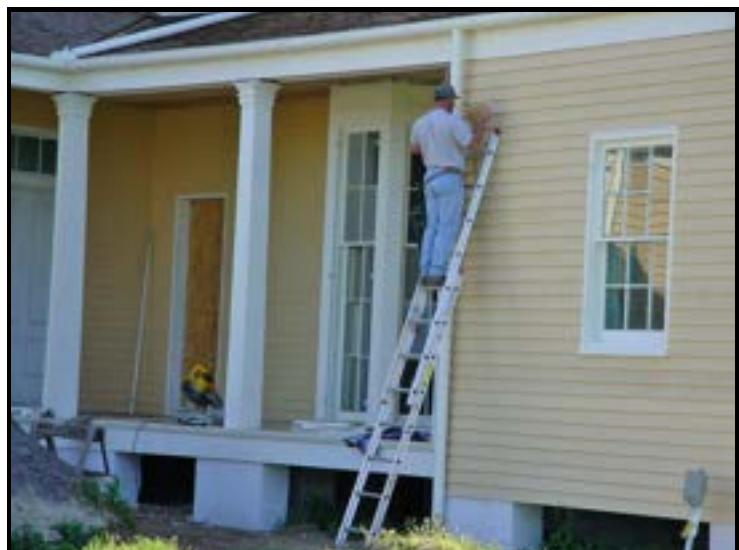
replacements and did not match the original. Repairs were made to the original and new columns were reproduced to match. The one pilaster on the south end of the porch was also original. A matching pilaster was also constructed for the opposite end. There was no evidence of a balustrade on the ell porch. For safety purposes, a metal guardrail was hand fabricated and mounted along the outside edge of the ell porch.

In the photo at right new columns have been constructed and set in place on the ell porch. The columns on the ell porch are built to match the columns on the front porch of Lakeport Plantation house

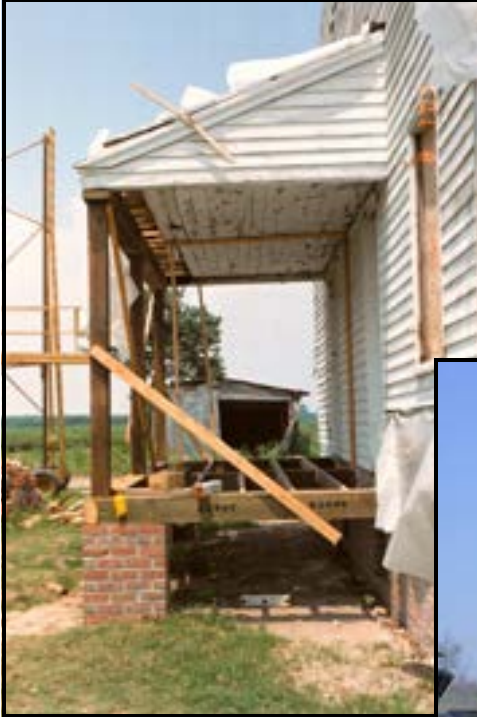
Before restoration began, excavation by the archeologists had revealed that the brick piers supporting the west porch had slid off of their original footers. When restoration began, the west porch was in dangerous condition. The flooring was decayed and the porch roof was being supported by 2"x4" boards. The bead-board ceiling was all that remained of the west porch that was original and in good condition. This ceiling also matched the front porch ceiling. New piers were built on the original footers and all new flooring was constructed. New columns were built to match the front porch columns and the original ceiling was left in place. A metal guardrail was mounted along the outside edge of the porch.

In the photo at left new piers have been built and new framework is being constructed for the west porch. In the photo below new columns are near completion for the west porch.

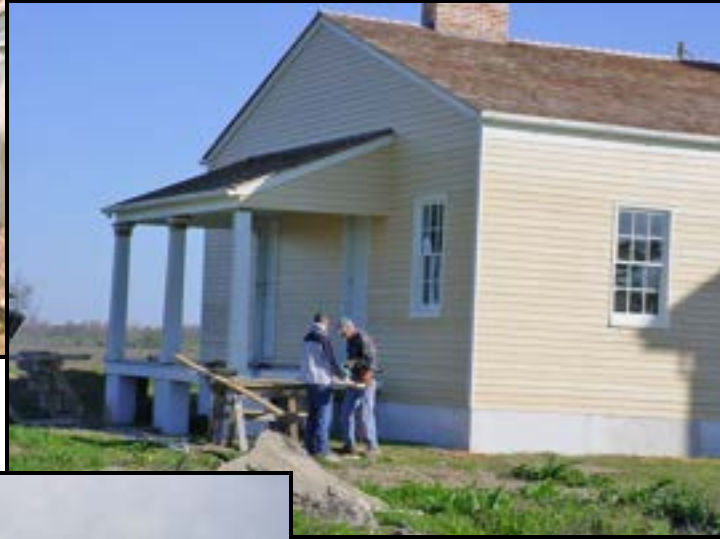
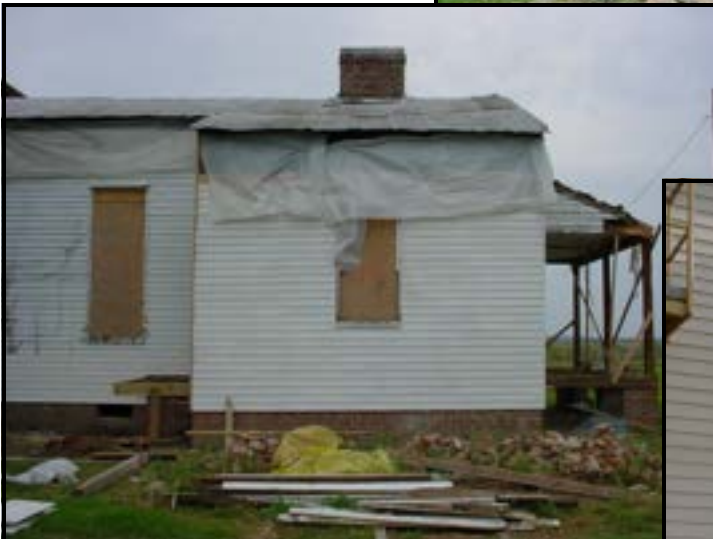
The stoop on the northwest side of the house was completely removed and rebuilt. Some of the original porch decking was used in the rebuilding. A new brick pier was built to support the stoop.

The photo above shows restoration work beginning on the stoop on the north side of Lakeport Plantation house. The stoop was completely removed and rebuilt. In the photo on the right the stoop is near completion.

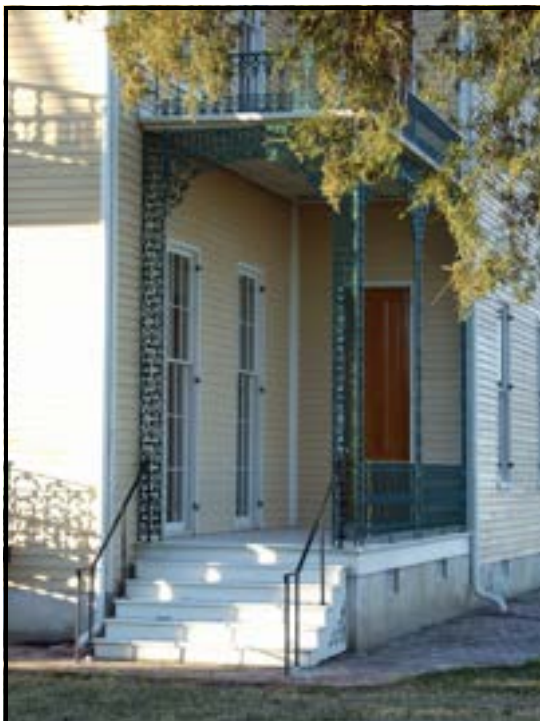
When restoration began, all of the porch steps were replacements. It is not known in what fashion the original steps were built. Historic, circa 1925, photos show wooden steps on all porches visible. However, because of the age of the house at that time, it is unlikely that these steps were original. Wooden steps with closed treads, traditionally found on homes of that period, were constructed for all of the porches. Metal handrails were installed on all of the porch steps for safety purposes.

The photo at left shows wooden steps that were built for the ornamental iron porch. Wood steps with closed treads were built for all of the porches of Lakeport Plantation house.
