# Lakeport Plantation Restoration

Technical Report No. 3

## Foundations & Footers

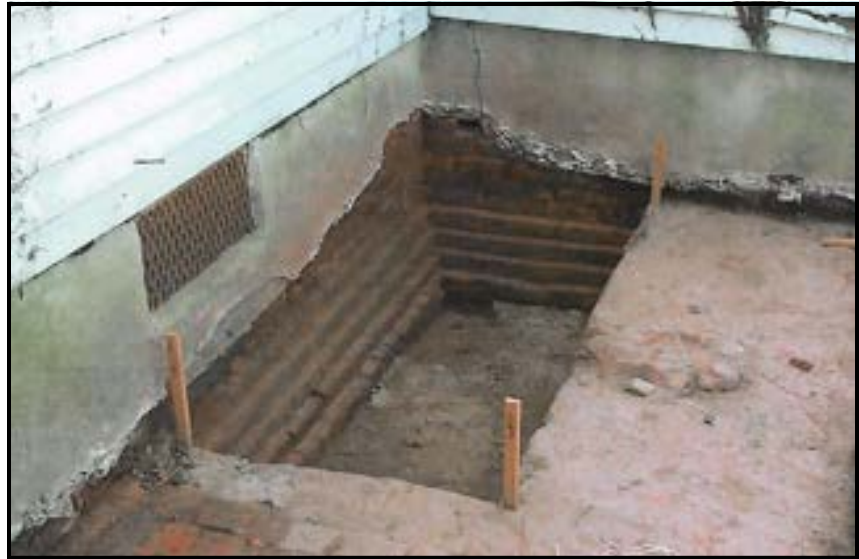
The photo above shows the corbelled brick footer that was uncovered by the archeologists during excavation of the grounds around Lakeport Plantation house. This photo was taken from the Historic Structures Report for Lakeport Plantation.

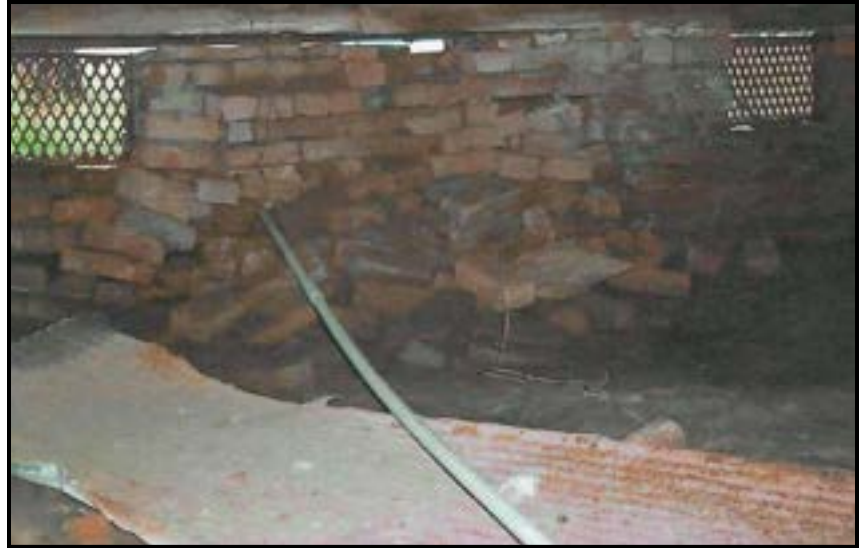
The exterior foundation walls were in poor condition. Settling had caused the majority of the foundation walls to be uneven and the north foundation wall was collapsing. Prolonged water exposure on the north side of the house had caused the mortar between the bricks to deteriorate and the foundation walls to collapse. The original plan was to disassemble the exterior foundation walls and reuse the salvaged bricks to rebuild the foundation walls. However, the hard portland cement that had been used to parge coat the exterior foundation walls in more recent years had a much stronger bond than the lime-based

The photo at right shows a view from underneath Lakeport Plantation house of the exterior foundation wall on the north side of the house. Years of water exposure had caused the mortar between the bricks to deteriorate and the foundation wall to crumble. This photo was taken from the Historic Structures Report for Lakeport Plantation.

mortar used for the original parge coating, making its removal impossible without causing serious damage to the soft, handmade bricks. The remaining bricks were spalling, or crumbling badly, due to prolonged water exposure. All of these factors combined resulted in the need to replace the exterior foundation walls.

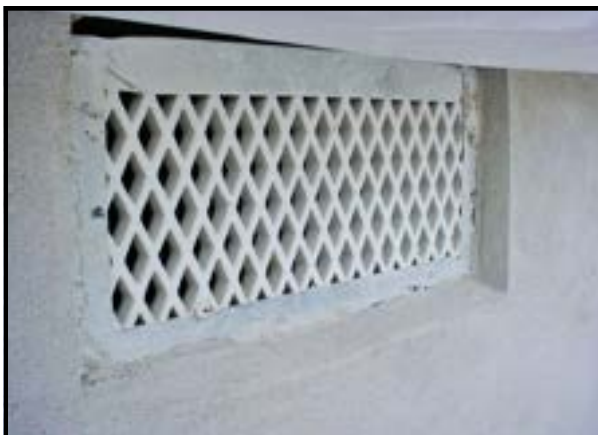
The photo at left shows one of the ornamental cast iron foundation vents after being sandblasted, painted and reinstalled in its original location. This photo was taken after the exterior foundation walls had been parge coated.

Ornamental cast iron foundation vents, seen in early photographs of the house, are believed to be original to the house. All of the foundation vents were carefully removed, sandblasted and then painted before being reinstalled in their original locations. There was no need for duplication of the vents as they were all in reusable condition and none were missing.

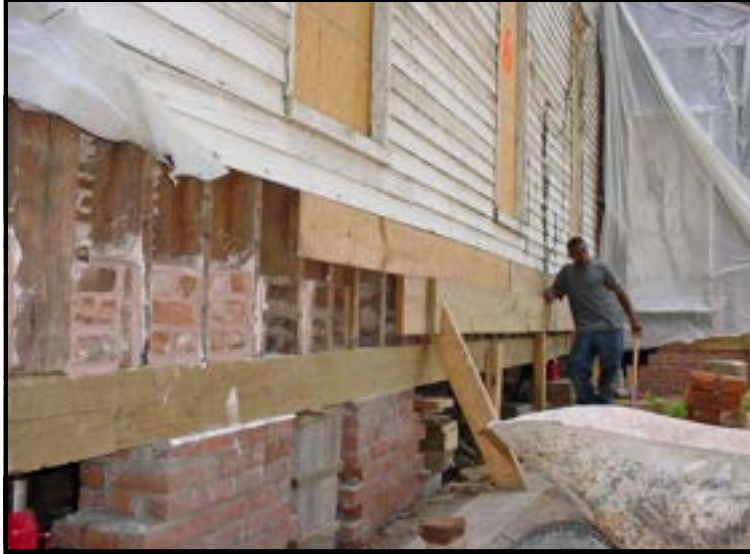
The photo at left shows a large sill beam that has been replaced, resting on top of the partially rebuilt foundation wall of Lakeport Plantation house. The sill beams support the floor joists and walls of the house.

During the removal of the foundation walls, large sill beams measuring approximately seven and one-half inches by twelve inches were exposed. The sill beams are the beams that set on top of the foundation walls and support the floor joists and walls of the house. Deteriorated sill beams were removed

and replaced with pressure treated southern pine materials. The sills and walls were held in place with hydraulic jacks and kicker boards to support the existing structure during the removal process.

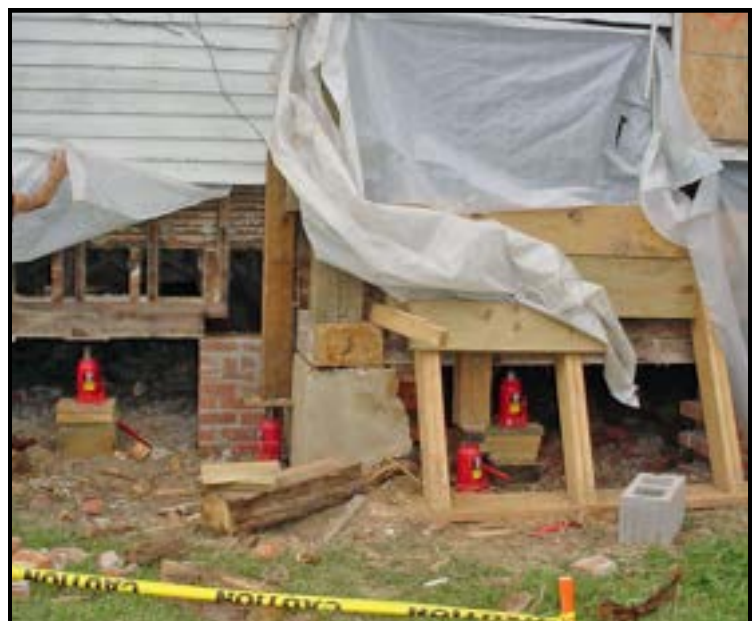
The photo at right shows the framing of Lakeport Plantation house being supported with hydraulic jacks and kicker boards during removal of the exterior foundation walls. The foundation walls were disassembled in short sections and rebuilt using reproduction "handmade" bricks.

All of the exterior foundation walls were carefully disassembled in short sections and then reconstructed on the existing footers using the new bricks. When laying bricks, the mortar should act as a bedding for the bricks. The mortar is laid with a trowel first and the new brick is pressed into place so that the mortar is pushed against all of the surrounding bricks. The strength of the bricks depends upon the quality of the mortar and the bond. The bond consists of various brick coursing patterns. Typical brick coursing patterns are running bond, which consists of all stretchers, common bond consisting of five rows of stretchers and one row of headers and Flemish bond, which consists of alternating rows of stretchers and headers. Bricks laid with the longest side exposed are called stretchers and bricks laid with the end exposed are called headers. The new foundation walls were laid in a running bond pattern.

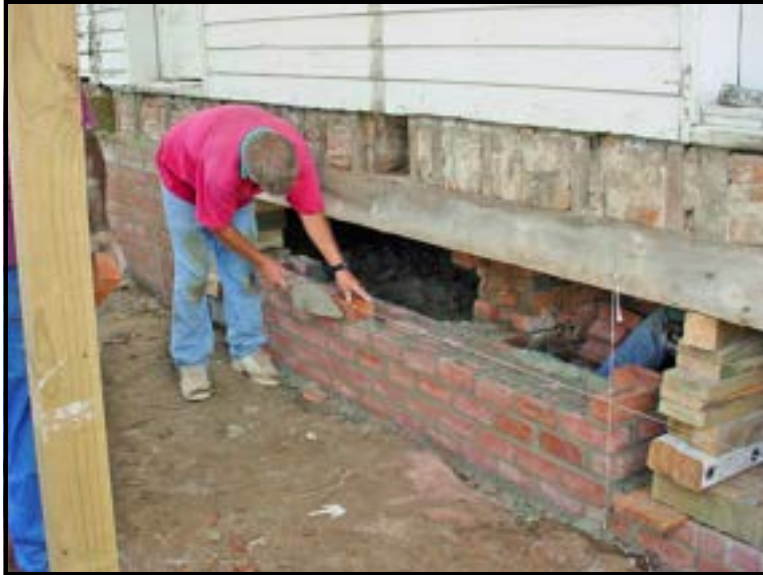
The photo at left shows a brick mason laying the new exterior foundation wall. The foundation walls are three bricks thick and ten courses high and set on top of the footers. There are foundation walls to support all interior as well as exterior walls.

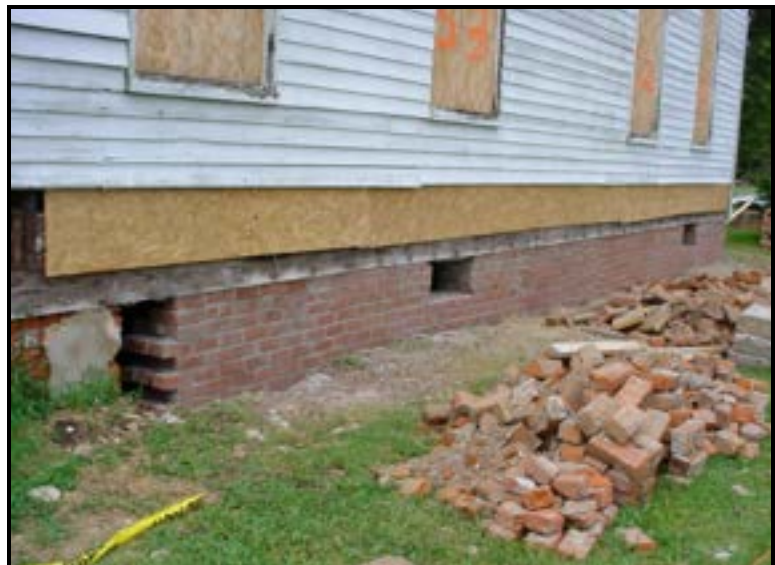
The photo at right shows a large section of the exterior foundation wall after being rebuilt. The brick piles are the original historic bricks that were disassembled and removed. The historic bricks were too deteriorated to be salvaged and reused.

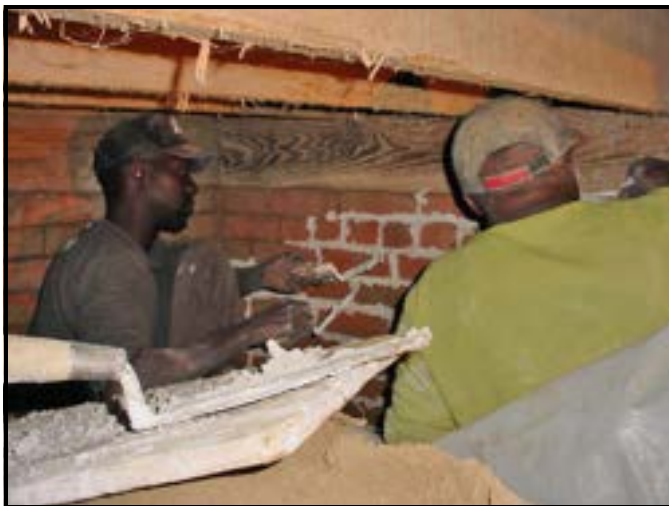
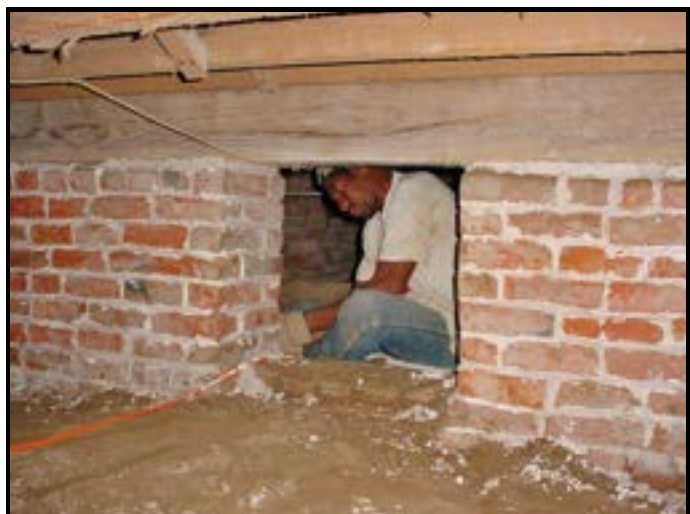
The photos at left and below show the brick masons working underneath the house, repointing mortar joints of the interior foundation walls. The mortar had deteriorated over the years and had to be removed and the foundation walls repointed.

For repointing the mortar joints of the interior foundation walls, where the historic brick remains, a traditional lime based mortar was used. Samples of the original mortar were taken from Lakeport Plantation house and sent to Wollenberg Building Conservation, LLC, in St. Louis, Missouri, to be analyzed. Results of the testing can be found in the Historic Structures Report for Lakeport Plantation. This report helped to determine the composition of the lime mortar that was used for repointing the interior foundation walls.

**When repointing mortar joints, the old mortar should be removed to about two to two and one-half times**

the width of the joint and deeper if necessary to ensure an adequate bond. It is best to remove the old mortar with hand tools. Power tools are often used to remove mortar from modern bricks but can cause serious damage to the soft historic bricks. Joints should be cleaned to remove any loose mortar and the bricks should be dampened prior to repointing. It is best to fill the mortar joints a layer at a time allowing each layer to dry before applying the next layer.
