# Lakeport Plantation Restoration

Technical Report No. 1

## Parge Coating

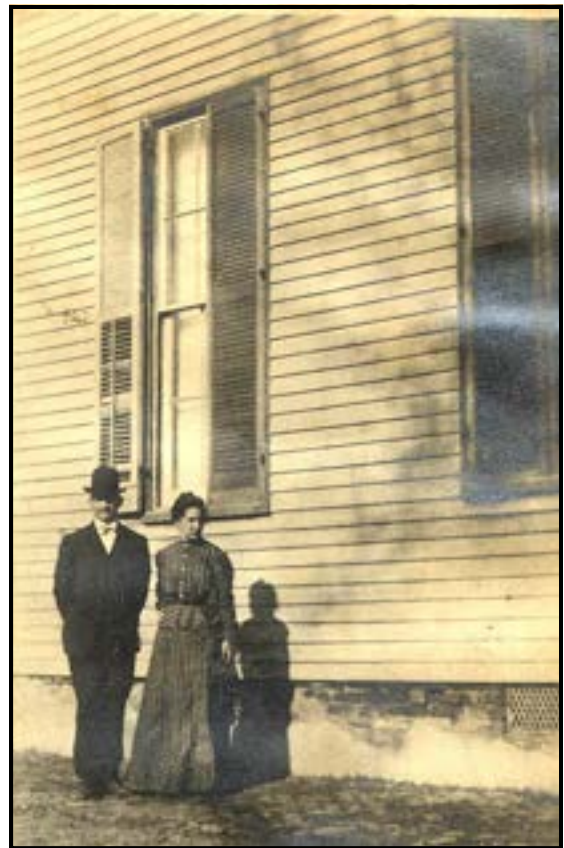
This photo of Lakeport Plantation house, taken during the early 1900's, shows the original parge coating on the foundation walls. This photo was provided by descendants of the Johnson family.

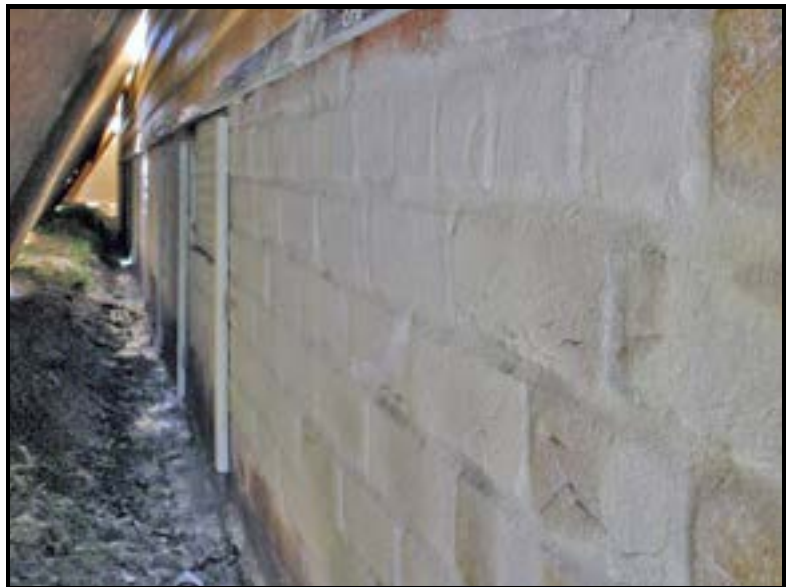
This photo shows the foundation walls of Lakeport Plantation house after the limewash was applied. Notice how the walls have been covered with sheets of plywood to protect the limewash from the sun to prevent quick drying.

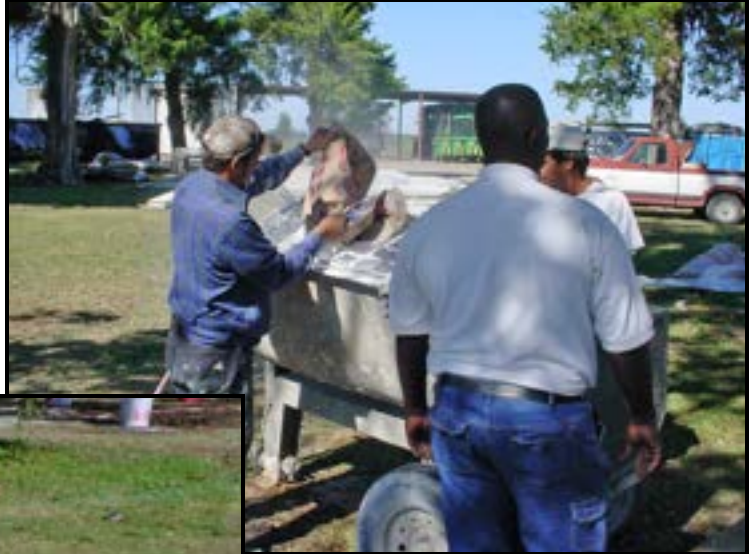
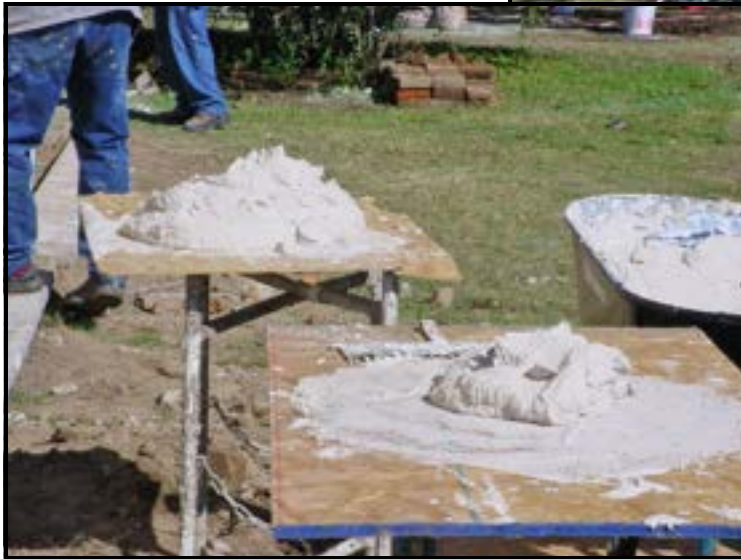
Photos of the restoration crew preparing the lime-based mortar mix used for parge coating the exterior foundation walls of Lakeport Plantation house.

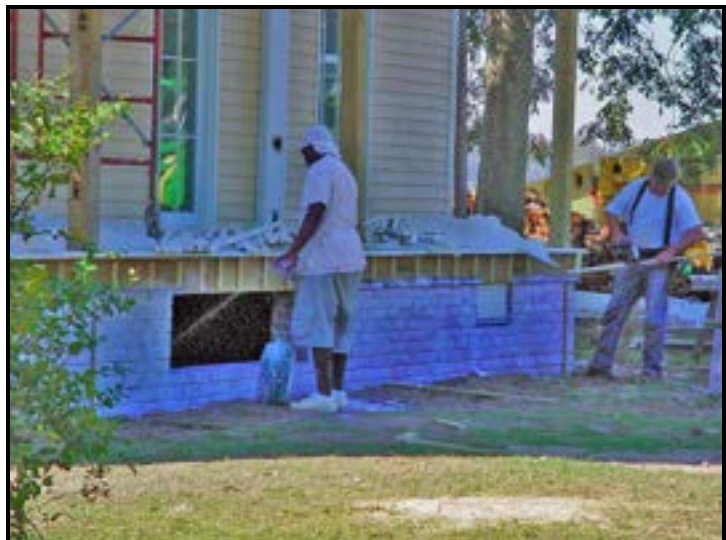
The photo above shows a restoration crew member misting the coat of limewash which will allow it to dry without cracking or flaking. To his right another crew member is applying the thin strips of wood called screeds which will be used to apply the plaster evenly.

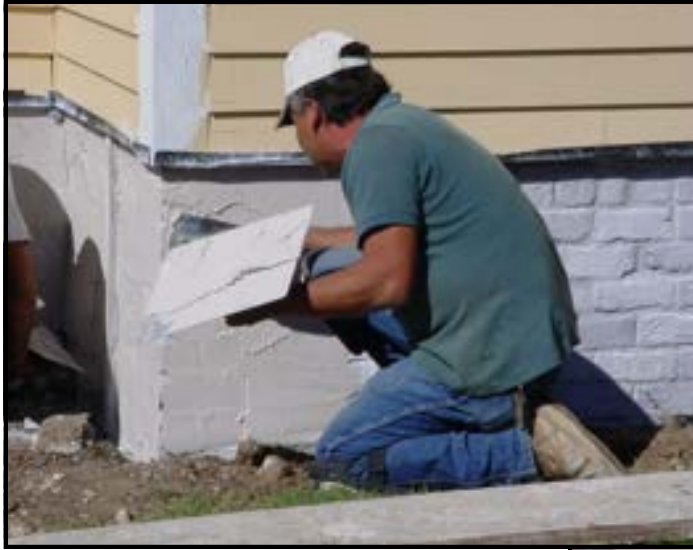
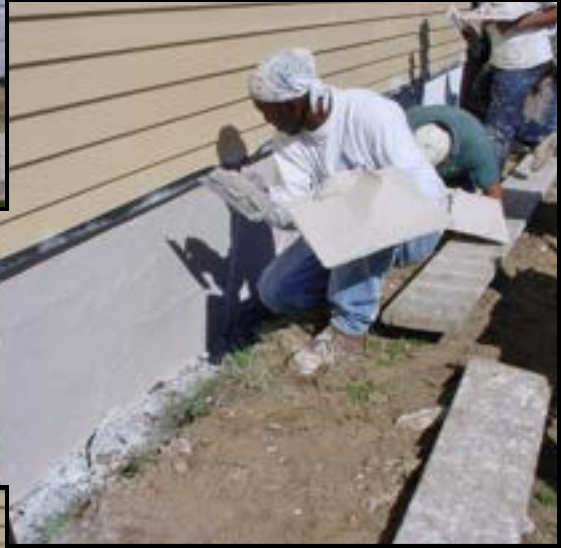
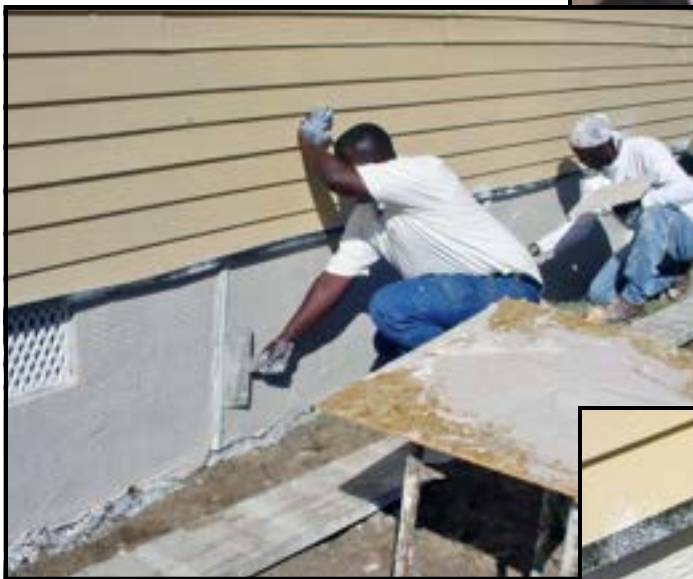
The photos at left and below show the scratch coat being applied to the foundation walls of Lakeport Plantation house.

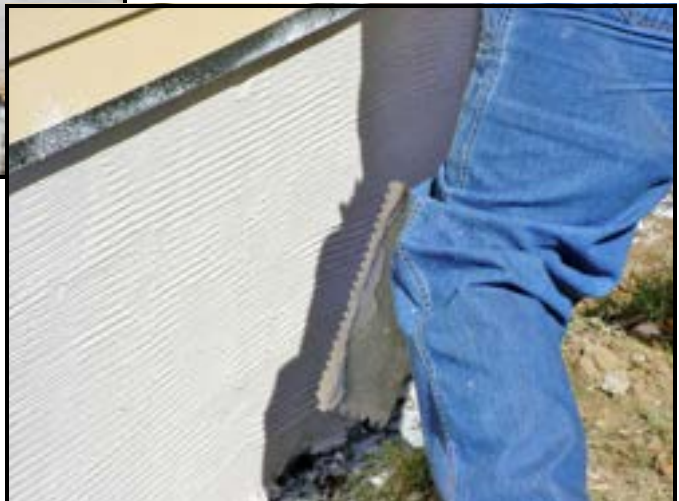
The photo at right is a close-up of the scratch coat after being raked or "scratched".

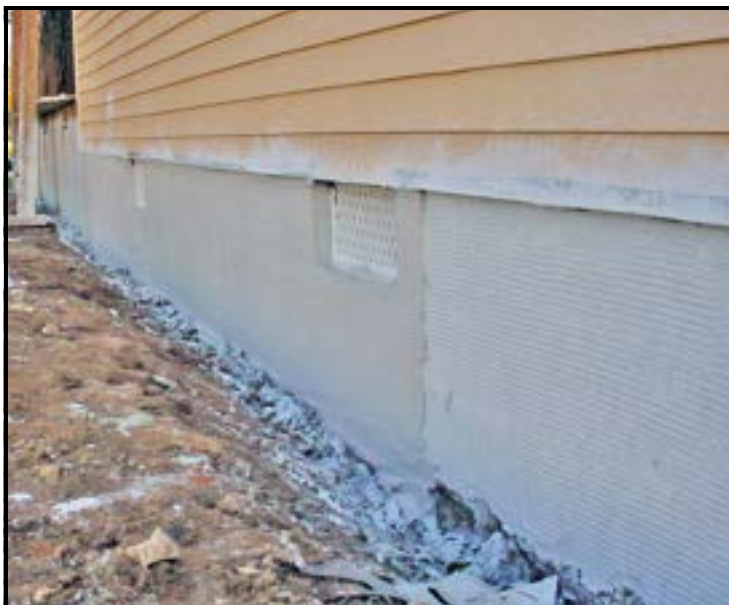
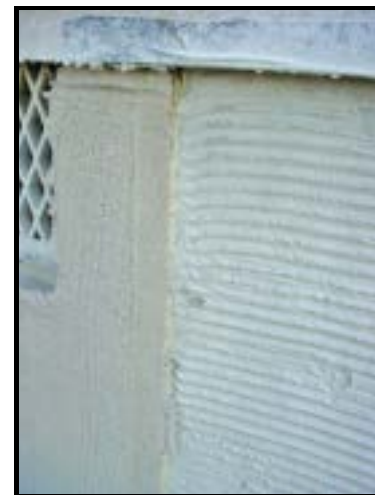
The photo at left shows a view of the scratch coat and brown coat applications side by side. The photo above shows an up-close view.

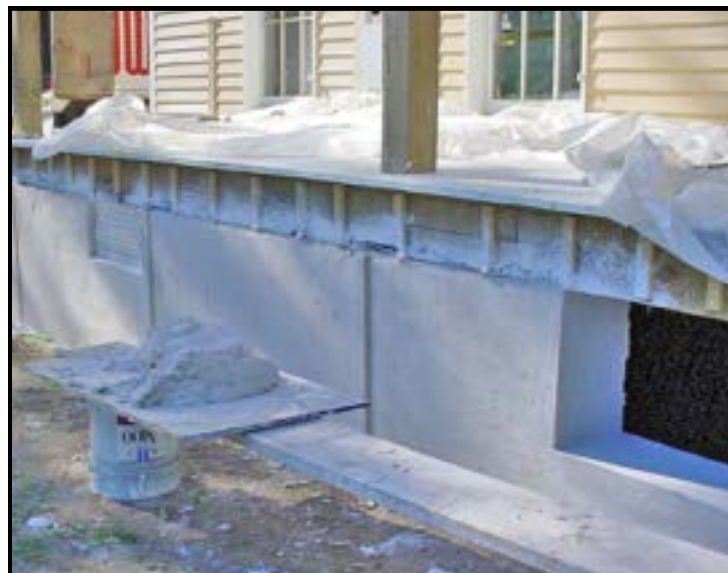
The photo at right shows the lime mortar ready to be used to fill voids left by the screed strips when removed after the brown coat was applied.

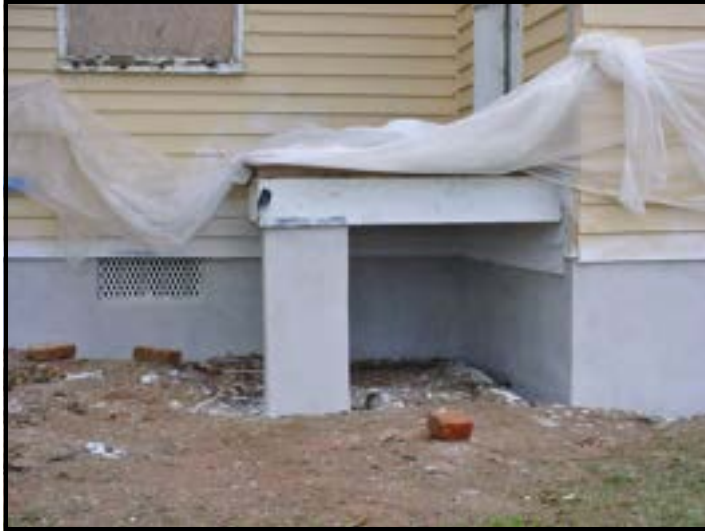
The photo at left shows the finished parge coating on the north side of Lakeport Plantation house. Notice the sheets of plastic attached to the siding of the house. The plastic was used to cover the plaster and protect it from the weather, allowing it to cure properly.

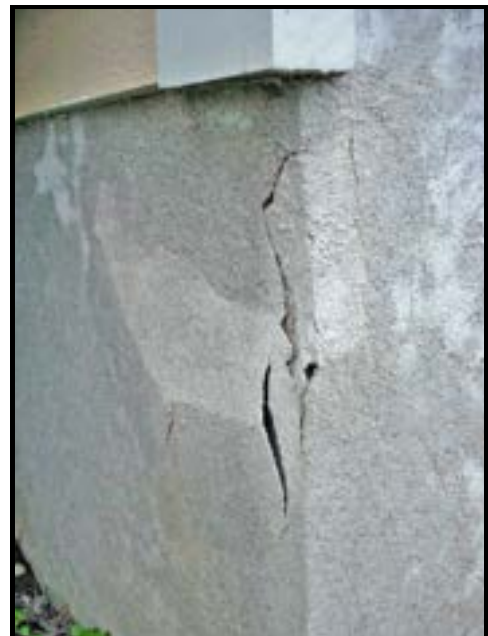
The parge coating on the foundation walls of Lakeport Plantation house has failed in several areas. In some areas the plaster has cracked and buckled and in other areas it is pulling away from the foundation wall. Some of this is due to the brick and plaster not being dampened enough to assure a tight bond during application. The modern brick that was used to replace the foundation walls is a harder brick than the original and is not as porous, meaning that it does not absorb moisture as easily. The modern brick would have required prolonged irrigation to become damp enough for the plaster coating to bond tightly.

The photo above shows the parge coating on a corner of the foundation wall where it has cracked and buckled. This is largely due to the plaster not being dampened enough to assure a tight bond during application.
