# Lakeport Plantation Restoration

Technical Report No. 7

## Cornice, Siding & Paint

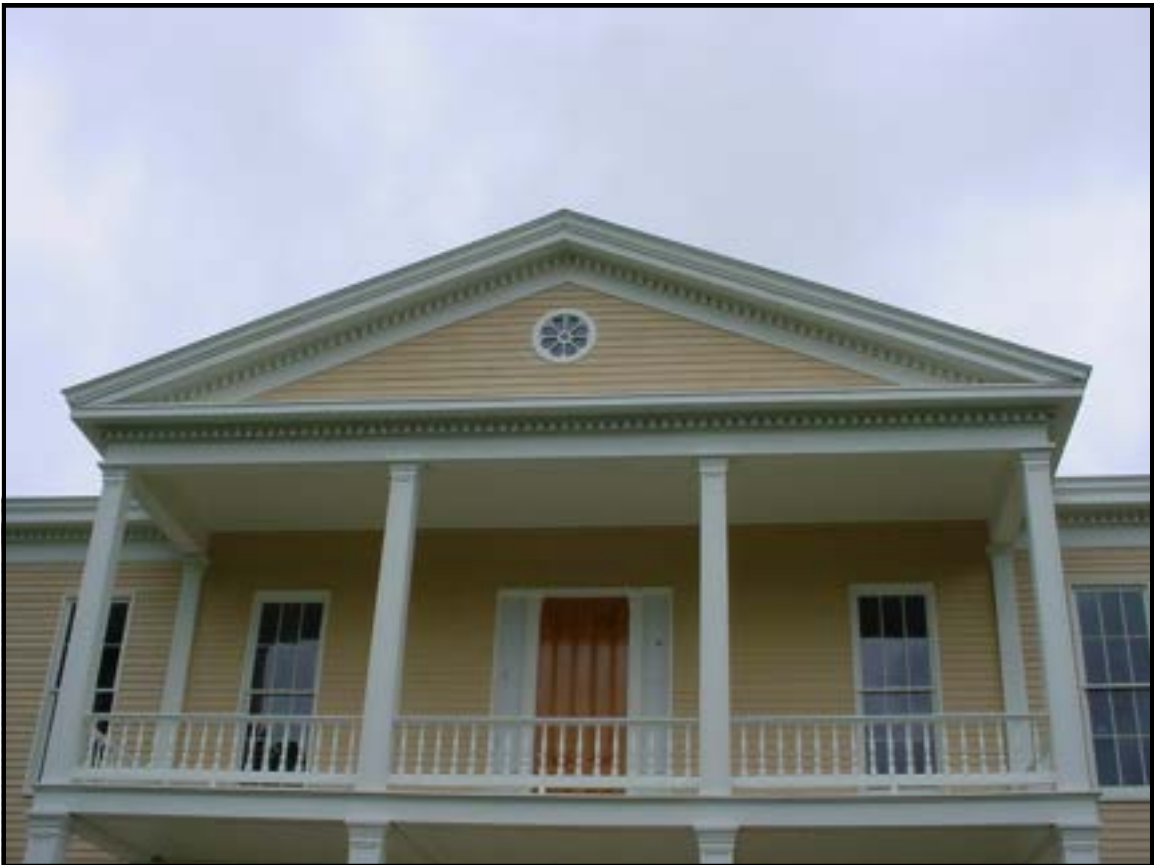
This photo was taken in March, 2003, before restoration had begun on Lakeport Plantation house. Painted white, the decorative trim blended with the siding and was hardly noticeable.

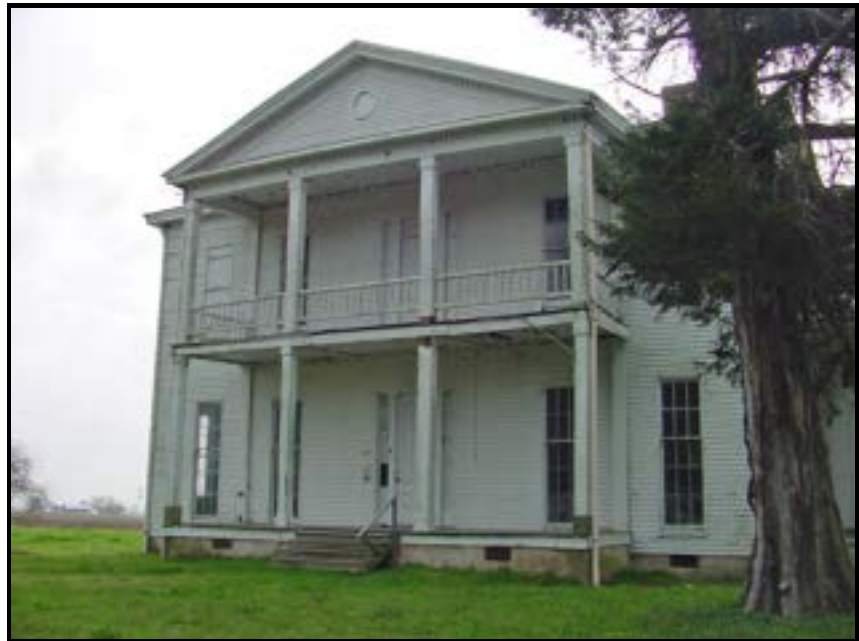
When restoration began, Lakeport Plantation house had been painted white for many years. The paint was worn, the siding weathered. The decorative trim that helped to define the Greek Revival architectural style of the house blended with the lap siding and was hardly noticeable. At a glance, the house appeared to be a plain and ordinary farmhouse suffering from years of neglect. With a closer look, however, one began to notice embellishments that hinted of the house's former beauty. With the completion of the first phase of restoration, the creamy white cornice, dentil molding and wide frieze board stood out against the golden yellow siding, framing the house. It was then that the house began to tell of its grand beginnings.

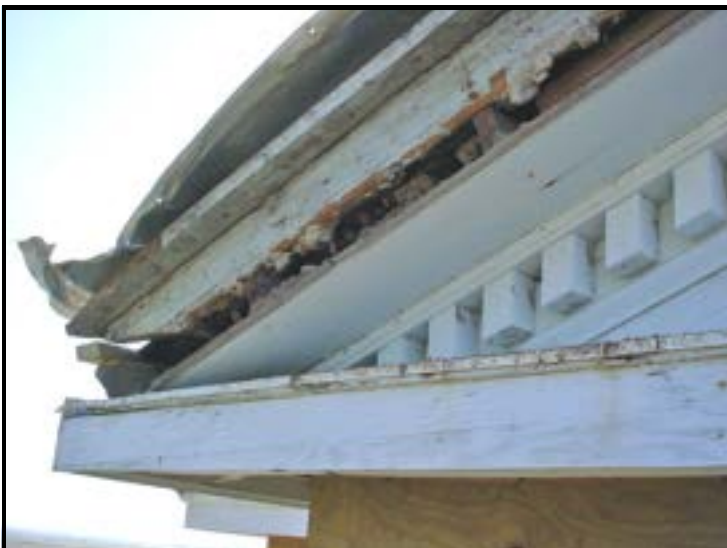
The photo at left shows the deterioration of the cornice before restoration began. The cornice assembly was rebuilt using reproduction moldings that were custom milled to match the profiles of the original moldings.

The original cornice, dentil moldings and frieze boards were removed for restoration of the box gutters. Plans were to reuse as much of the original material as possible. Most of the cornice moldings and frieze boards were in poor condition and could not be salvaged. The dentil moldings on the west side of the

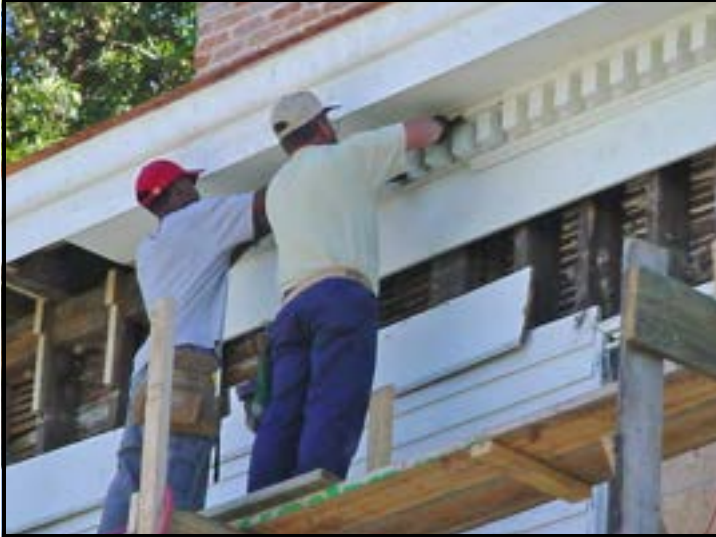
The photo at left shows Lakeport restoration workers putting up new dental molding on the west side of the house. The dental molding on this side of the house had been removed in earlier years and was never replaced.

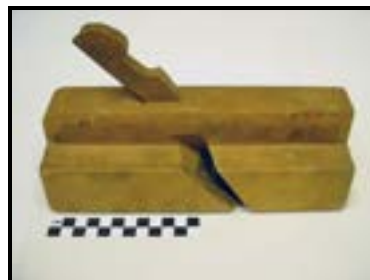
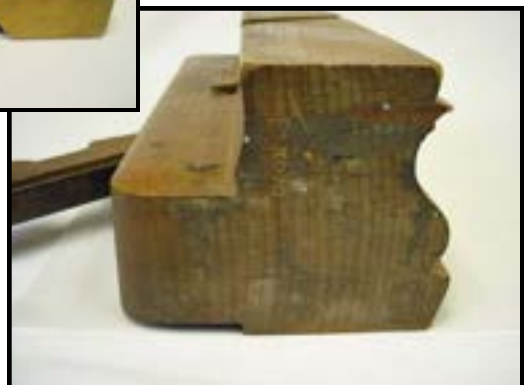
These photos show a nineteenth century molding plane that would have been used by craftsmen of that period to produce decorative moldings. The photo at right shows the molding profile of this plane. This molding plane is a part of the Sam Strauss Collection of Historic Woodworking Tools, a collection belonging to the Arkansas State University Museum in Jonesboro, Arkansas.

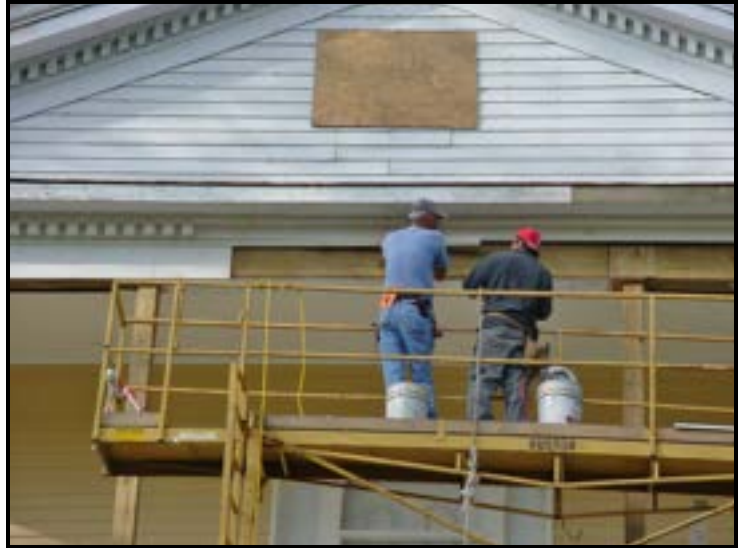
The photo at right shows restoration workers laying the frieze board and bed moldings below the front porch pediment of Lakeport Plantation house.

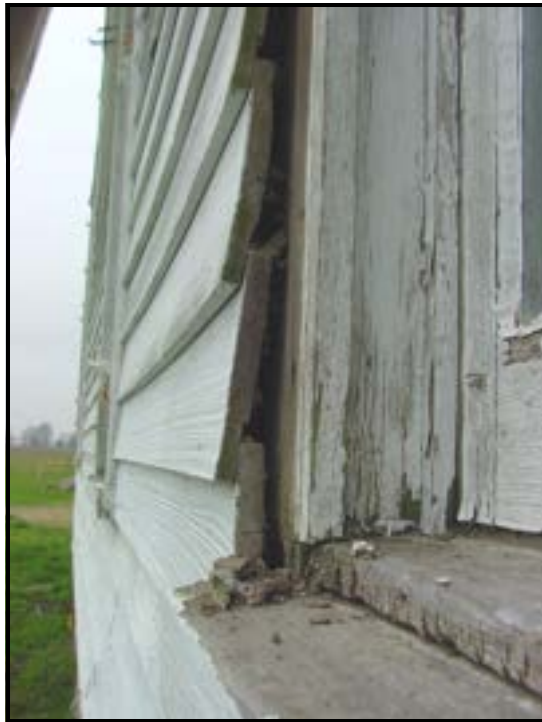
The photo at left shows the profile of the original lap siding for Lakeport Plantation house. The recess cut along the inside bottom of the board is called a rabbet. When lapped over the board below, the rabbet provides a tighter joint than other siding types.

The siding on Lakeport Plantation house is an unusual type of lap siding. Built from six inch wide boards, approximately one-half inch thick, each board, instead of being fully beveled, has a slight bevel at the top back side of the board. Each board has been rabbeted, meaning a recess has been cut on the inside bottom of each piece of siding. When laying this type of siding, the rabbeted edge of the top board fits over the top edge of the board underneath. Siding with a rabbet edge can be

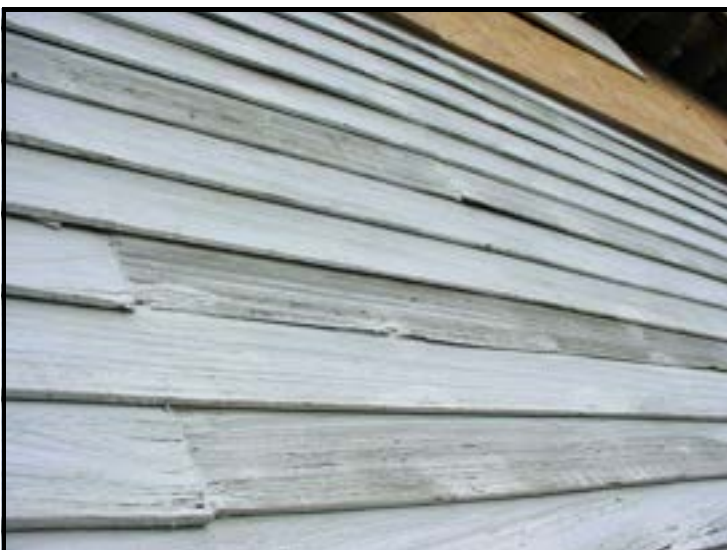
This photo shows a close-up of the siding on the west wall above the servery and ell porch. The damage done by power washing can be seen here where the wood was washed away, leaving some boards very thin. In extreme cases, it is possible for power washing to wash a hole through the wood.

Years of exposure to the elements, followed by a harsh power washing, had damaged the exterior wood of Lakeport Plantation house. In 1984, when work was done to stabilize the house, a power washer was used to clean the exterior of the house before being painted. The high pressure from the power washer blew away the soft grain of the wood siding and left the hard grain, resulting in a washboard effect. The deteriorated siding was removed from sections on the north side of the house near the ironwork porch and plantation office, the southwest corner of the house near the servery, and the gable end of the ell above the west porch. Masonite siding that had been used to replace original siding on the west side of the main

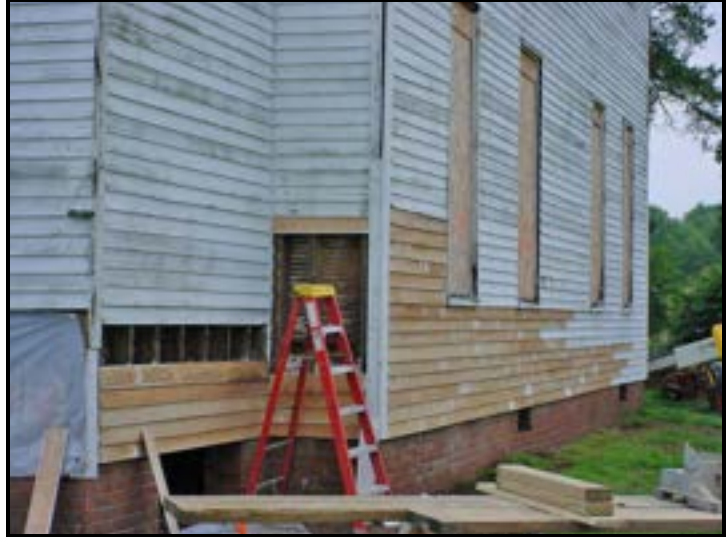
The photo at right shows an area on the south side of the house where siding was replaced. The original cypress siding was replaced with sinker cypress, old growth cypress that has been recovered from the bottoms of lakes and rivers.

house was also removed. The deteriorated siding was replaced with sinker cypress.

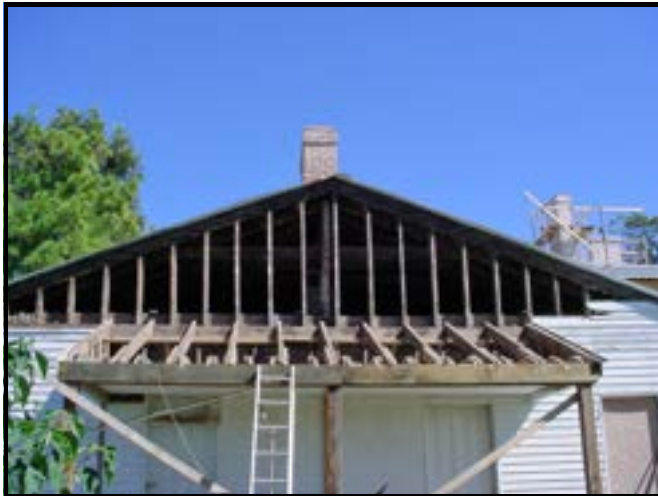
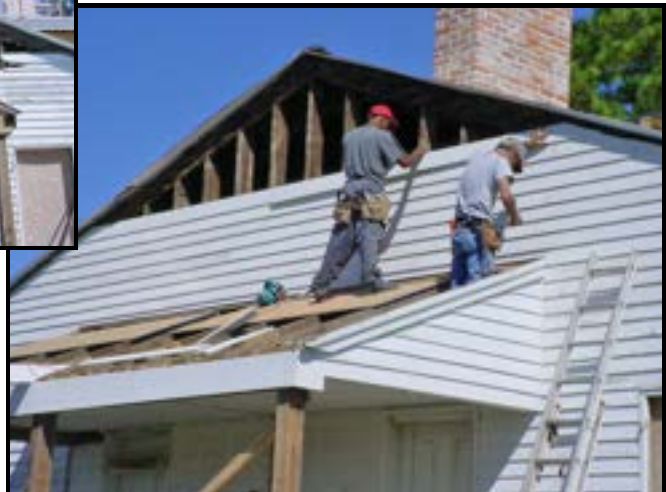
The photos above and at right show the gable siding replacement above the kitchen and plantation office of Lakeport Plantation house. The siding was deteriorated beyond repair and required replacing.

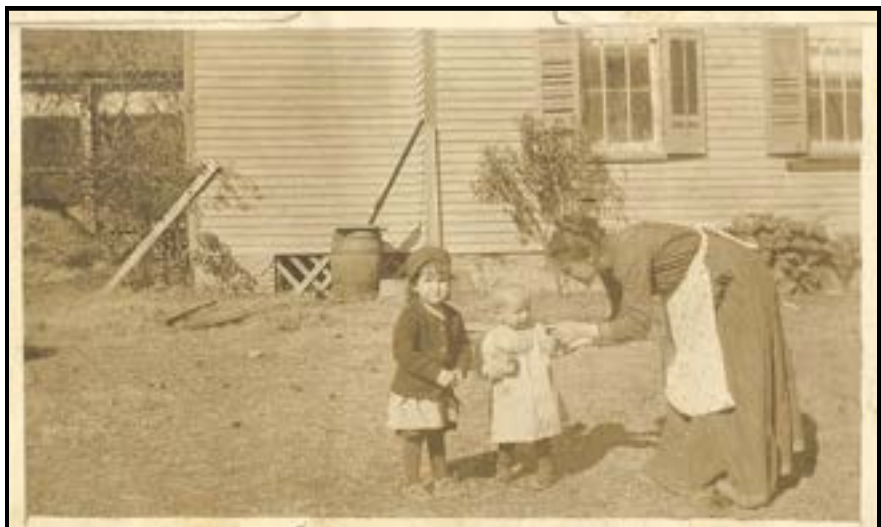
The historic photo at right shows the original latticework that was built between foundation piers at the back of Lakeport Plantation house. This photo was provided by descendants of the Johnson family.

Although no latticework remained at the time that restoration began, historic photographs show a latticework frame built between the foundation piers of the ell porch. The latticework was reconstructed using the photos to determine the building pattern and dimensions.

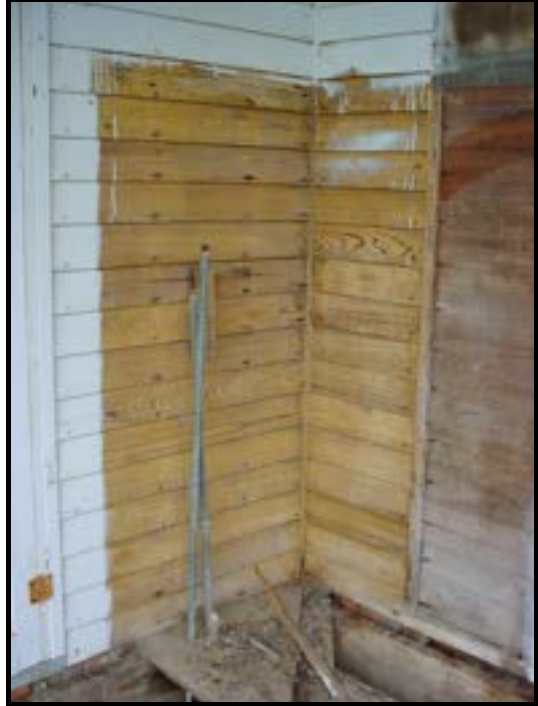
This photo shows a hint of the original paint color found on siding in a corner of the ell porch where a hot water heater was installed. The heater had been boxed in, which had protected the paint from exposure to power washing in the 1980's. A paint sample taken from this area was used for historic paint analysis.

Power washing the house, during the 1980's, had removed most of the original paint and it was difficult to find areas where it still remained. Some of the original siding paint was found in a corner of the ell porch behind a hot water heater that had been installed years ago. The heater had been boxed in and this had protected the paint underneath. Early in the restoration process, the

hot water heater was removed, exposing some of the original paint still intact. A paint sample for the trim was taken from the uppermost point of the north porch pediment. This is an area that would have been difficult to reach when the house was power washed. Paint analysis determined the original siding to be golden yellow color and the trim a creamy white. The original paint was determined to be an oil based lead paint.

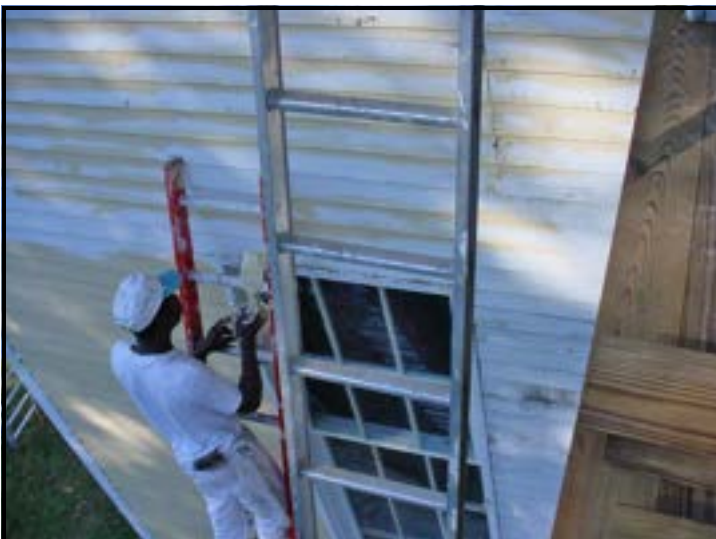
The photo at left shows the original paint color going back on the siding of Lakeport Plantation house.

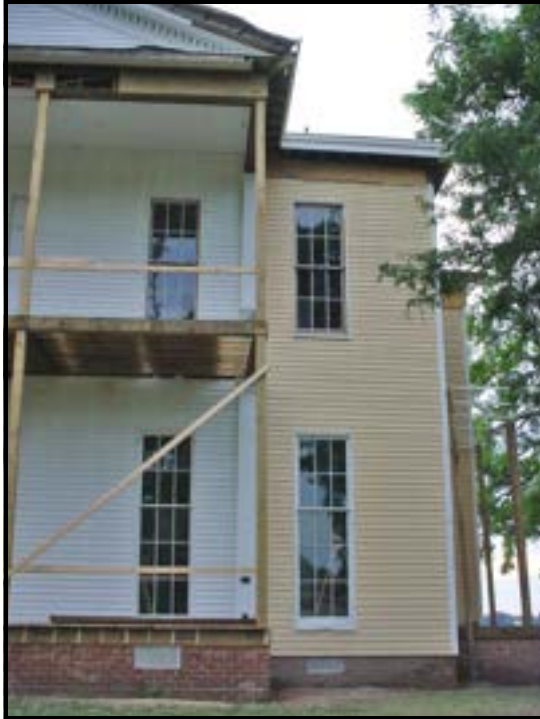
The photo at left shows the contrast of new and old as a reproduction of the original paint colors goes back on Lakeport Plantation house.

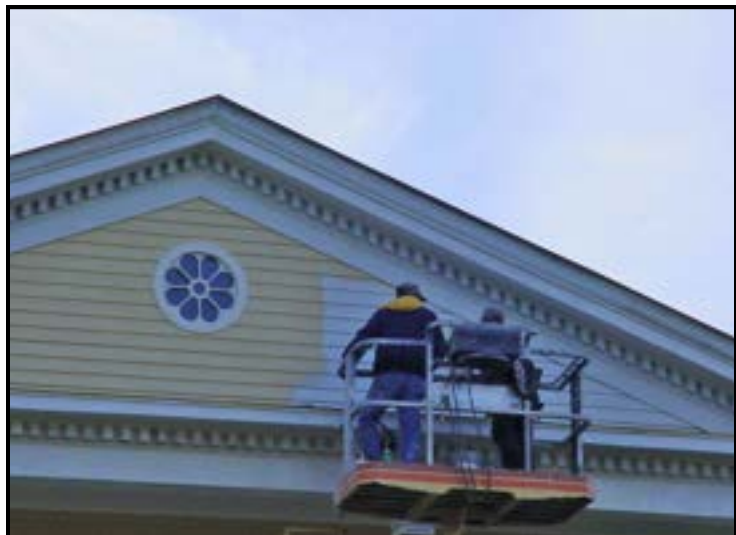
The photo at right shows the front porch pediment receiving a coat of paint. The paint color, a reproduction of the original, emphasizes the intricate detailing of the newly restored rose window.

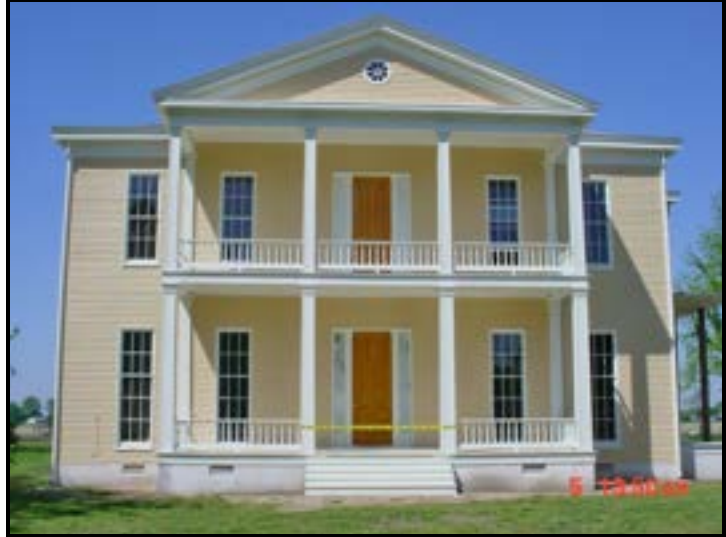
In this photo, the first phase of restoration is near completion. The siding and cornice moldings are restored and painting is complete. The creamy white trim frames the yellow gold siding and Lakeport Plantation begins to return to its former glory.
