# Lakeport Plantation Restoration

Technical Report No. 6

## Guttering & Sheet Metal Work

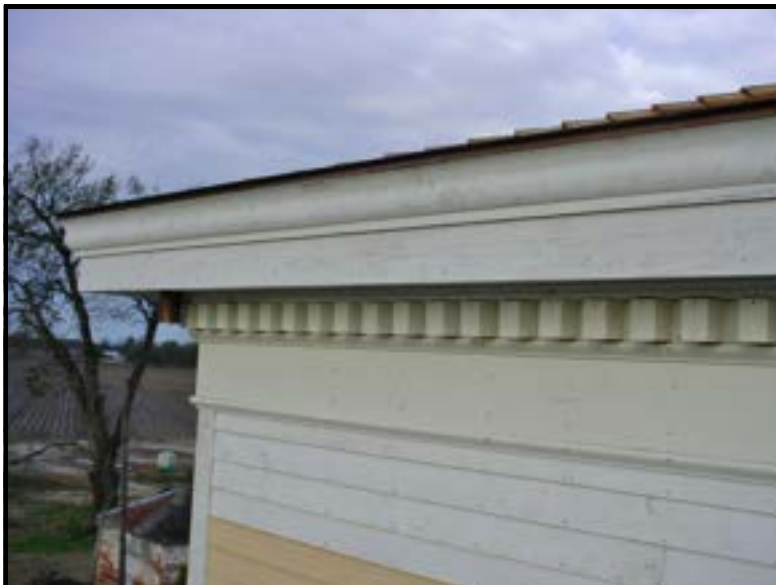
The photo at left shows the cornice molding that hides the box gutters on Lakeport Plantation house. Built-in gutters provide water drainage without interfering with the architectural details of the house.

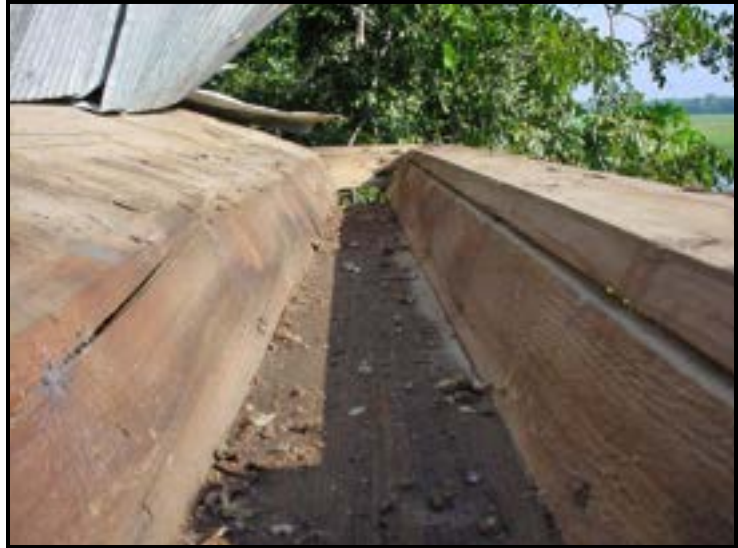
At right is a photo of the original box gutter trough that was found beneath the corrugated tin roof on Lakeport Plantation house. Built of cypress, originally it would have been lined with tin or tene metal.

When restoration began on Lakeport Plantation house, part of the original box gutters still remained on the north side of the house, above the ornamental iron porch. Evidence showed that they had been removed from the west side of the house in earlier years and were never replaced. Lack of maintenance had resulted in the deterioration of the rest of the gutters. The original box-shaped gutters were built of cypress and lined with sheet metal. The Lakeport ceiling joists, built to extend past the tops of the walls and become the exterior overhang, served as the frame to hold the box gutters. Because of the importance of the gutters in protecting the house, it would have been too risky to leave the original gutters. What remained of the original

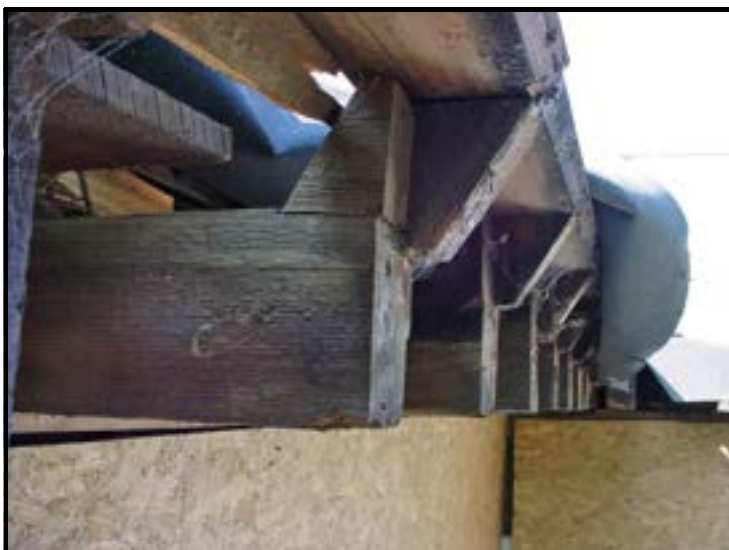
The photo at left shows the ceiling joists that extend past the tops of the walls of Lakeport Plantation house to become the exterior overhang as well as the frame that holds the wooden trough for the box gutters.

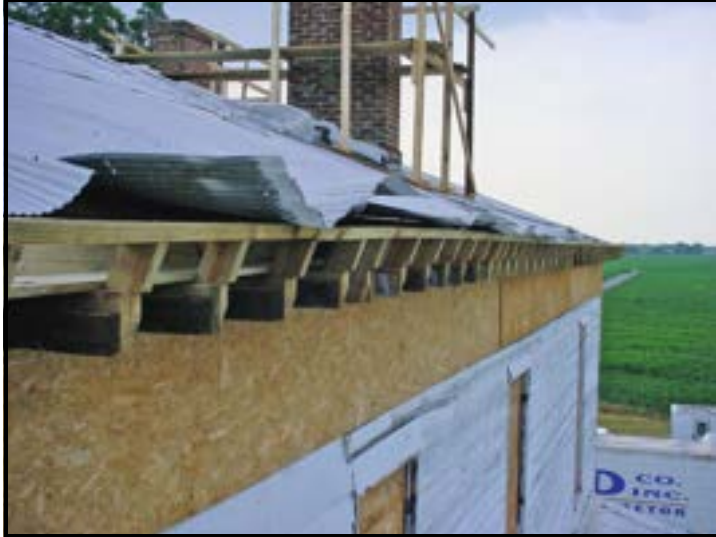
Most of the original box guttering was gone when restoration began and what remained was removed and replaced using new materials. This photo shows the new frame that was built along the west wall of Lakeport Plantation house to hold the new box gutters.

gutters was removed and new box gutters were built using a pressure treated pine material. The purpose of the pressure treated pine is to protect the wood from insect invasion and fungal deterioration. The ends of the ceiling rafters that held the box gutters were also deteriorated and had to be rebuilt as well. Once the box gutters were complete, copper liners were fabricated to fit the gutters.

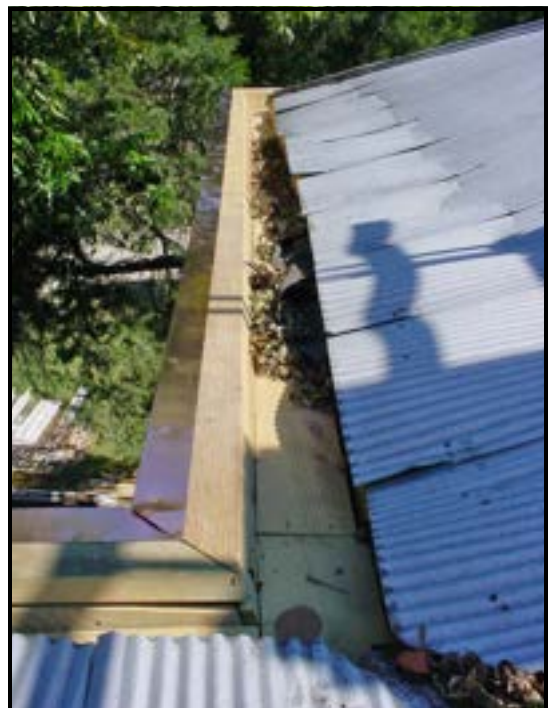
The photo at right shows the new box gutters built into the cornice of Lakeport Plantation house. The new gutters are built of pressure treated pine material and will be lined with copper. The trough is built to slope to the nearest downspout to insure proper water drainage.

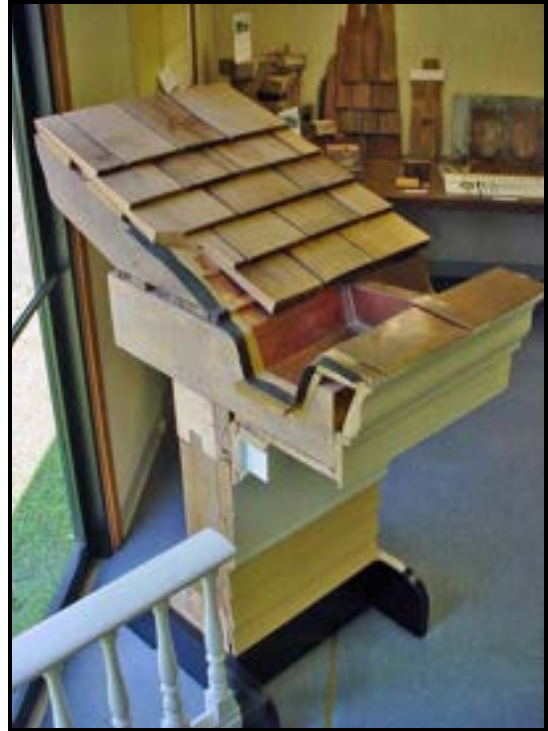
Before being allowed to begin work on Lakeport Plantation house, contractors were required to provide a mock-up of their work for approval. The photo at right shows a mock-up built for the box guttering and roofing systems as well as the cornice and dental molding and fascia boards that were to be restored.

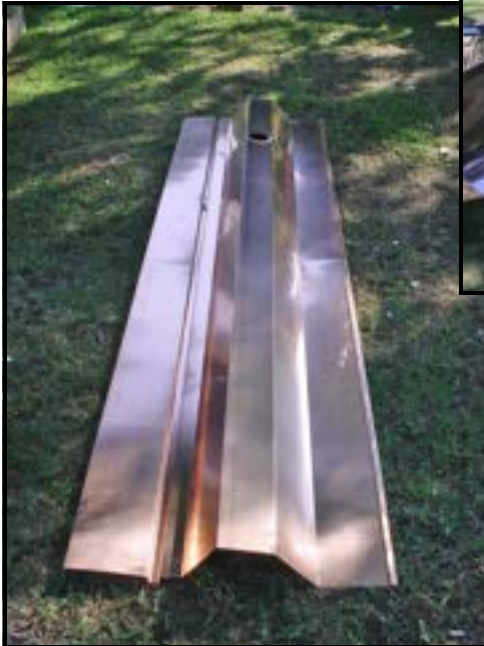
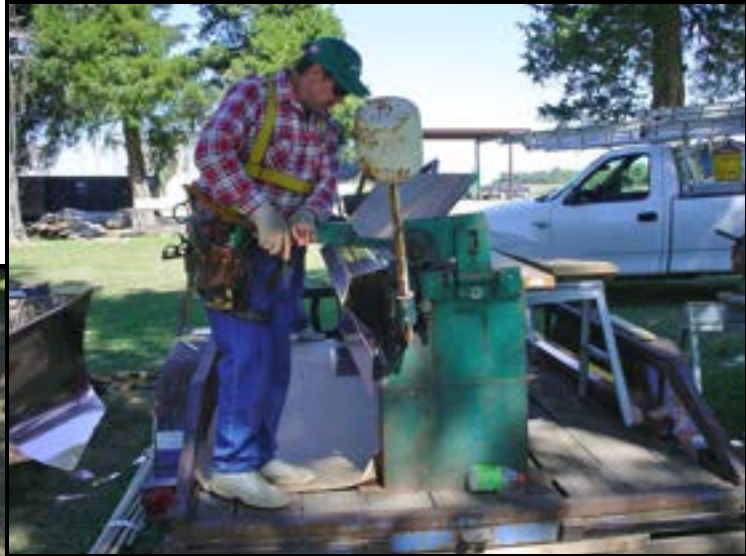
These photos show the fabrication of the copper liners that will line the wooden troughs of the box gutters for the two-story section of Lakeport Plantation house.

The photo above shows a restoration sheet metal worker using the sheet metal brake to bend and shape the copper liners. The photo at left shows a section of the liner ready for installation.

All of the sheet metal work was done on-site using traditional tools of the trade. A sheet metal brake, designed to bend and shape metal, was used to fabricate the long pieces for the gutters, downspouts and liners for the gutter boxes. Tin shears and hand bending tools were used to cut, bend and shape the ends for the gutters, deflectors and other small pieces and to cut the holes for the downspouts. Gas fire pots and soldering irons were used to solder the joints together, although coal heat would have been used originally. Copper was used for all of the sheet metal work because of its durability.

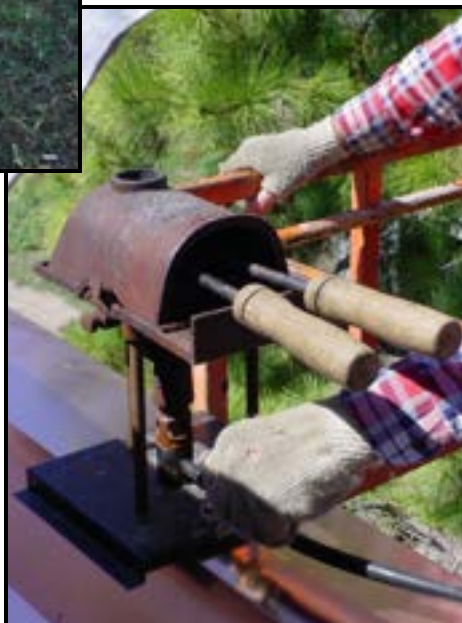
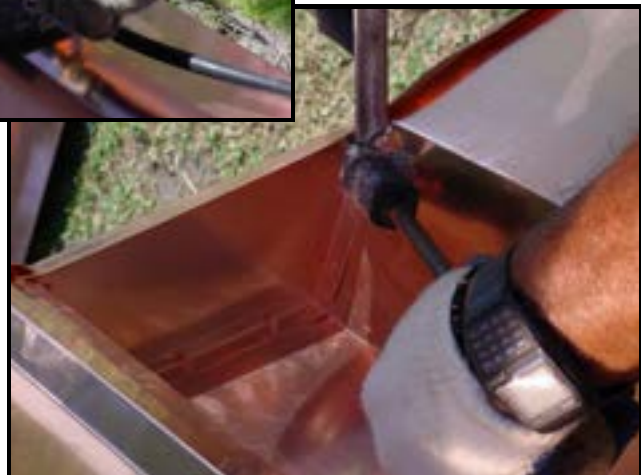
The photo above right shows the gas fire pot being used to heat the soldering irons. The photo at right shows an end piece, after being cut and shaped, being soldered to the end of a gutter liner.

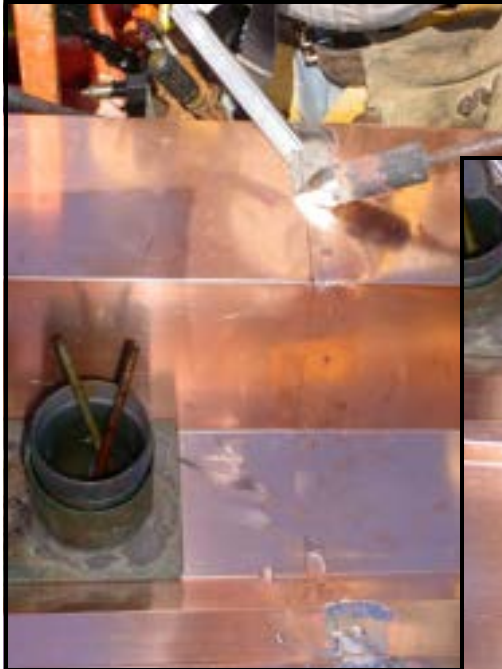
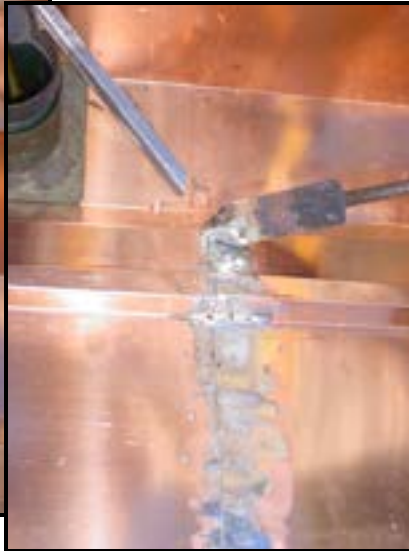
The photo at left shows two sections of the copper liner for the box gutters being soldered together. Inside the small jar is a cleanser that is used to keep the end of the soldering iron clean. The photo below shows a close-up view of a joint being soldered together. It is important that the joint be as smooth and tight as possible to allow the liner to function properly.

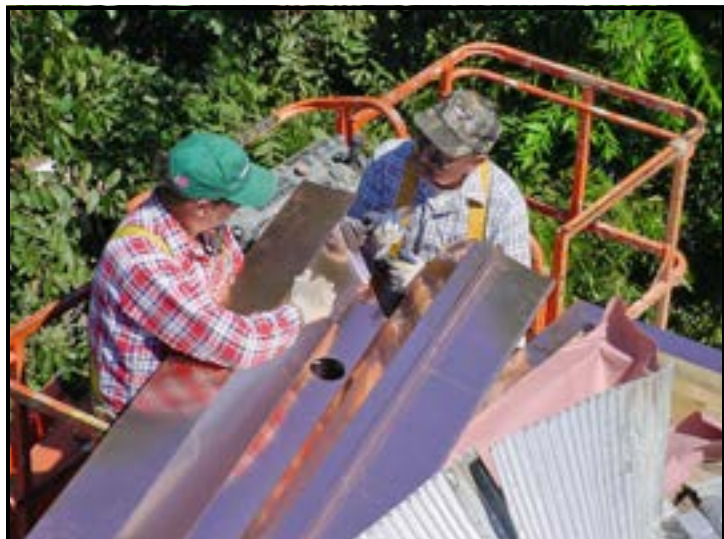
The photo at right shows restoration sheet metal workers cutting and fitting the copper liner for a box gutter at the corner of the roof of Lakeport Plantation house. The hole that has been cut in the liner is to allow for water to flow through to the downspout that will be attached below the cornice.

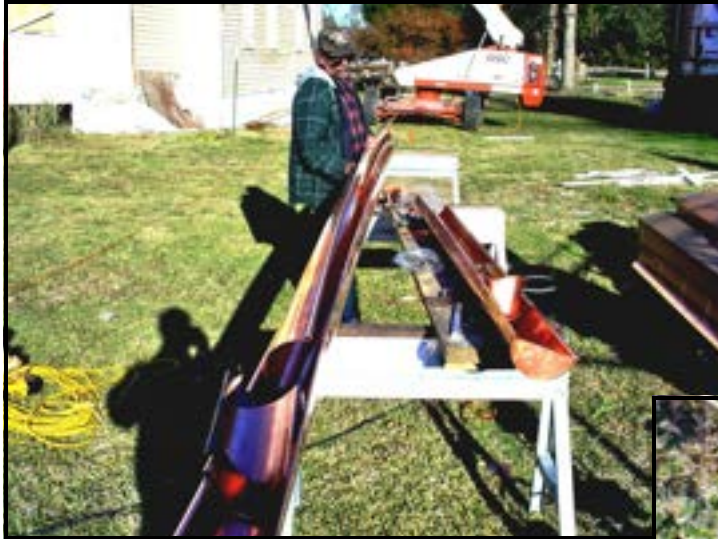
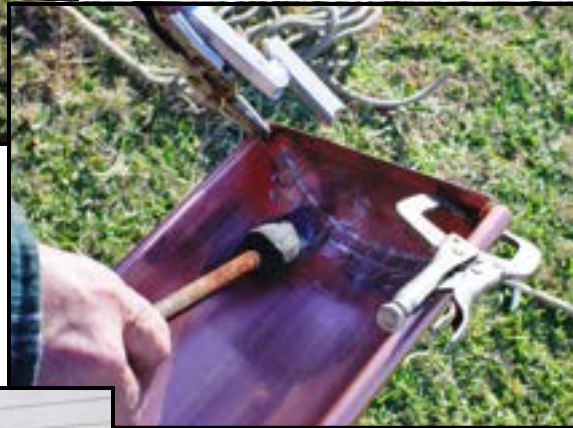
These photos show the fabrication of the half-round copper gutters that were installed on the ell part of Lakeport Plantation house.

The photo at left shows sections of the half-round gutters being readied for installation. The photo below shows an end piece being soldered to a half-round gutter.

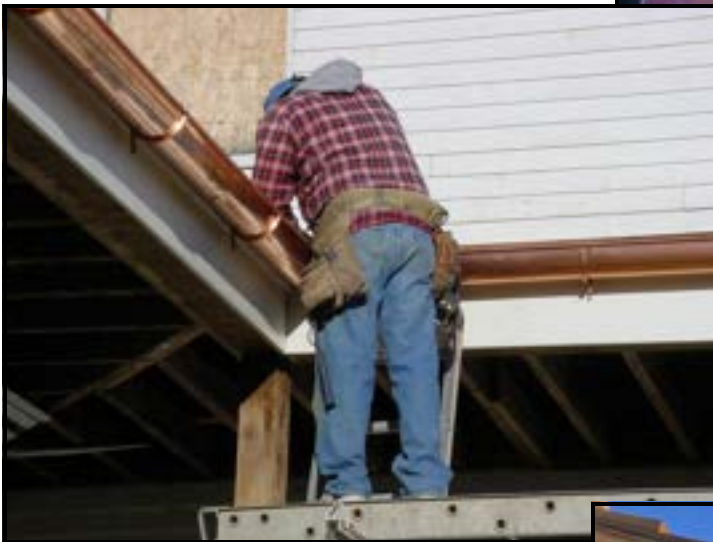
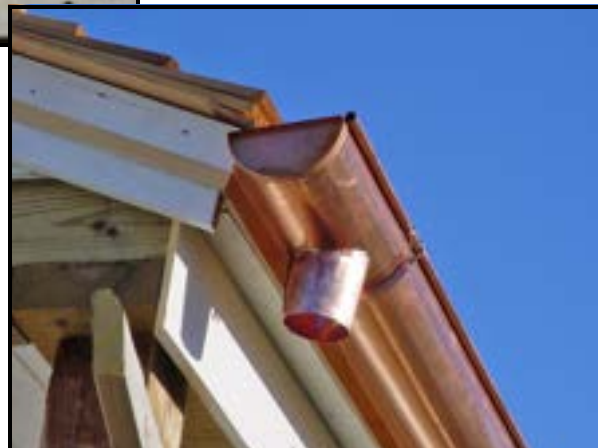
The photo above shows the half-round gutters being installed on the inside corner of the ell porch. The photo at right shows the beginning of a downspout that has been fabricated and attached to a half-round copper gutter.

The half-round gutters were attached to the roof using copper gutter hangers and brackets. The brackets run underneath the shingles and are secured to the roof. The hangers are then attached to the brackets and hold the gutters. The brackets are designed to allow for gutter adjustments as well as allowing the gutters to move. Although copper is extremely durable, if not allowed to move, it will break apart. The

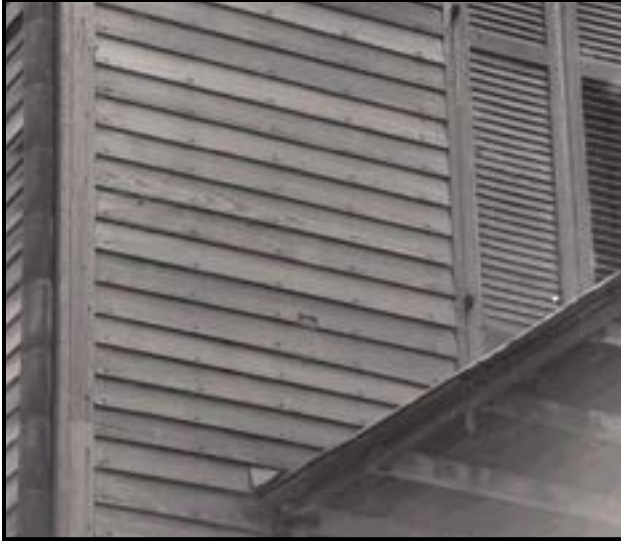
The photo at left is taken from an early photo of Lakeport Plantation house. In the photo, to the far left, can be seen a piece of the original downspout attached to the corner of the house. Fabricated from short pieces of sheet metal, the downspout would have required many hours of labor to construct. This photo was taken from the Historic Structures Report for Lakeport Plantation.

The original downspouts can be seen in historic photos taken in the early 1900's, and pieces of the original were found above the kitchen in the ell of the house. The original downspouts were built from pieces of sheet metal measuring 9 3/4" in length, that were joined and soldered together repeatedly. All of the original sheet metal work would have been done by hand, requiring a great amount of time and labor.

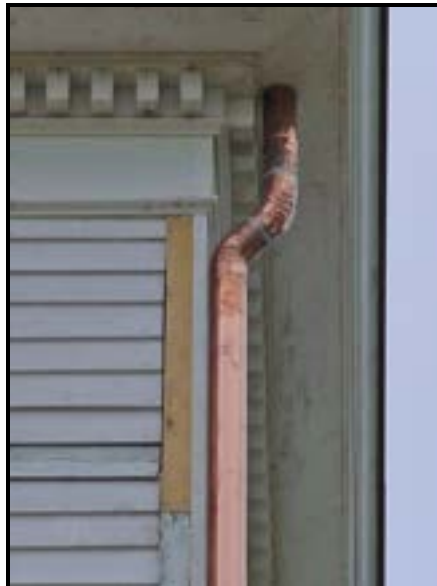
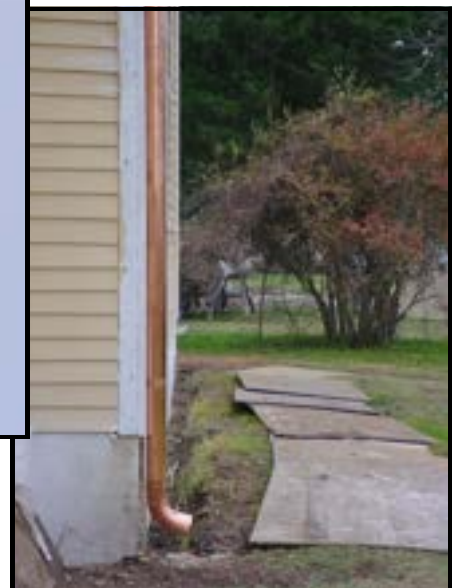
The photos above and at left show the newly fabricated downspouts for Lakeport Plantation house. The photo above shows a downspout as it extends from the cornice that holds the box gutters. The photo at right shows the bottom of a downspout where the water will flow into an underground drainage system. The curved neck and mouth of the downspouts were fabricated by skilled sheet metal workers.

liners for the gutter boxes were secured using copper tabs that were nailed to the roof underneath the shingles. The lip of the liner hung from these tabs, which allowed the liners to move. The downspouts were held in place with copper straps that were attached to the house at one end, wrapped around and were riveted to the downspout at the other end.

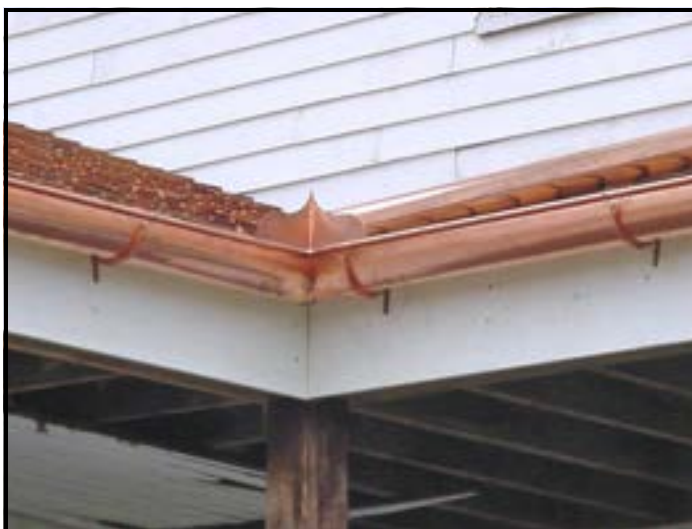
The photo at left shows a deflector that sets above the gutters in the corner of the ell porch. Hand fabricated by a restoration sheet metal worker, the deflector is used to keep the water that runs down the valley of the roof from splashing over the gutters.

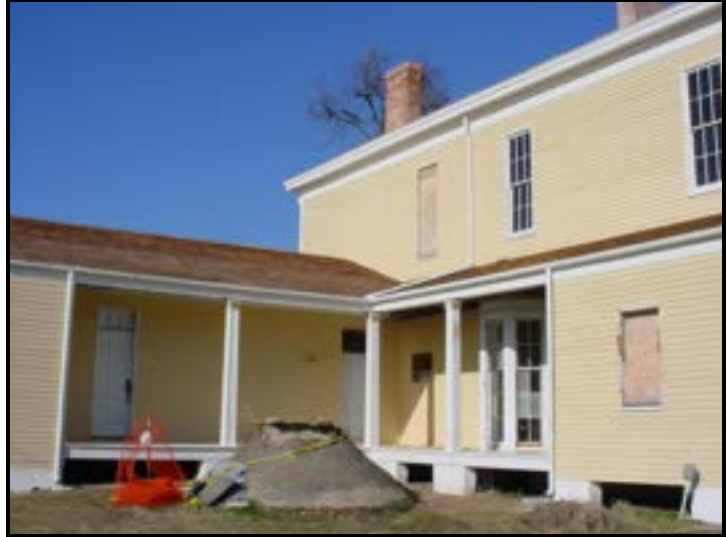
In the photo at right the copper gutters and downspouts at the back of Lakeport Plantation house have been painted white. Although it is not necessary for exposed copper to be painted, the new gutters and downspouts were painted for historical accuracy.

Although exposed copper does not require painting, all of the gutters and downspouts were painted white for historical accuracy. The metal used to make the original gutters and downspouts was a tin orterne metal and would have required painting to keep them from rusting.
