# Lakeport Plantation Restoration

Technical Report No. 9

## Braced Frame Construction

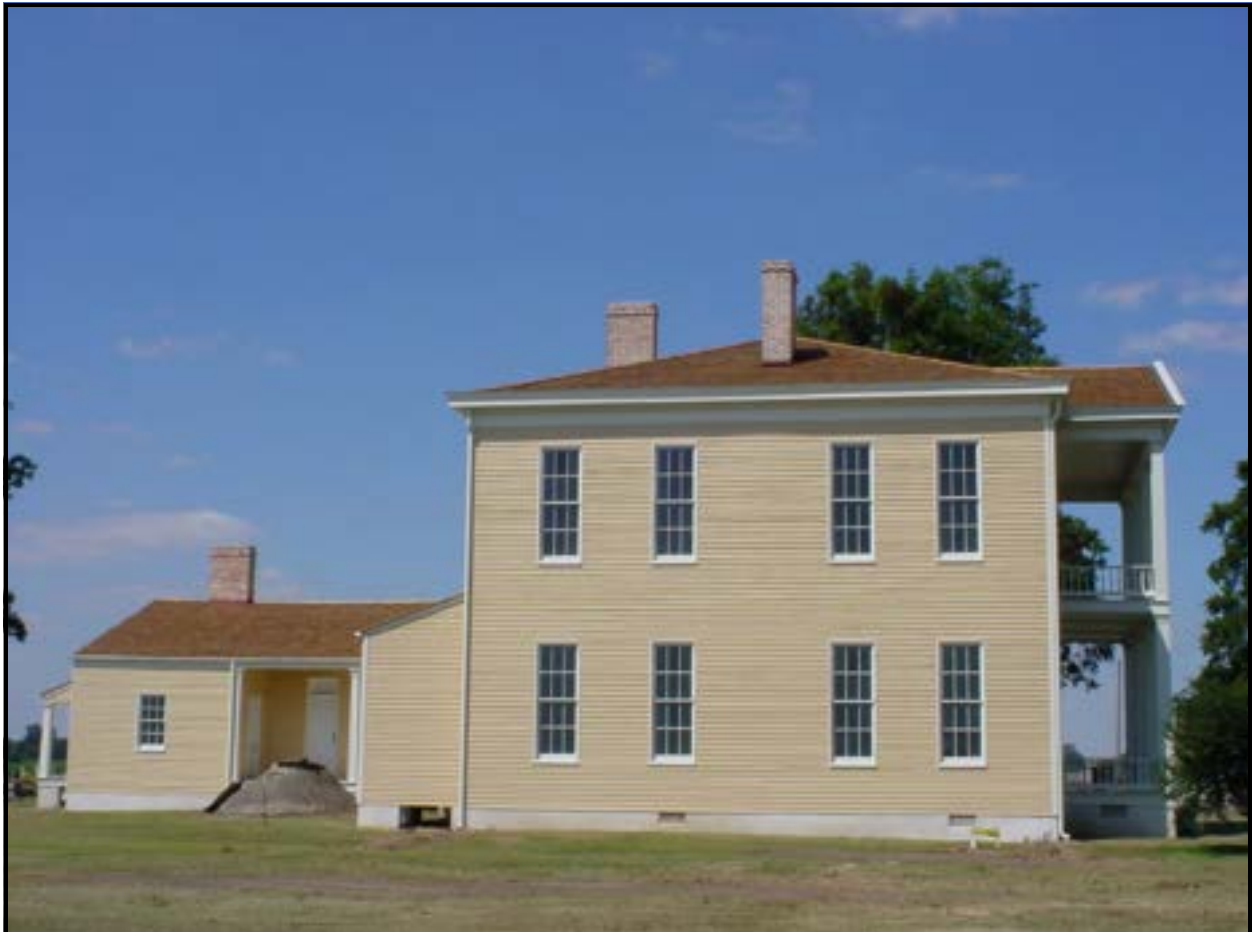
Lakeport Plantation house is built of wood frame construction using a building technique known as braced frame, or full frame, construction. Braced frame construction was used during the eighteenth and nineteenth centuries for large wood frame buildings. In braced frame construction, heavy timbers are held together with mortise and tenon joinery. Nails are used only for the rafters, floor beams and smaller pieces. Framing members consist of heavy sill beams, corner posts and top plate beams framed together and strengthened by corner braces that extend diagonally from the heavy plate beam to the corner post. Vertical framing members called studs are evenly spaced and extend from the sill beam to the plate beam. The floor joists rest on the sill beam and the rafters are notched to lay on the plate at the top of the studs.

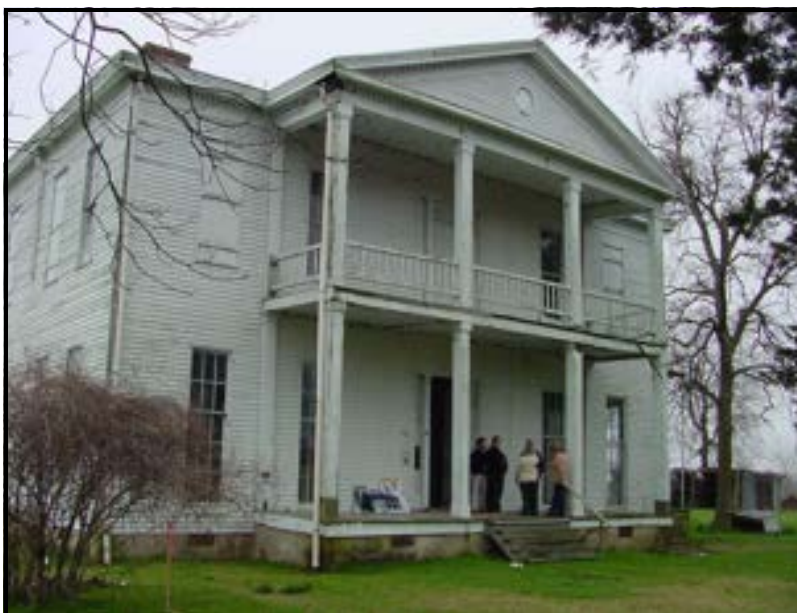
The photo at left was taken in March, 2003, as restoration was beginning. At that time, Lakeport Plantation house was approximately 140 years old. The braced frame method of construction used to build Lakeport had kept the house straight and strong through the years.

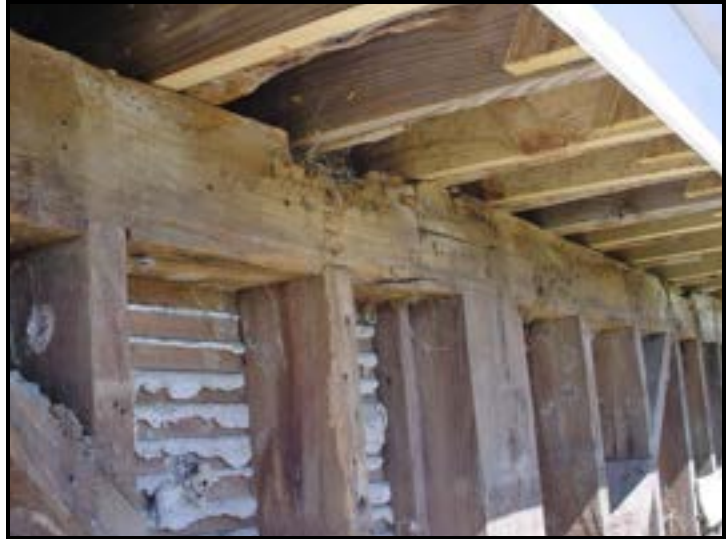
The photo at right shows the top plate beam, wall studs, a vertical intermediate post and braces. The bracing is running from the intermediate post to the top plate beam. The top plate beam is supporting the second floor ceiling joists. The ends of the ceiling joists extend beyond the top plate beam to become the roof overhang.

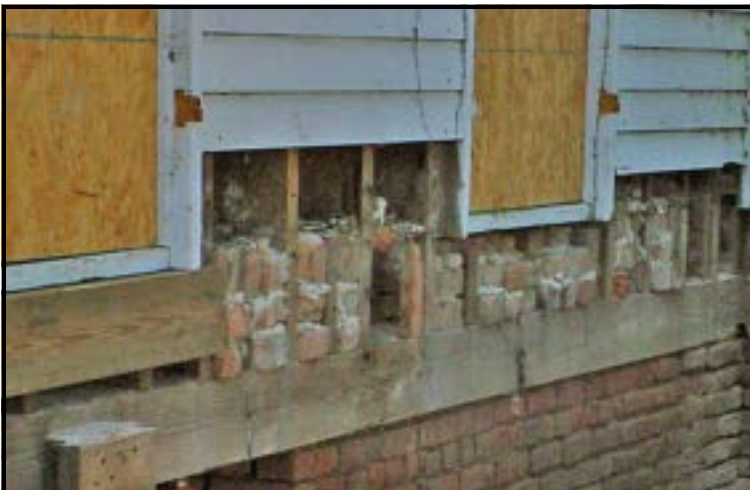
The photo at left shows the brick nogging that was discovered during restoration of Lakeport Plantation house. The nogging in this photo was exposed when siding was removed prior to restoration of the foundation walls.

The brick nogging was also exposed when the siding was removed. Although missing in some areas, the nogging was found to be in generally good condition. The missing nogging was replaced to match the original.

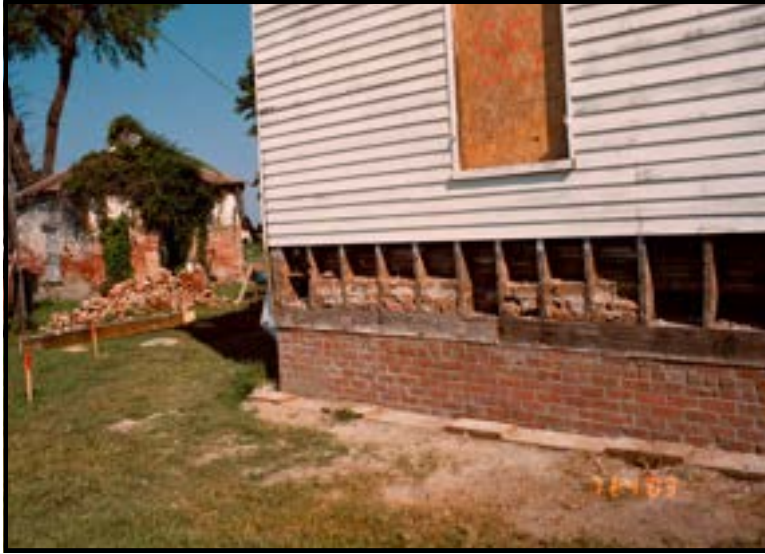
During restoration, the lower siding of Lakeport Plantation house was removed, exposing the framework. In this photo the original sill beams, wall studs and brick nogging can be seen. Notice the missing nogging between some of the wall studs.

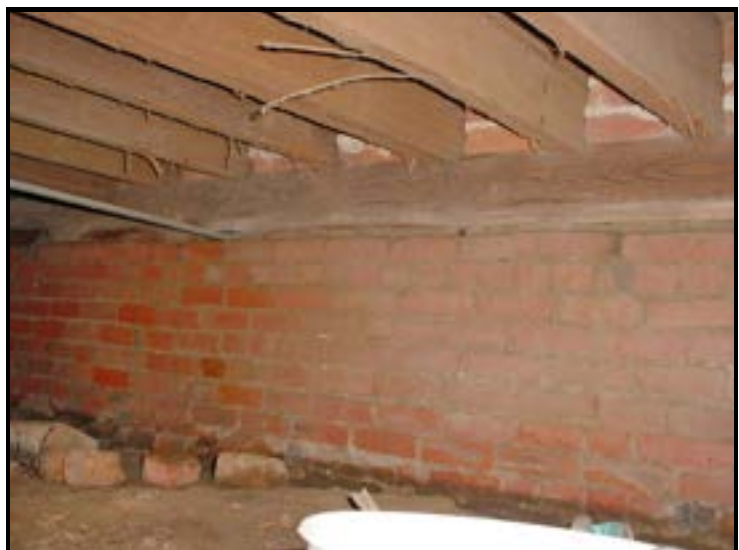
In the photo at right the floor joists, sill beam and foundation wall can be seen from underneath the house. Notice the moisture in the bricks near the ground. The moisture is absorbed up from the ground, through the mortar, and will eventually reach the sill beams.

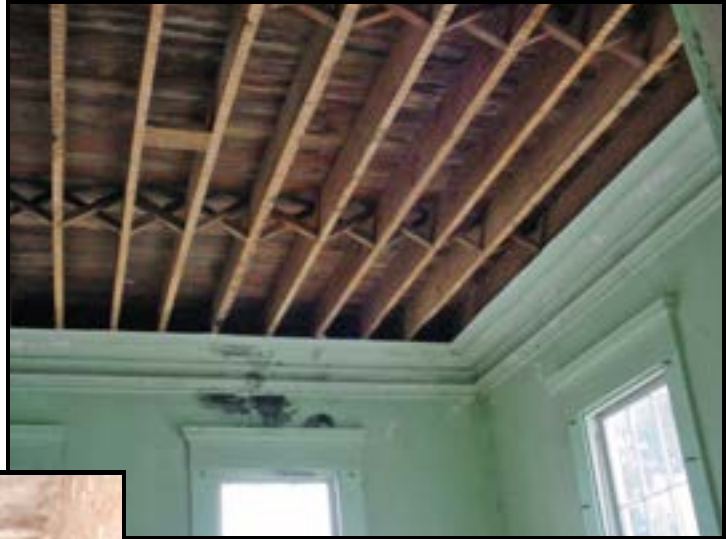
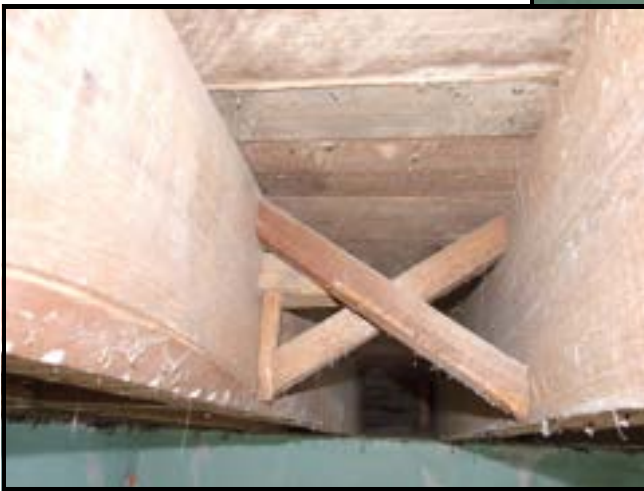
The photo at right shows the cross bridging between the floor joists of the second floor. The purpose of the cross bridging is to strengthen the floor by distributing the load over several joists. The photo below shows a close-up view of the bridging.

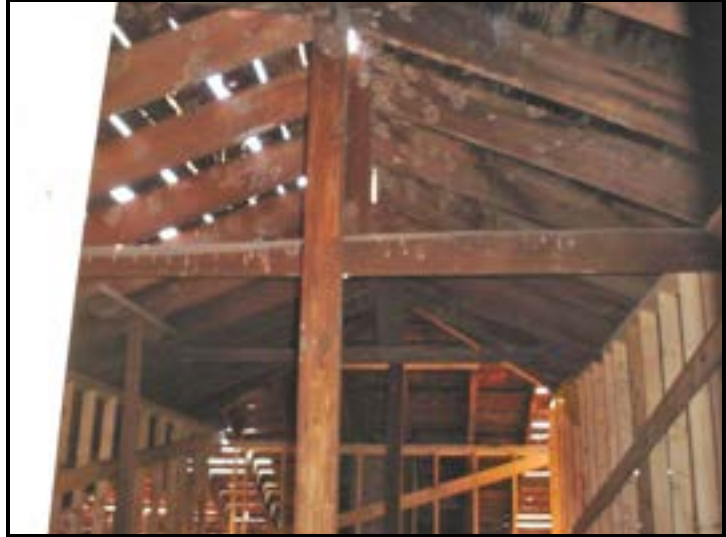
The photo at right shows the large rafters which can be seen from the attic of Lakeport Plantation house. The rafters provide the framework for the roof. The vertical support post, in the center of the photo, provides structural support for the roof.

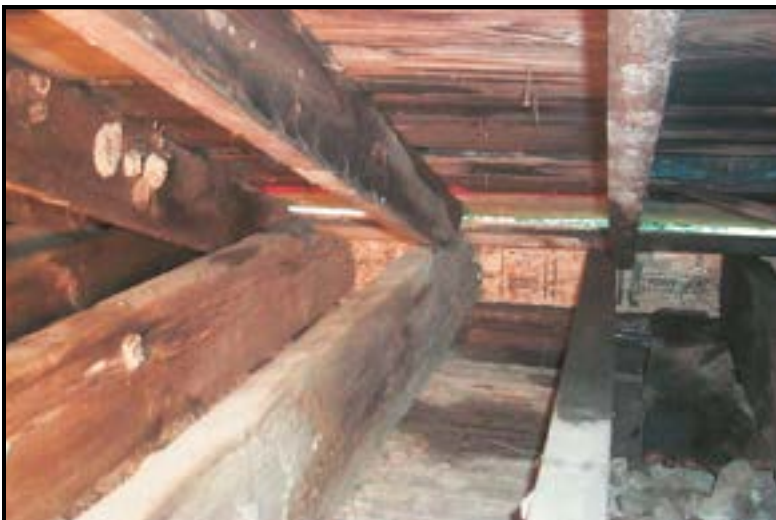
The photo at left shows the rafters and second floor ceiling joists where they meet in the attic of the house. A support board sets on top of the floor joists to support the rafters. This photo was taken from the Historic Structures Report of Lakeport Plantation.

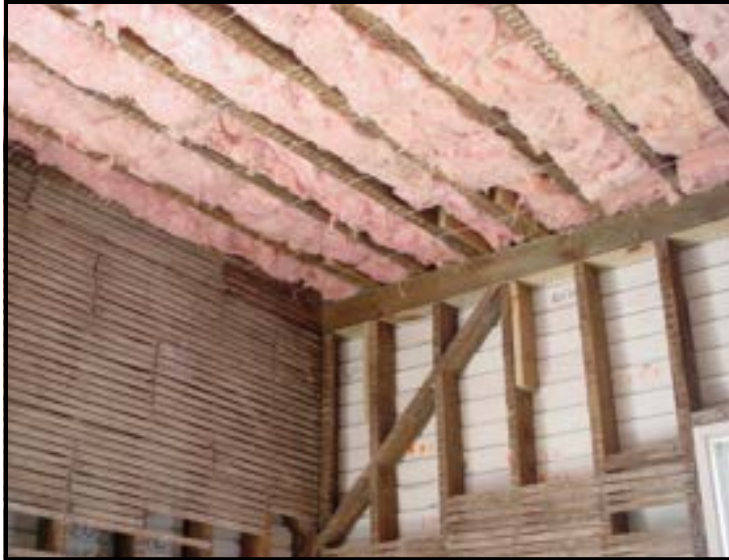
The photo at left shows the braced frame construction from the interior of Lakeport Plantation house. Seen in this photo is a corner brace, wall studs and top plate beam as well as ceiling joists for the plantation office. The siding that covers the framing on the exterior and the plaster lathing that covers the framing on the interior can also be seen.

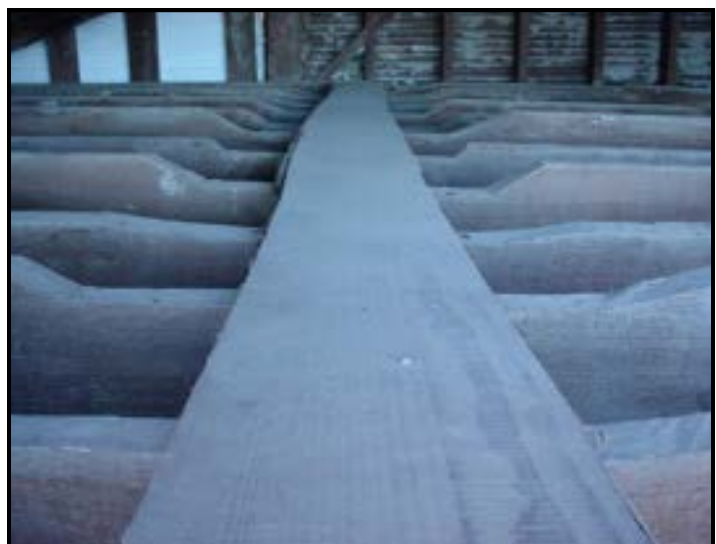
This photo was taken in the attic above the plantation office. The center board, called a rat run, is used to tie the ceiling joists together. The boards used for the ceiling joists were all different widths and had to be cut away in the center at different depths for the rat run to lay level.

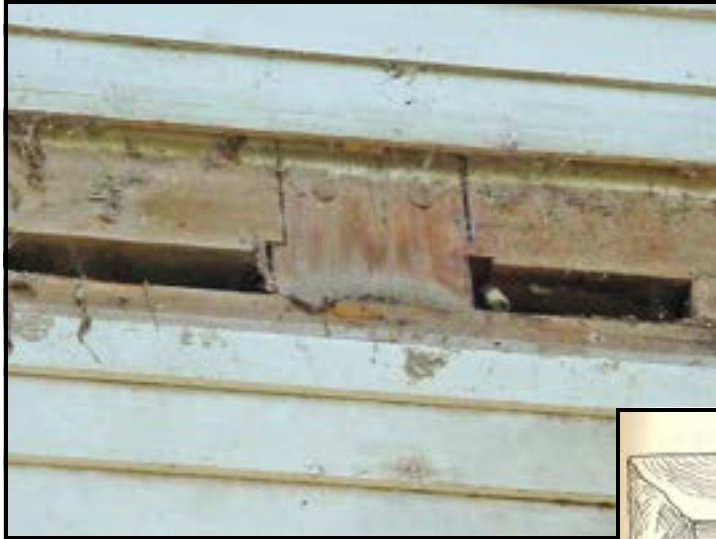
The photo at left shows the mortise and tenon joinery used for the second floor porch tie-in to the front of Lakeport Plantation house. The intermediate vertical post is mortised on each side to accept the tenoned top plate beams and the joint is secured with wooden pegs.

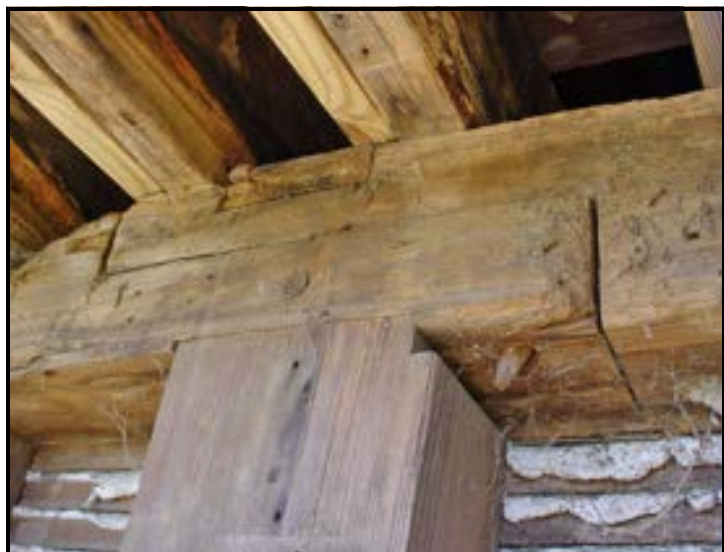
The photo at right shows a half-lap joint where two sections of the top plate beam are joined together. The top plate beam is resting on top of a vertical support post. The half-lap joint is typical joinery used in braced frame construction.

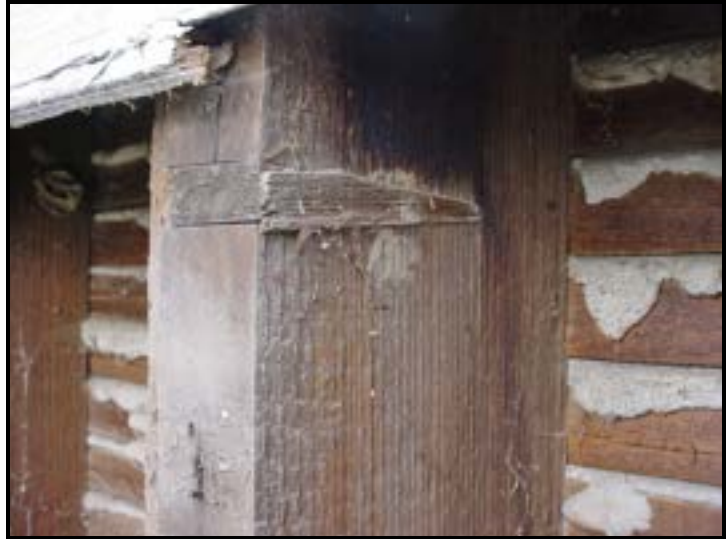
Several interesting building techniques were discovered during restoration of Lakeport Plantation house. The photo at right shows a wooden wedge driven into a wall stud, a technique used to straighten a bow in the stud.

Some interesting building techniques used in the framing of Lakeport Plantation house were discovered during restoration. Wooden wedges, found in several of the wall studs when siding was removed, revealed a technique that was used to straighten the bowed studs. Each stud was sawn two-thirds of the way through on the opposite side of the bow in the stud. The wedge was driven into the saw cut as pressure was put against the bow. The wedge prevented the bow from returning after pressure was released. It was important to have the wall framing as straight as possible for plastering.

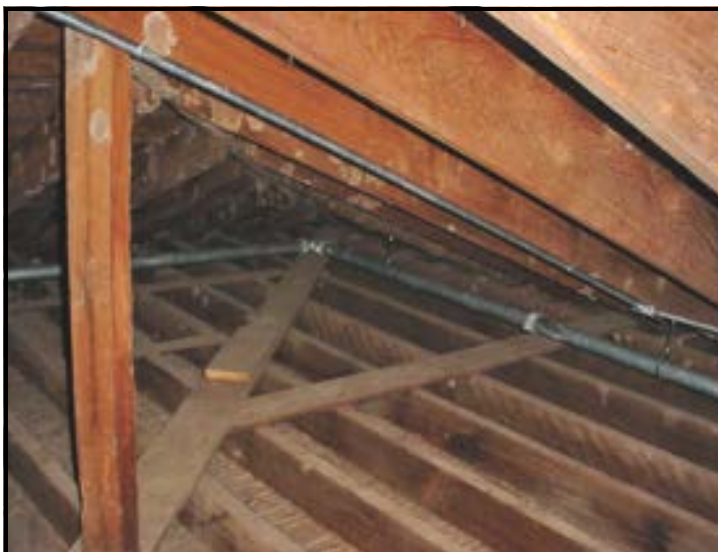
The photo at left shows the diagonal bracing found nailed to the tops of the ceiling joists in the attic of the house. The boards run diagonally, intersecting with each other. The purpose of the bracing is to prevent the house from twisting during high winds.

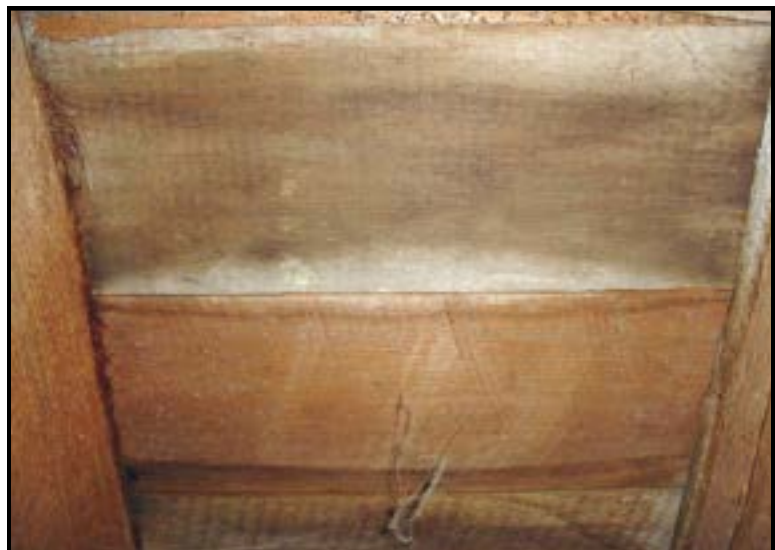
The photo at right shows two different types of saw marks on the bottom of the flooring material used to build Lakeport Plantation house. The board at the top shows up-down saw marks while the board below it shows circular saw marks.

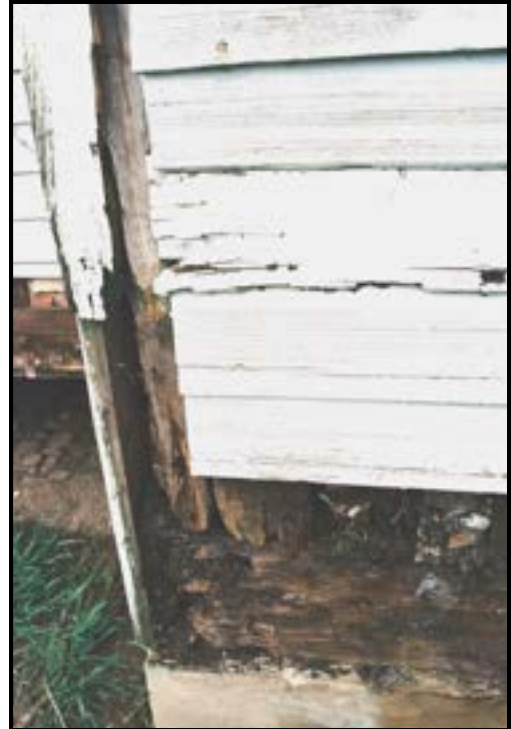
The photo at right shows a deteriorated corner post and sill beam on the north side of the plantation office before restoration began. Further deterioration was discovered when siding was removed during the restoration process.

To rebuild the foundation walls, the frame of the house was lifted up with the use of hydraulic jacks. Damaged sill beams were removed at this time and replaced using pressure treated southern pine material. Traditional half-lap and mortise and tenon joinery were used for the restoration of the sill beams. Deteriorated corner posts were replaced and the deterioration at the ends of the wall studs was cut away and new materials were spliced onto the existing studs.

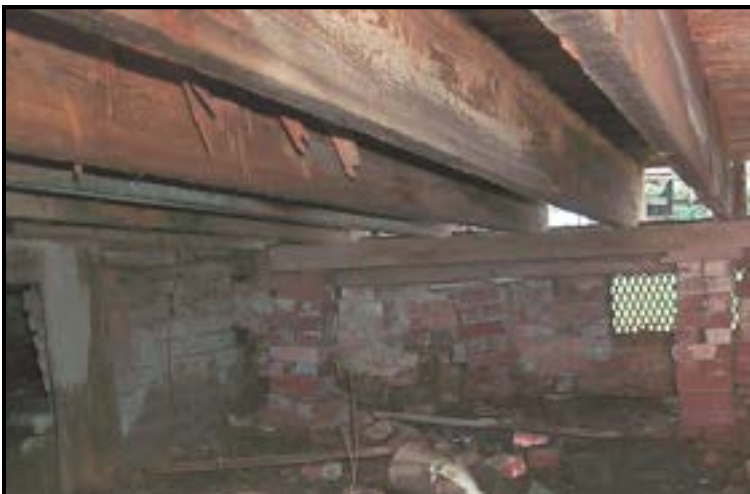
The photo at left shows the exterior foundation wall from underneath the house before restoration began. Prolonged water exposure had caused the mortar to deteriorate and the foundation wall to collapse. Brick piers had been built to support the house framing. This photo was taken from the Historic Structures Report for Lakeport Plantation.

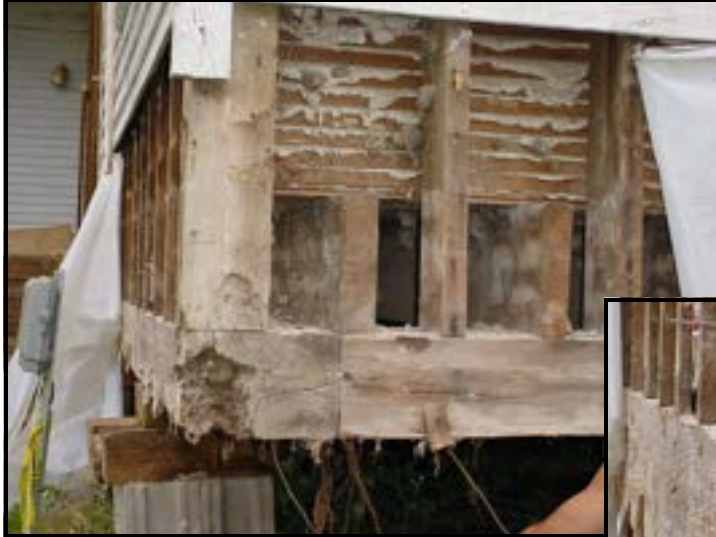
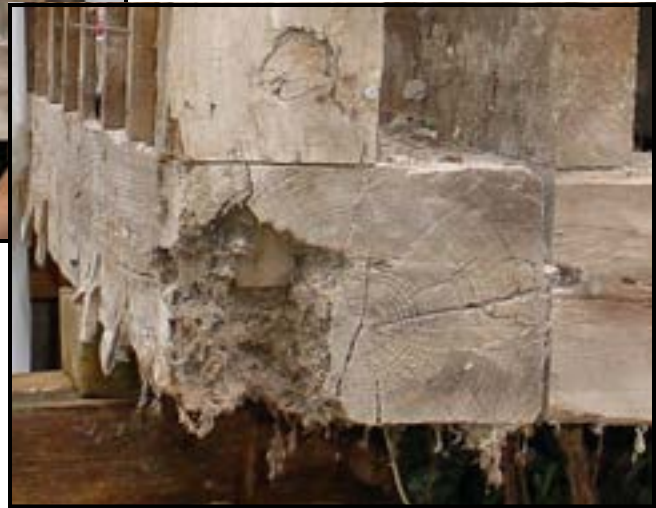
The photo at left shows a deteriorated sill beam at the southwest corner of the main house. In the close-up below, the deterioration has left a corner post tenon exposed.

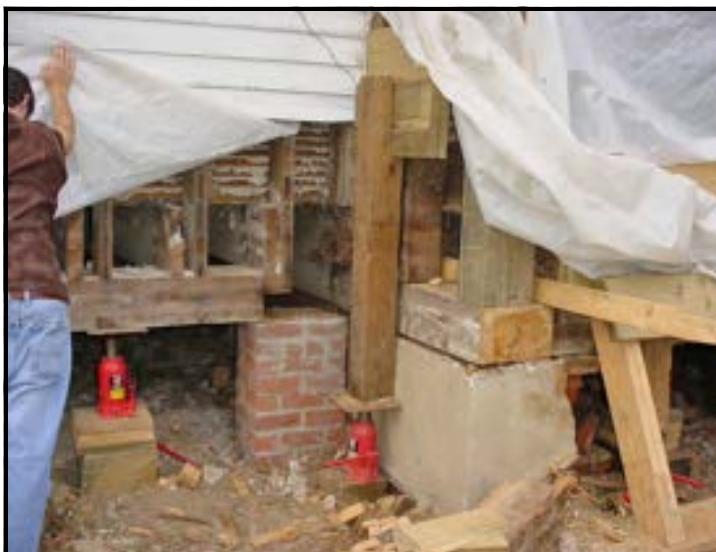
The photo at left shows the framework of Lakeport Plantation house being lifted with the used of hydraulic jacks as the foundation walls were being rebuilt. The foundation walls had collapsed in several areas causing the framework of the house to sag.

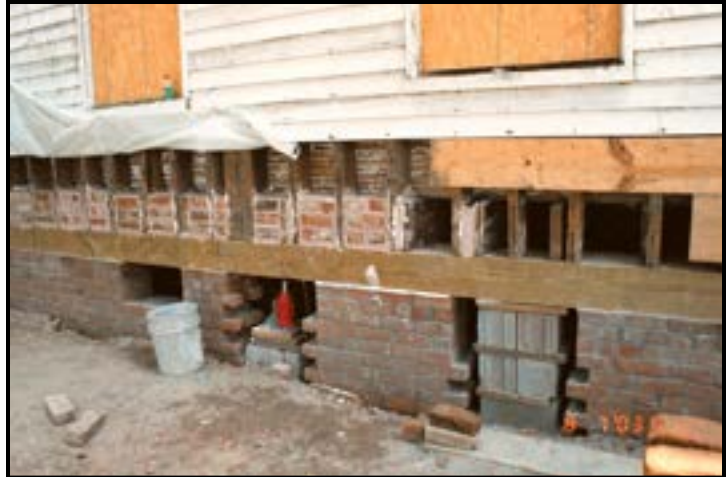
The photo at right shows the north side of Lakeport Plantation house as the foundation walls are being rebuilt. Deteriorated sill beams have been replaced and brick nogging is being laid where original was missing.
