# Lakeport Plantation Restoration

Technical Report No. 2

## Chimneys

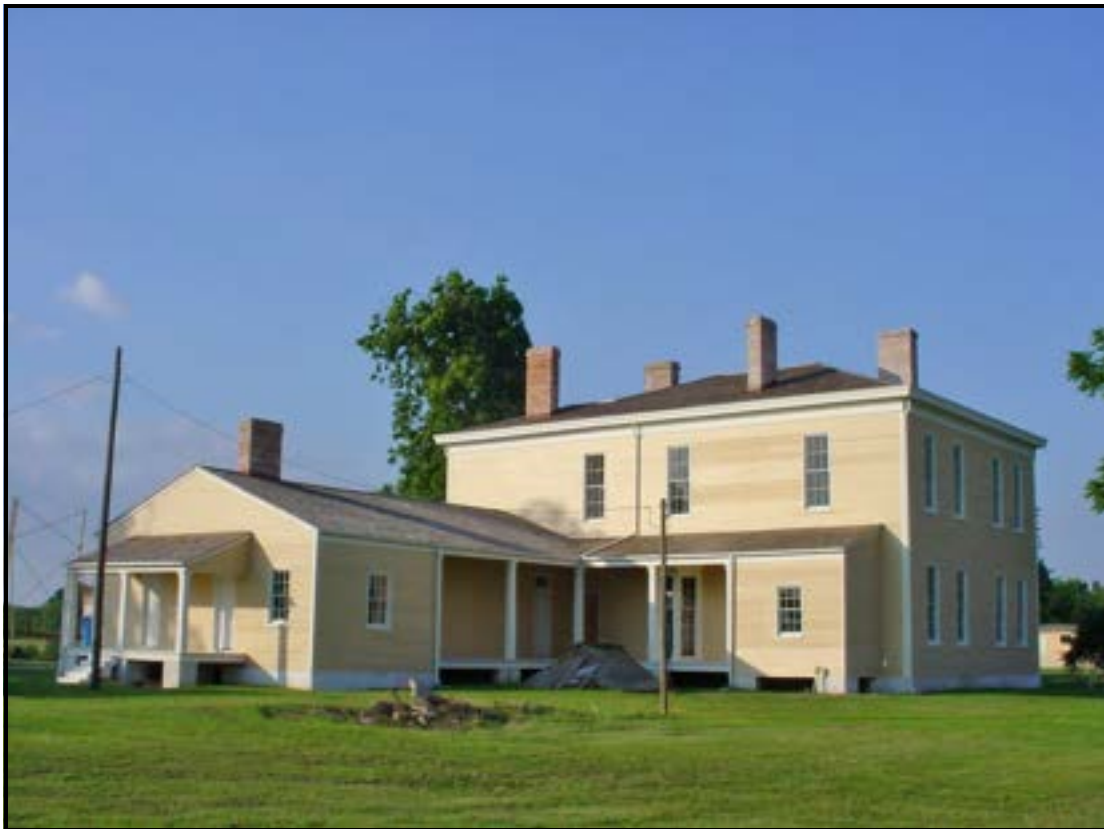
Lakeport Plantation house has five large chimneys, each serving two or more of the thirteen fireplaces found throughout the house. Each chimney rests on a large footer that corbels outward eleven courses, providing a solid foundation for each chimney. The chimneys are built with the same handmade bricks as were used to build the foundation walls, dairy and original smokehouse. A lime parge coating, applied when the chimneys were built, lines the interior of the chimney flues. Near the top of each chimney, two rows of bricks have been offset to create a decorative band around each chimney.

At the time that restoration began, the northwest chimney of the house stopped just below the roof and was not visible. Evidence shows that this chimney may have partially collapsed before being taken down to below the roof line. The chimney at the back, or west wing, of the house was noticeably shorter than the other chimneys. When compared with historic photos of the house, it was determined that this chimney had been shortened in years past. The three remaining chimneys all showed evidence of mortar repair, believed to have been made during the 1980's.

Plans are to use the chimneys to conceal the climate control/HVAC system designed for Lakeport Plantation house. The chimney flues will be restored to accommodate the duct liners for the system.

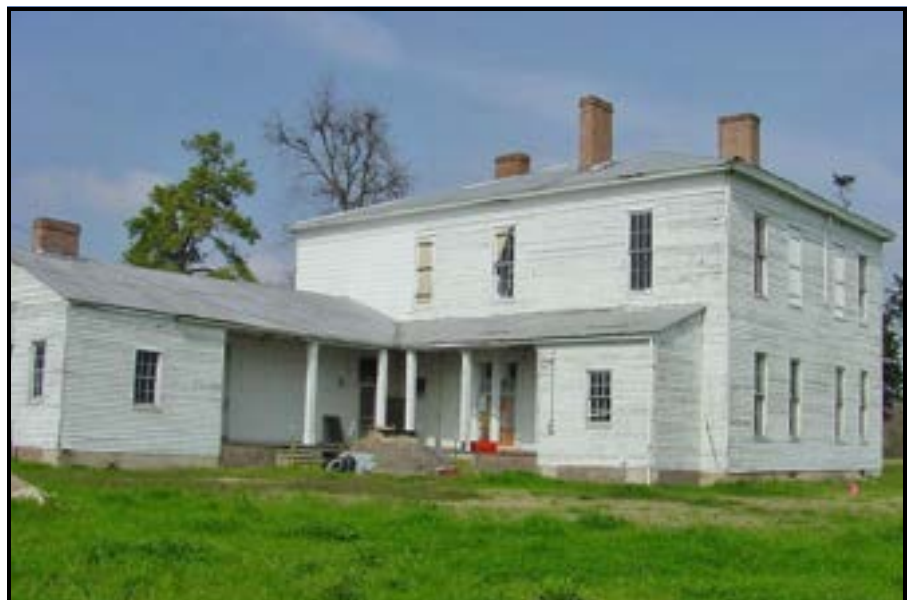
This photo of Lakeport Plantation house shows the four chimneys that were visible at the time restoration began. The fifth chimney had been taken down to below the roof line.

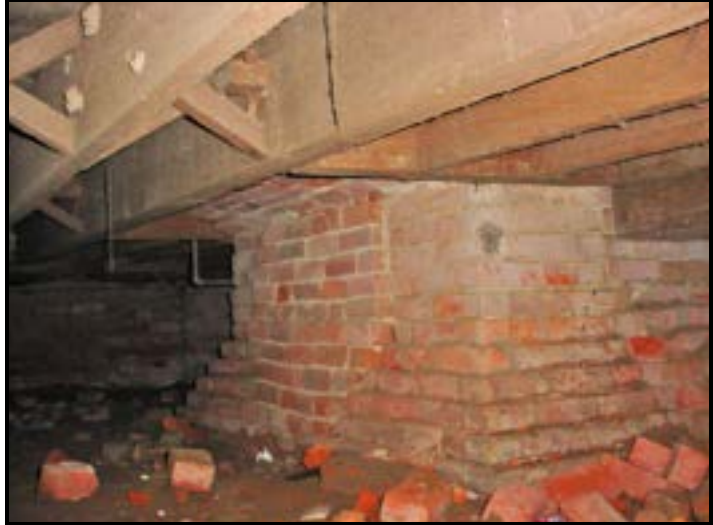
The photo at right shows the corbelled brick foundation that supports one of the chimneys of Lakeport Plantation house. This method of brick laying was also used to build the footers for the house.

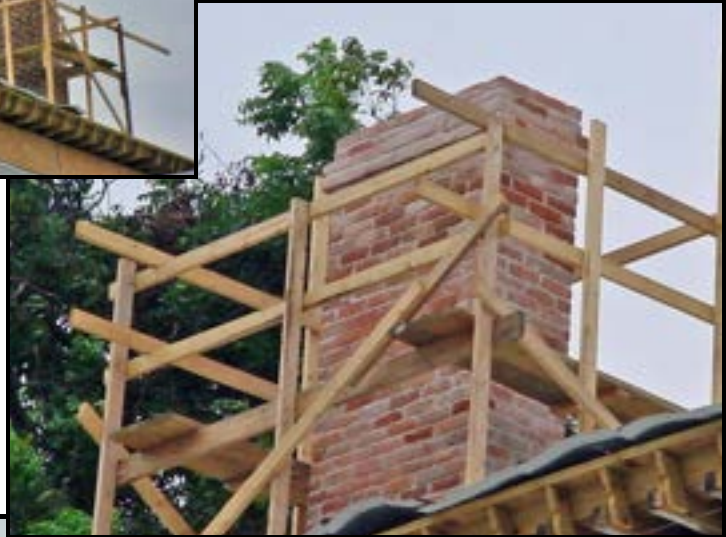
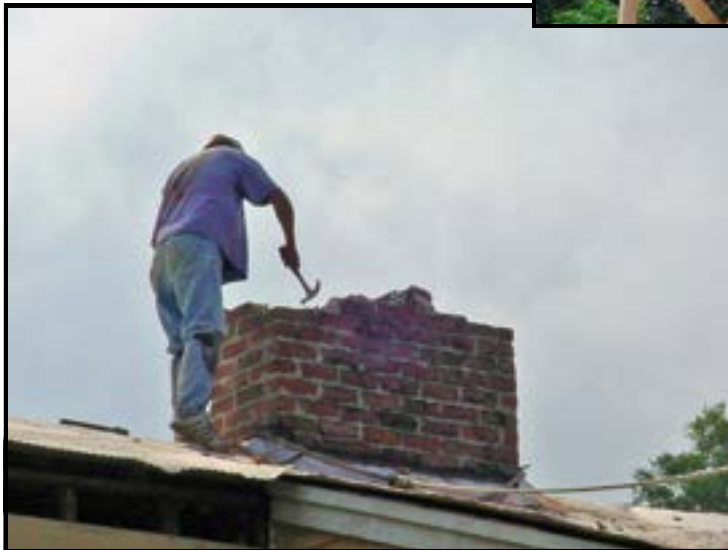
The photo at left shows a comparison of the southwest chimney on the right and the northwest chimney rebuild on the left. The northwest chimney had been taken down to below the roof line before restoration began. The photo below shows a closer view of the northwest chimney after being rebuilt.

The northwest chimney, having already been disassembled to below the roof line before restoration began, was rebuilt to match the existing chimneys. The west wing chimney, shorter than the other chimneys, was disassembled to the roof line and rebuilt, also to match the other chimneys. Both chimneys were rebuilt using original handmade bricks salvaged from the foundation walls when they were rebuilt. Although most of the bricks from the foundation walls were damaged, enough were salvaged to rebuild the two chimneys of Lakeport Plantation house.

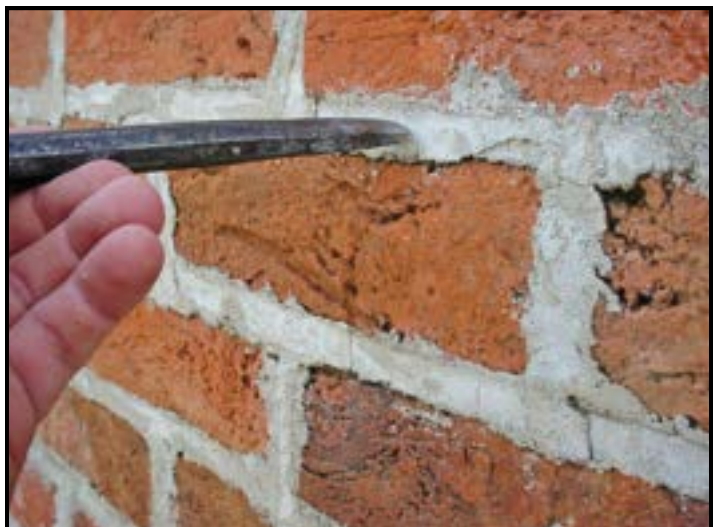
This photo of an 1850's structure shows the damage caused by a hard portland cement that was used to repoint the soft historic brick. The portland cement mortar was too hard for the soft brick, causing the brick to deteriorate rather than the mortar. This is a good example of why the mortar should be softer than the brick.

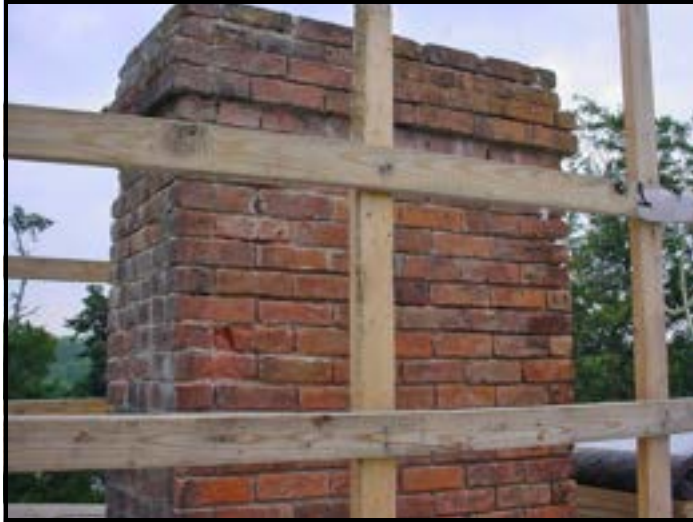
This photo shows a close-up of one of the chimneys that had been repointed with a portland cement mortar that was too hard for the soft historic bricks. Because it had not been applied correctly, it had not caused damage to the bricks. Instead, the mortar was cracking and pulling away from the brick.

When the three remaining chimneys were repointed in the 1980's, a modern portland cement was used for the mortar. Portland cement is much harder than the soft, historic bricks and can cause serious damage to the bricks. Because the portland cement applied in the 1980's had not been applied correctly,

it had not caused damage to the historic bricks, but was cracking and in poor condition. The portland cement was removed and a lime mortar that was compatible with the historic bricks was used to repoint the chimneys.

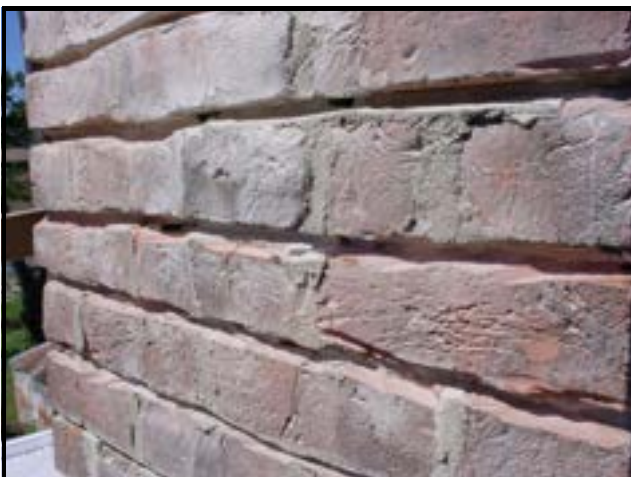
The above photo shows the southwest chimney after being repointed. A lime mortar compatible with the soft historic bricks was used to repoint the chimneys.
