# Lakeport Plantation Restoration

Technical Report No. 4

## Windows

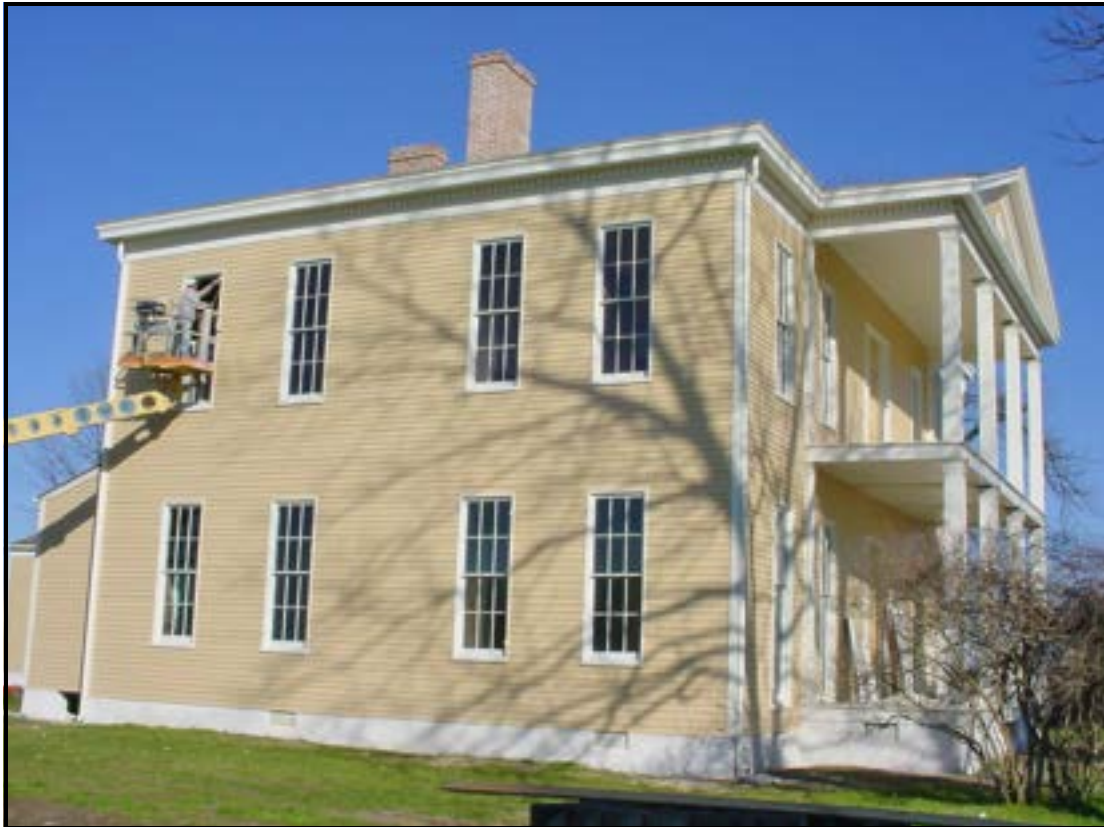
The tall, symmetrical windows of Lakeport Plantation house help to define the Greek Revival architectural style of the house.

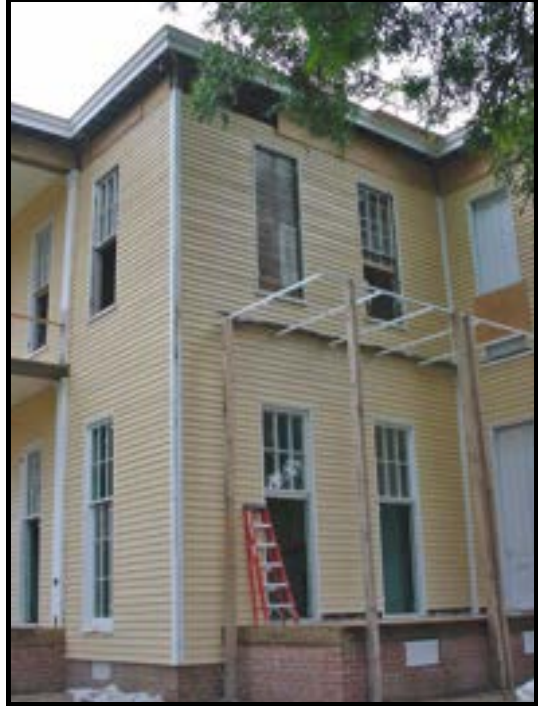
This photo shows the false window on the second floor exterior of Lakeport Plantation house. The interior wall, in the master bedroom, does not have a window. This provides additional wall space in the master bedroom while maintaining the architectural symmetry on the exterior of the house. The shutters will always be kept closed to hide the obvious fact that it is a false window.

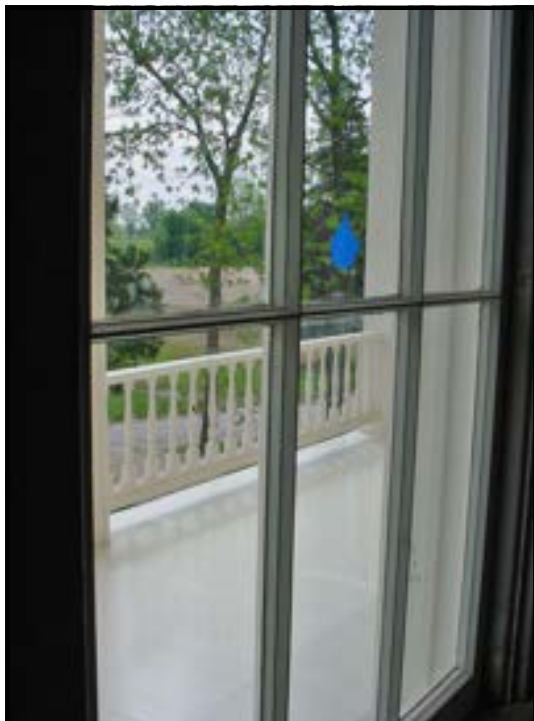
This interior view of the window sash at Lakeport shows the detailing of the window muntins. By the time the Lakeport Plantation house was being built, circa 1859, window sash were being manufactured at specialized mill shops. The window sash are believed to have been built in Madison, Indiana, and shipped downriver to Lakeport Plantation.

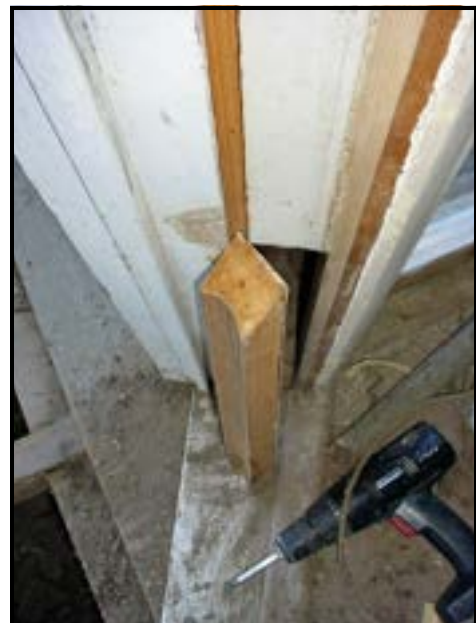
The photo at left shows the window pocket which houses the window weight for the bay window at the back of Lakeport Plantation house. The pocket runs the length of the window to allow the weight to move up and down as the window is raised and lowered. The photo at right shows the pocket door which provides for easy access to the window weight when repairs are necessary.

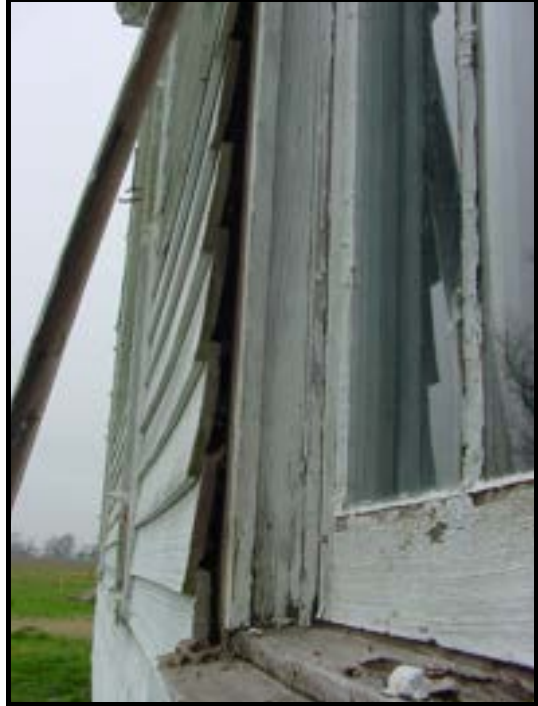
Details of joinery of an early 19th-century sash. (Michael J. Devonshire)

The above illustration shows the construction of an early 19th century, double-hung sash window. This illustration was taken from the book *Repairing Old and Historic Windows*, published by John Wiley & Sons, Inc., 1992. The Lakeport Plantation window sash were constructed using this same type of joinery.

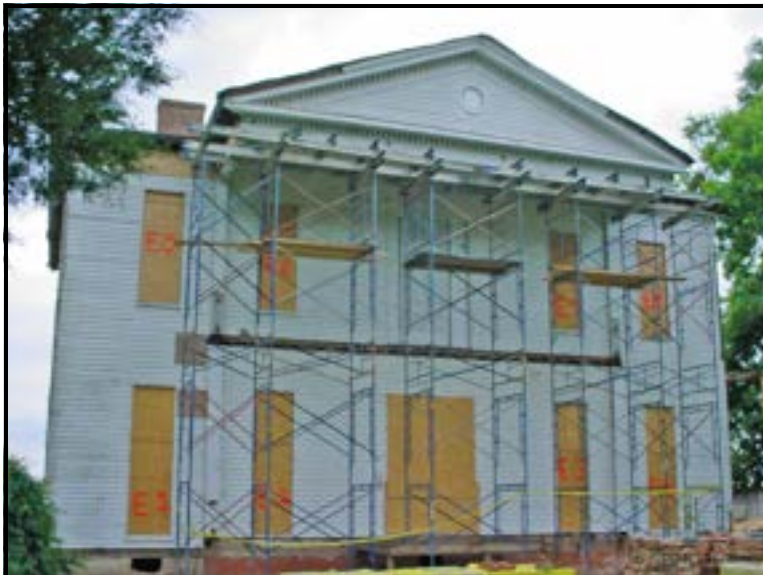
This photo shows the exterior window casing being removed from a window of the house. When restoration of Lakeport Plantation house began the windows were in poor condition. Window glazing was loose or missing. Paint was peeling and the wood was cracked and deteriorated.

Lakeport Plantation house had been unoccupied for thirty years at the time that restoration began. Although many of the windows had been covered with sheets of corrugated fiberglass roofing material, years without maintenance had left them in need of repair. Some windows were in worse condition than others. All of the

windows had cracked, peeling or missing paint, cracked or missing window glazing, and weather deteriorated wood. Many of the windows had parts that had deteriorated to the extent that they would need to be replaced.

All of the window sash were removed and taken to a mill shop to be restored by a craftsman skilled in window restoration. The window glazing and glass were all removed, the paint was stripped and the wood was sanded where there was minor deterioration. Where there was more extensive wood deterioration, dutchmen, or small pieces of wood used as fillers, and epoxy patching methods were used. The window components that were beyond repair were replaced using old growth sinker cypress. The window sash were then primed, re-glazed using the original window glass, and reinstalled. The balance weights were reinstalled and attached to the window sash using new sash rope. Some of the original sash locks still

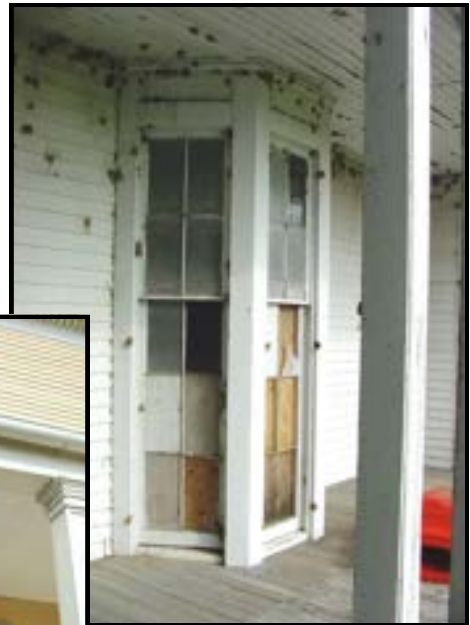
This photo shows the front entry door of Lakeport Plantation house with the decorative glass sidelights. Three of the original glass panes remain. Reproduction glass panes were made and installed where the original were missing.

panes remain on the main floor and one remains on the second floor. Reproduction glass panes were made in the same manner as the original and installed where the original were missing. The bay window was also filled with decorative patterned glass, though of a different pattern than the sidelights. Many original panes remain in the bay window and reproduction glass panes were made to replace these missing panes as well.

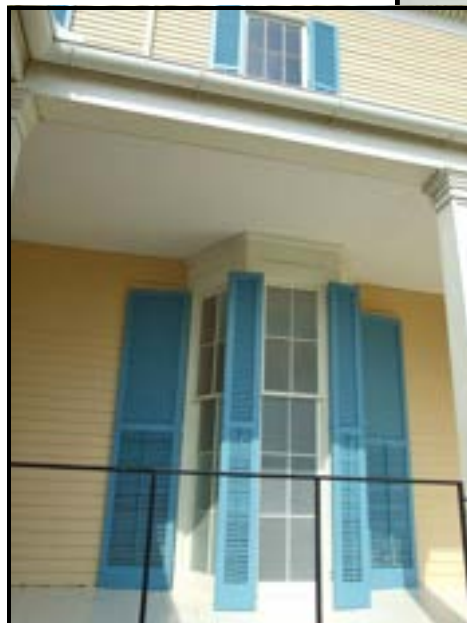
Before and after photos of the bay window at Lakeport. Many panes of decorative glass are original. Reproduction glass replaces any missing or broken panes.

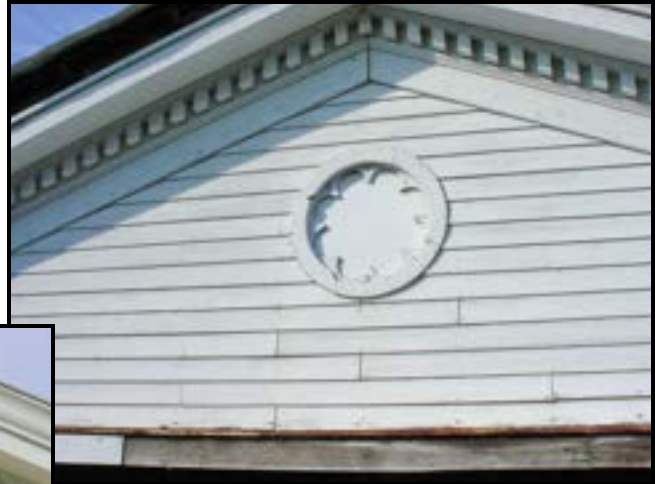
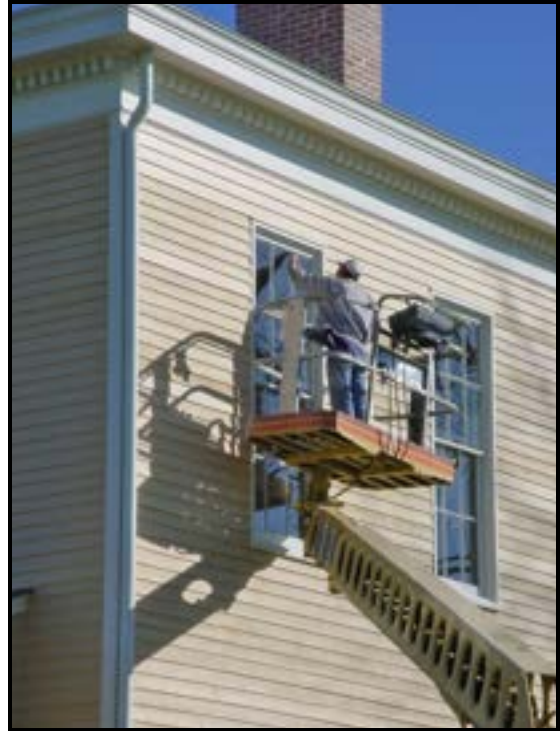
These photos show the rose window before and after restoration. Before restoration the window was in poor condition. It had been painted over and was unnoticeable. After restoration the rose window once again decorates the front porch pediment of Lakeport Plantation house.

The rose window on the front porch pediment is one of the most decorative features of the house. When restoration began the rose window had been painted over and was unnoticeable. The original glass, exterior trim and scalloped window sash remained, although deteriorated and in need of repair. One original window muntin remained. The rose window was removed and the exterior trim and wood sash were restored. Window muntins were reproduced to match the original. A decorative center piece was also reproduced and new window glass replaced the old. Once the restoration was complete the rose window was reinstalled on the front porch pediment.

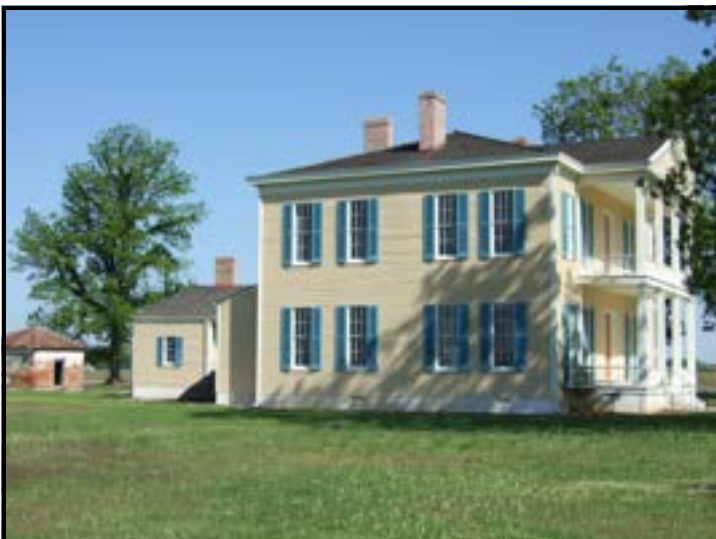
In this photo the restored window sashes have been installed and a member of the restoration crew is preparing the windows to receive a final coat of paint.

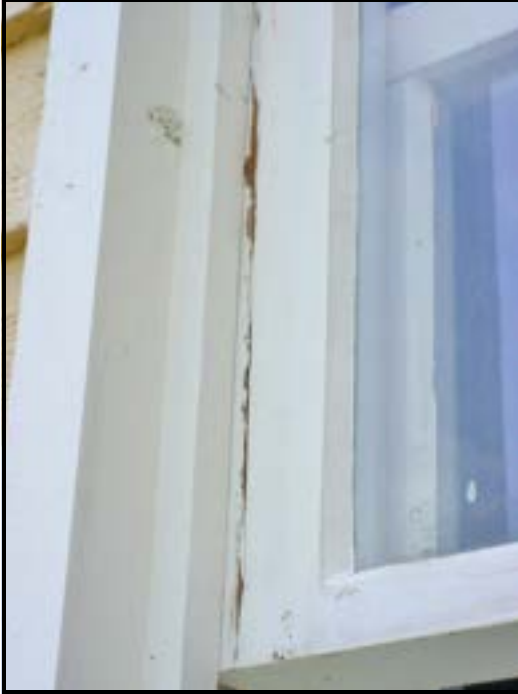
This photo shows the damage done to a Lakeport window sash during restoration when a sharp object was used to loosen the window sash after it had been painted shut. There are painting techniques that can be used to prevent windows from sticking when painted. The window sash was removed, sanded and repainted to repair the damage that was done.

There are special painting techniques to use to keep the window from sticking when painted. When painting the window sash, the most important painting technique is to let the paint flow approximately 1/32 of an inch over the window glazing and onto the glass. This seals the new putty and protects it from the weather.
