# Lakeport Plantation Restoration

Technical Report No. 8

## Lakeport Porches

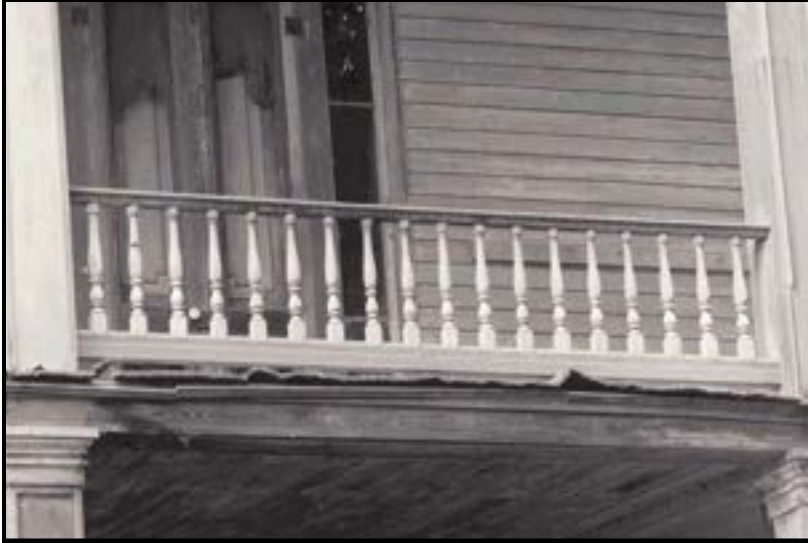
In the photo at right are two of the original front porch balusters found above the shelving in the commissary when restoration began. These balusters were used as a model for reproduction of the original front porch balustrades.

The original front porch balustrades were missing from both floors. The second floor did have a simple balustrade that had been built to replace the original. Mortises of the original handrail and foot rail were uncovered when pieces of sheet metal were removed from the pilasters. This gave information about the shape of the railings as well as the height and how they were attached to the pilasters. Two of the original balusters were found on top of the commissary shelving, providing a model for their exact replication. The porch balustrades were constructed using old growth cypress material that had been salvaged from old industrial buildings in Greenville, Mississippi.

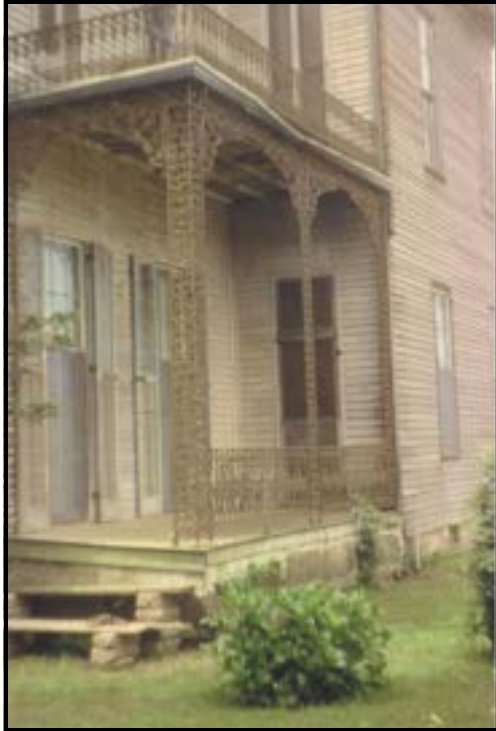
The photo at left shows the ornamental iron porch as it was in April, 1956. This photo was provided by Jerry Ford, the son of Alvin Ford, Sr., whose family was the last to occupy Lakeport Plantation house.

**When** restoration began on the ornamental iron porch, the decorative cast iron columns and balustrades were also missing. All that remained of the original cast iron was the frame, which had been left in place when the rest of the ironwork was removed. The brick foundation walls and floor joists were original but in poor condition and had to be removed and replaced. The existing flooring was not original to the house. It was in poor condition as well and was removed and replaced with a pressure treated pine material. The existing roof was a corrugated tin that had been put

on in the 1950's. From evidence found during restoration, it is believed that the original roof was a traditional flat seam metal roof. Copper was used for the new roof because of its durability. The original cast iron columns and balustrades were recovered from the same house in Lake Village that had acquired the balconettes. The ironwork was restored and, through paint analysis, was returned to its original green color. Once restored, the decorative ironwork was returned to its original location.

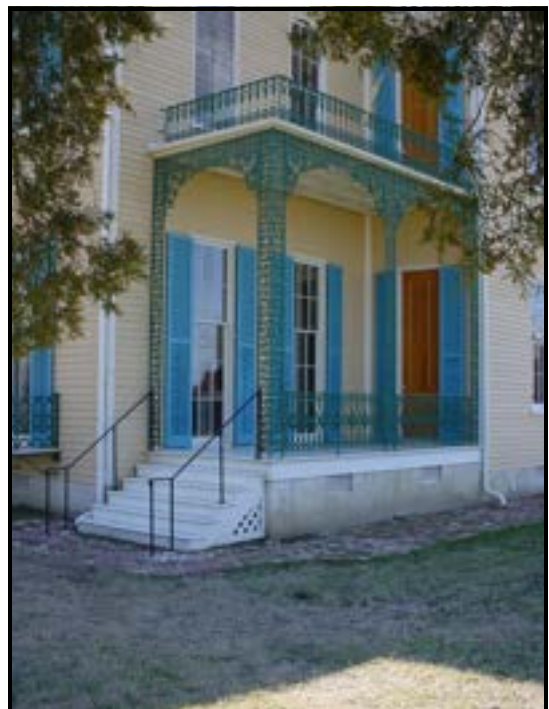
In the photo at right the ornamental iron porch has been completely restored to its original condition.

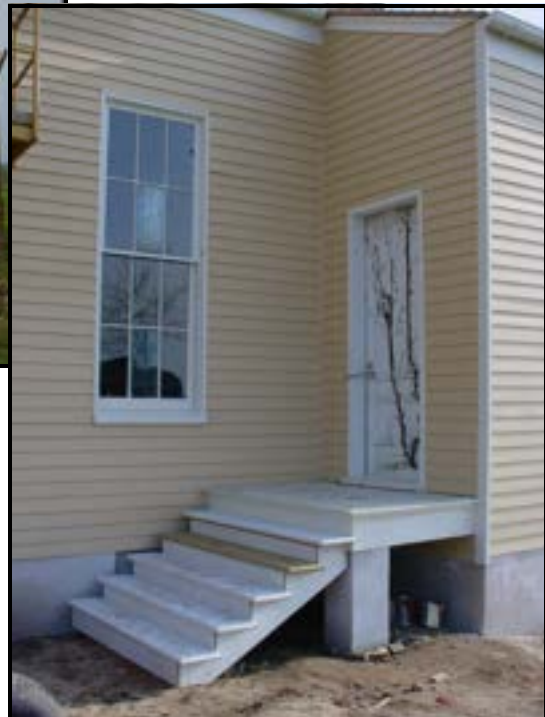
When restoration began, all of the porch steps were replacements. It is not known in what fashion the original steps were built. Historic, circa 1925, photos show wooden steps on all porches visible. However, because of the age of the house at that time, it is unlikely that these steps were original. Wooden steps with closed treads, traditionally found on homes of that period, were constructed for all of the porches. Metal handrails were installed on all of the porch steps for safety purposes.
