# Lakeport Plantation Restoration

Technical Report No. 10

## Smokehouse and Mechanicals

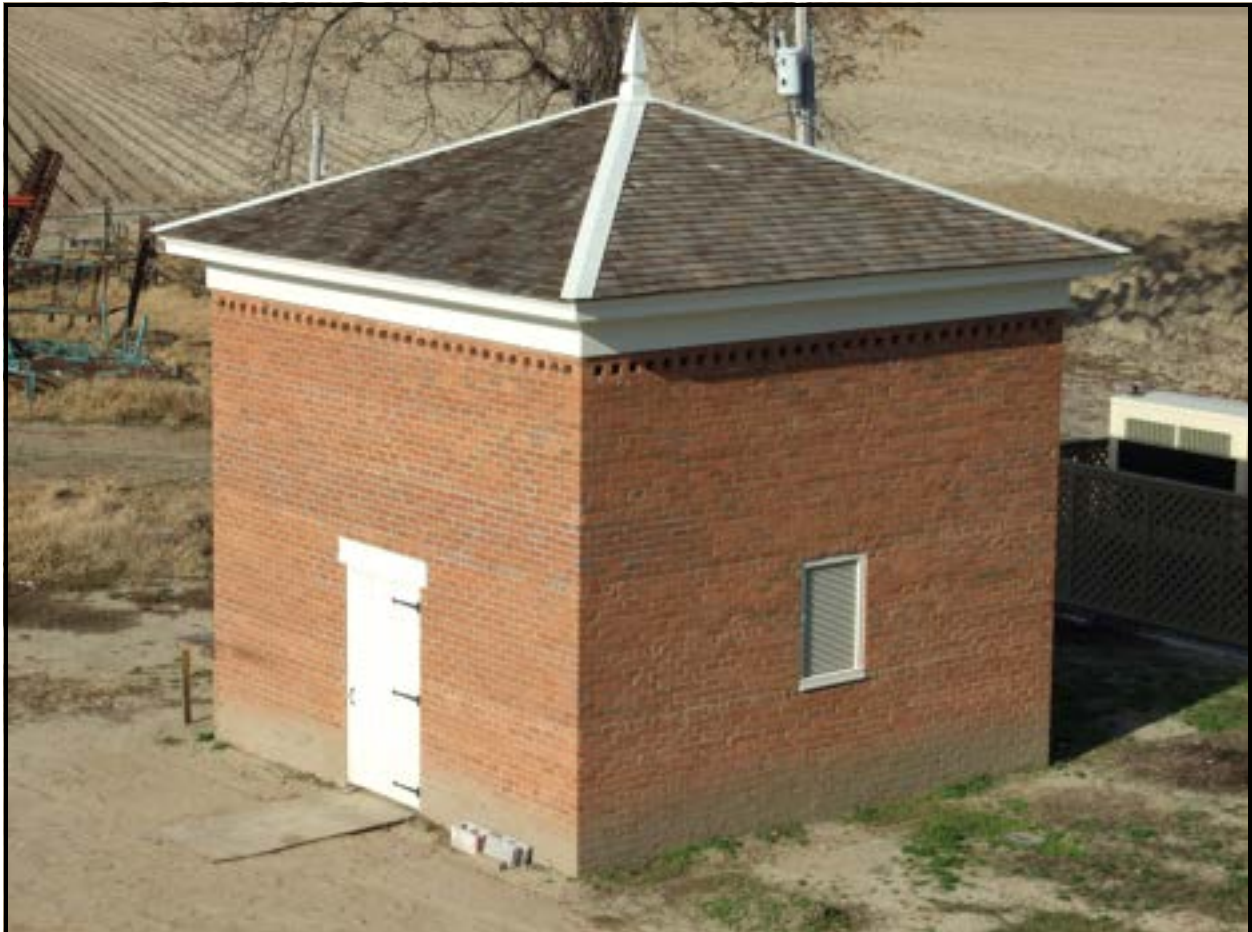
The original smokehouse was no longer standing at the time that restoration began on Lakeport Plantation house. It had collapsed sometime during the 1980's and only a pile of bricks remained. There was enough photo documentation, however, to be able to rebuild the smokehouse with historical accuracy. Historic photos showed the original smokehouse to be a large, square, brick building with a board and batten door. Vent holes near the top gave evidence that the building was used as a smokehouse. The hip roof was covered with wooden shingles and a wooden finial could be seen at the peak of the roof. Cornice moldings and frieze board along the eve of the roof matched the trim on Lakeport house.

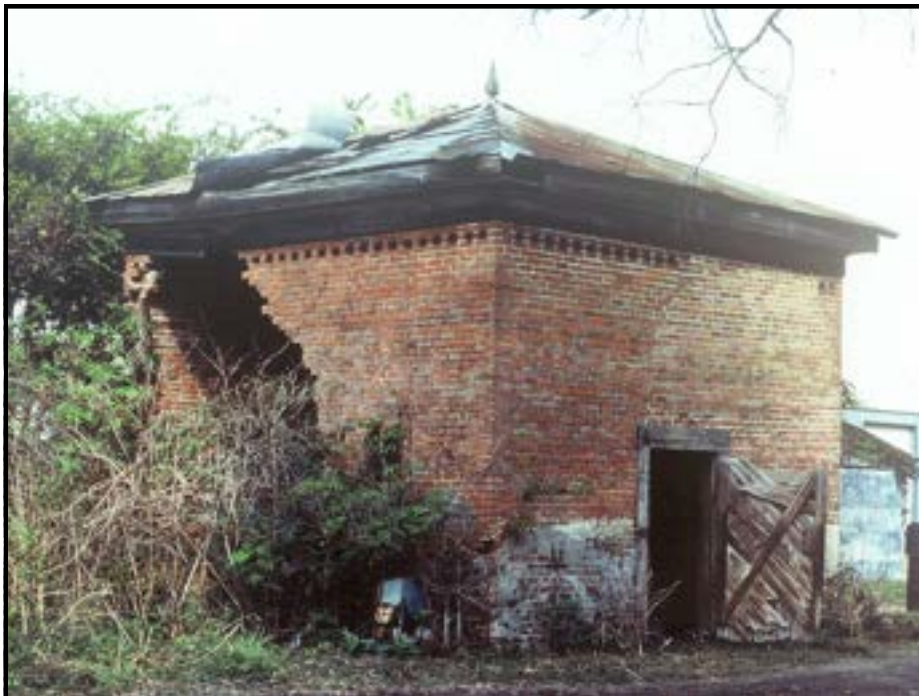
The original Lakeport smokehouse, seen in the photo at left, fell sometime during the 1980's. When this photo was taken, the west wall had already begun to collapse. This photo was provided by descendants of the Johnson family.

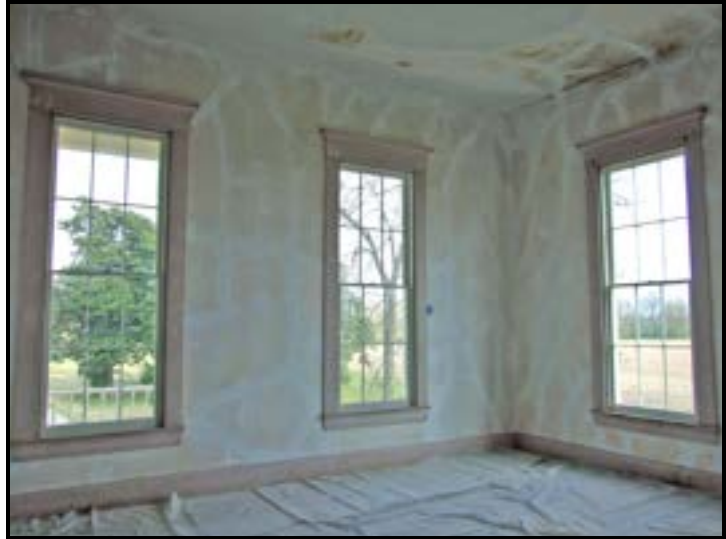
In the photo at right can be seen the original lime plaster walls that were found in Lakeport Plantation house when restoration began. The lime plaster walls on the second floor of the house had never been painted. These walls are in the southeast bedroom on the second floor of the house.

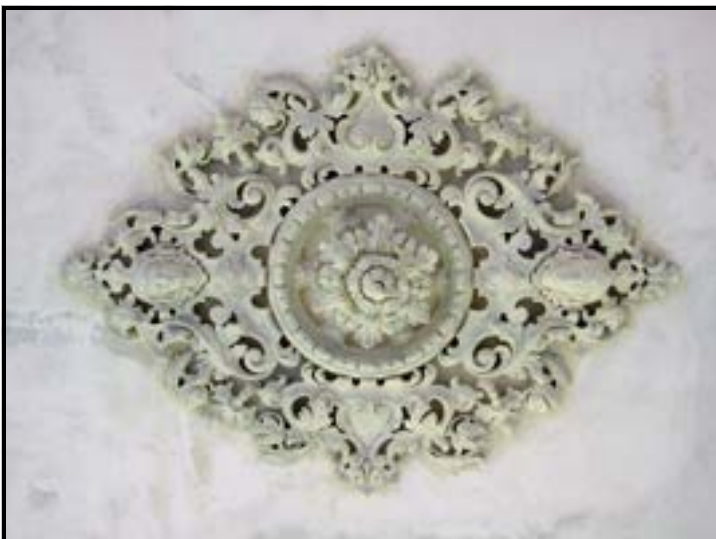
The photo at left shows the ceiling medallion that was found in the south parlor of Lakeport Plantation house. The ceiling medallion, made of lime plaster, is original to the house.

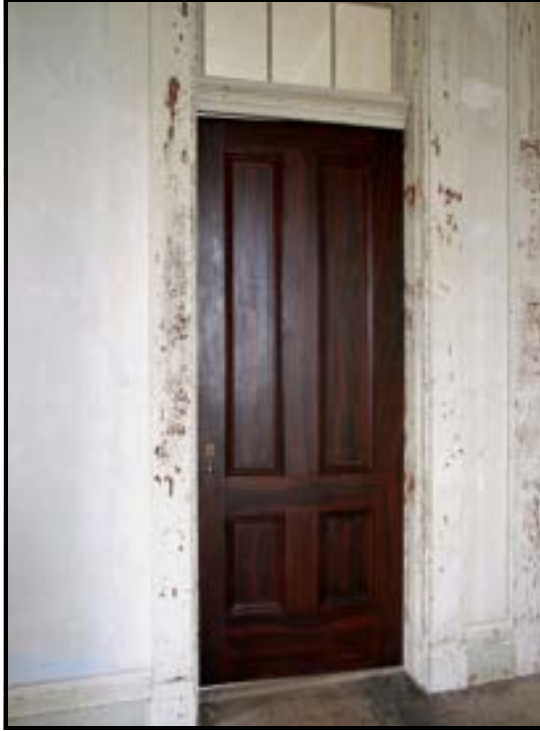
The door shown in the photo at left opens into the master bedroom on the second floor of Lakeport Plantation house. All of the doors on the second floor still hold their original rosewood faux finish that has never been painted over.

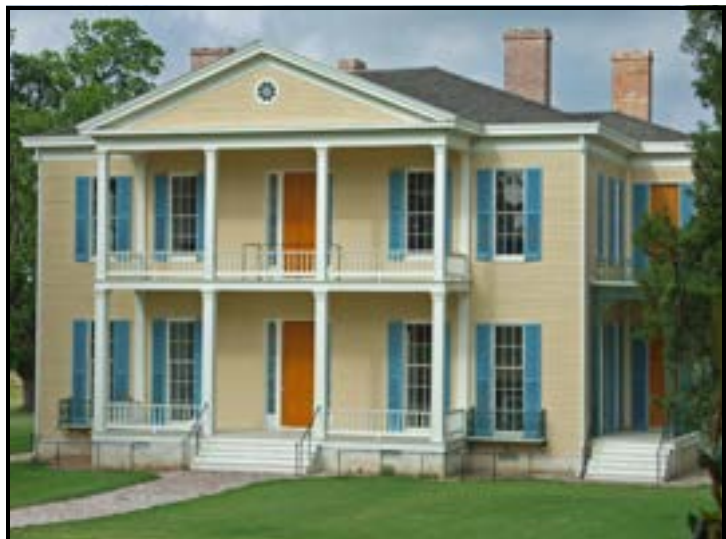
The photo at right shows the tall windows and doors and large porches that have provided ventilation for Lakeport Plantation house from the time that it was first built.

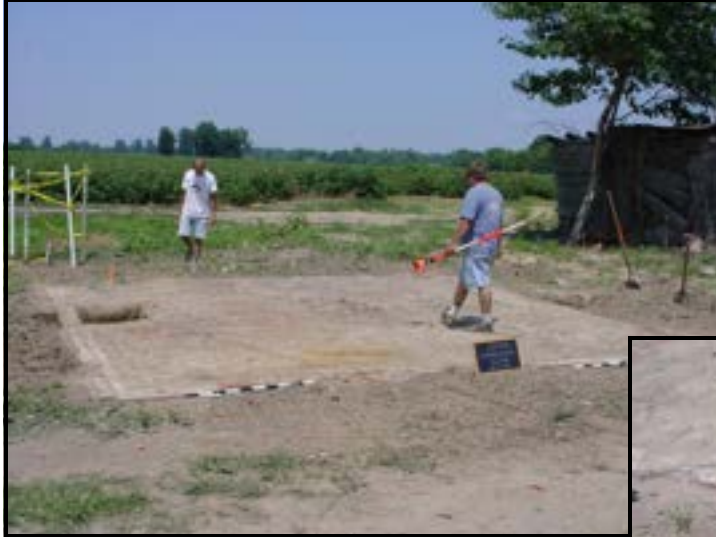
In the photo at left the floor of the original smokehouse has been exposed by the project archeologists. Excavation showed that the smokehouse floor was built of handmade bricks, many of them half bricks. It is believed that these bricks were left over from the construction of Lakeport house.

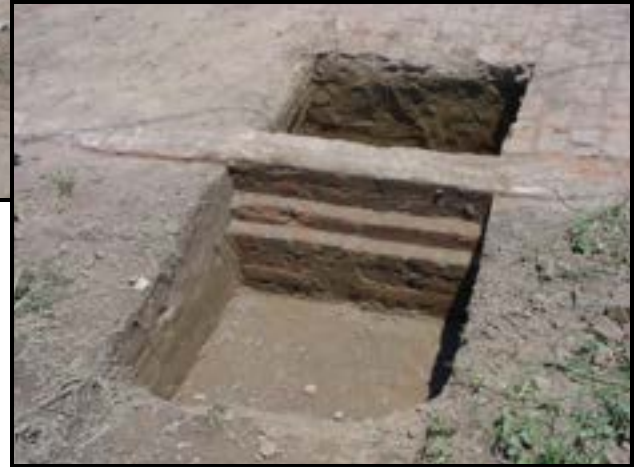
Also exposed were the original smokehouse footer and part of the smokehouse wall. As seen in the photo at right, the smokehouse footer was built in a corbelled design, similar to the footer built to support Lakeport Plantation house.

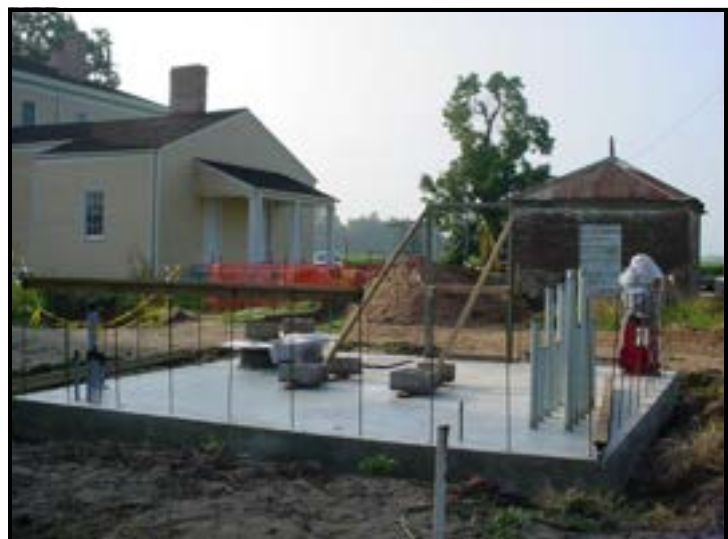
Many of the mechanical components were installed prior to pouring the concrete slab for the smokehouse. In the northwest corner of the smokehouse is the piping to the geothermal field. The fire pump sets at the southwest corner. In the southeast corner are the supply and return air ducts and in the northeast corner is the electrical supply for all of the mechanicals.

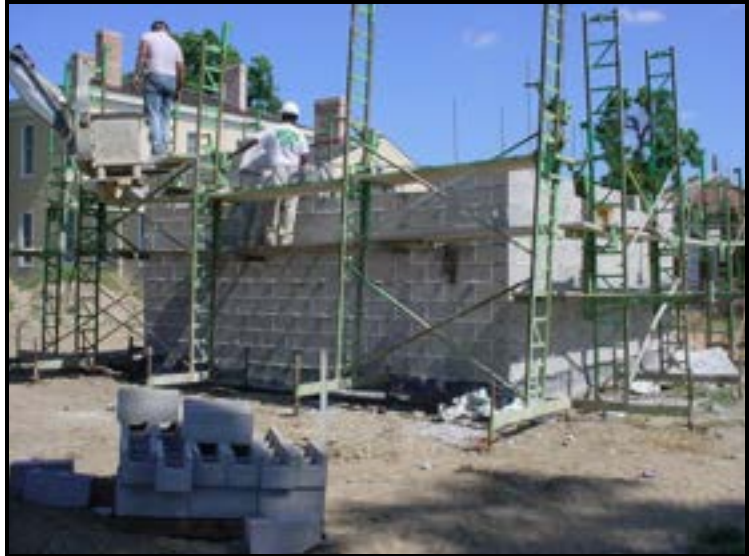
The photo at right shows concrete masonry blocks being laid as the construction of the new smokehouse begins.

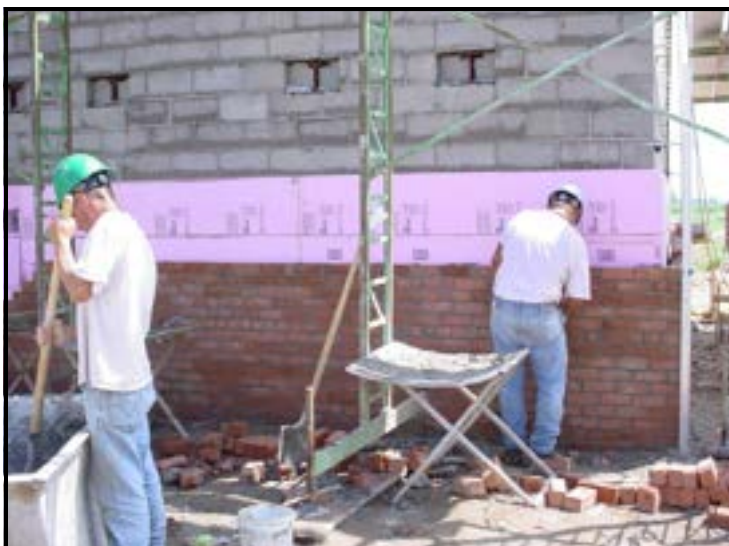
In the photo at left brick masons are laying reproduction "handmade" bricks over the concrete masonry blocks. Reproduction bricks were found to match the bricks from the original smokehouse.

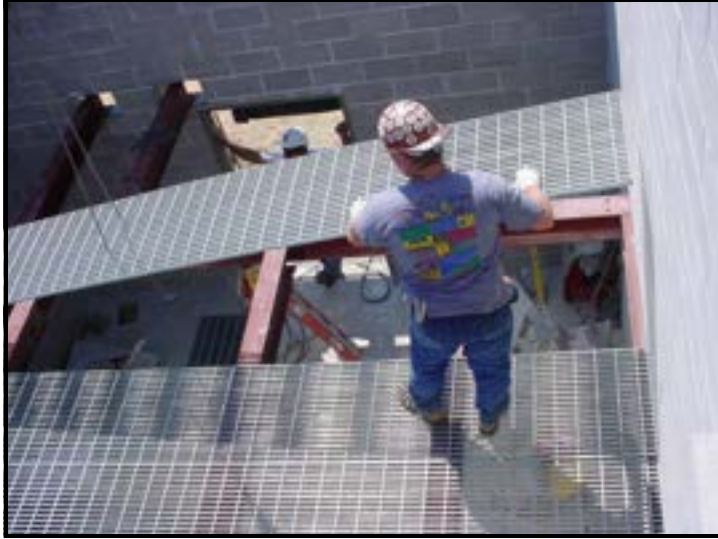
The photo at left shows the construction of the mezzanine floor in the new smokehouse. The mezzanine floor was necessary to be able to house all of the mechanical equipment in the smokehouse.

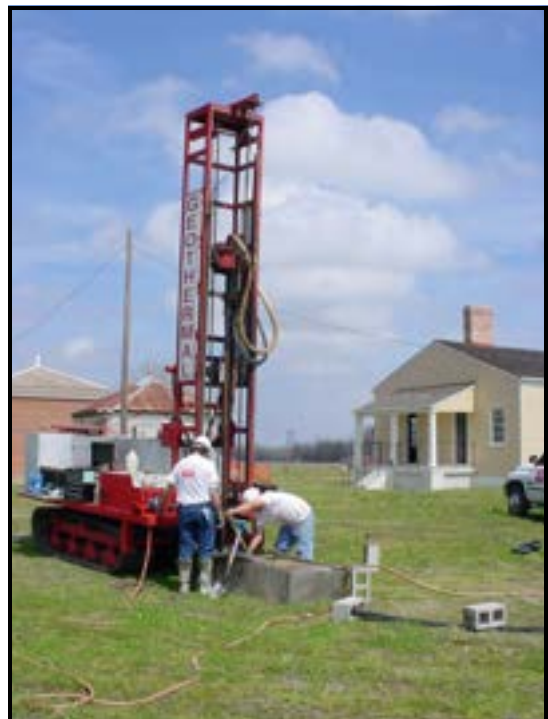
In the photo at right preparations are being made to begin digging the wells for the geothermal field for Lakeport Plantation house. A test loop had previously been dug and it was determined that, to maximize the thermal quality of the ground, each well would need to be three hundred and sixty feet deep with a distance of twenty-five feet between all wells.

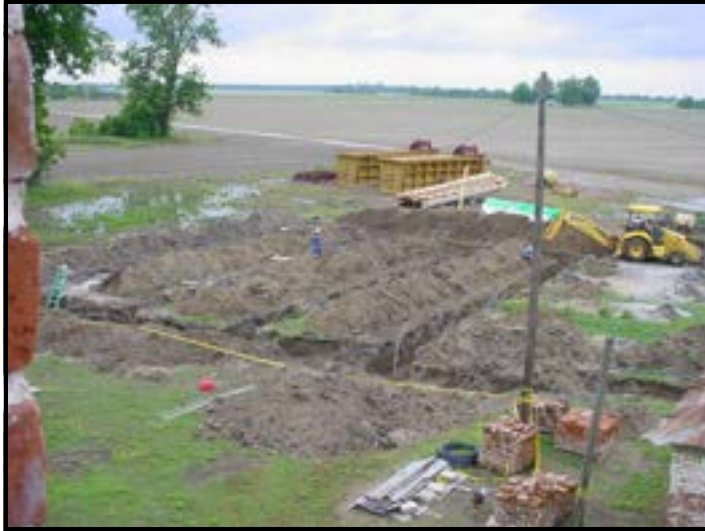
The photo at left shows an aerial view of the geothermal field as it is being dug for Lakeport Plantation house. The geothermal field consists of five rows of loops with five vertical loops, or wells, in each row.

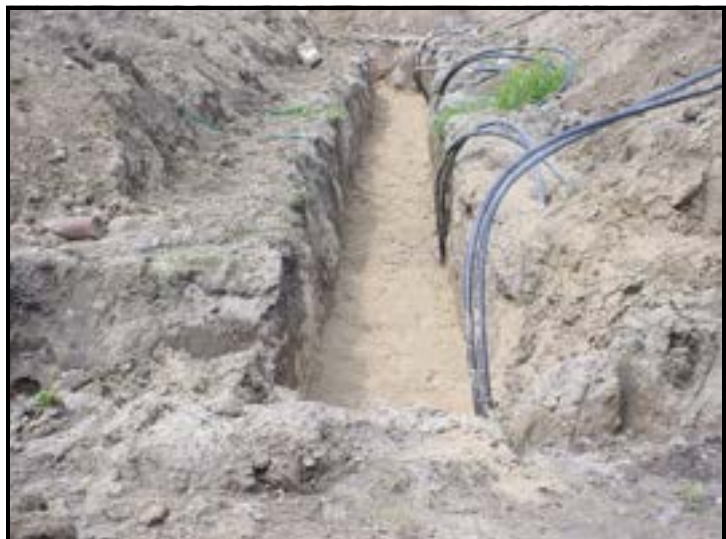
The photo at right shows a single row of five wells. What appears to be two pipes running into the ground for each well is actually one pipe that runs into the ground, loops below ground, and then comes up and out of the ground.

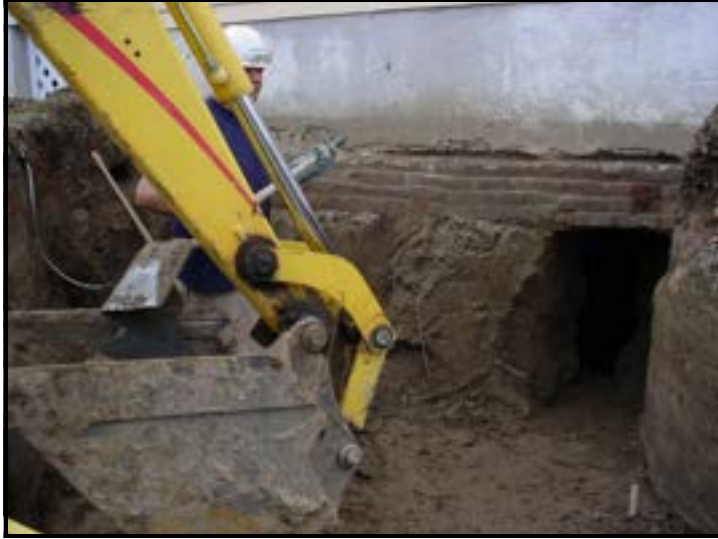
The photo at left shows the removal of dirt from beneath the footer of the house to make way for the large cast iron pipes. Once the pipes are run beneath the foundation, they will connect to the sheet metal ductwork that will carry the supply and return air throughout the house.

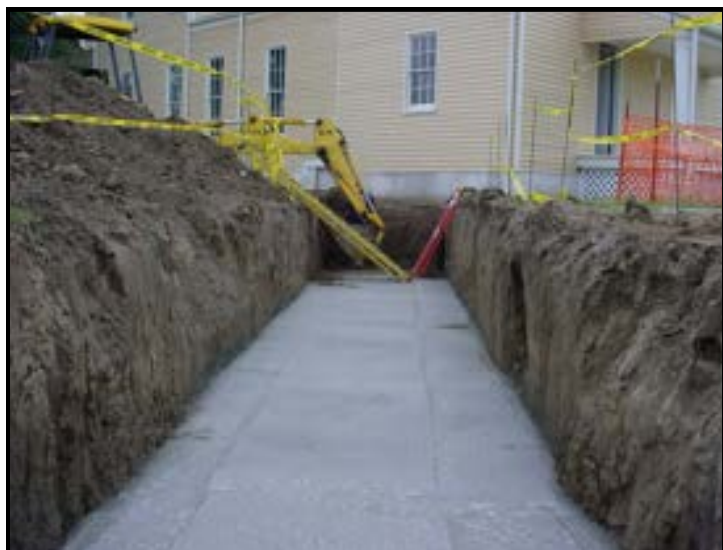
In the photo at right a concrete floor has been poured at the bottom of the trench. The concrete floor will support the large cast iron pipes that carry the supply and return air from the mechanicals inside the smokehouse to the inside of Lakeport Plantation house.

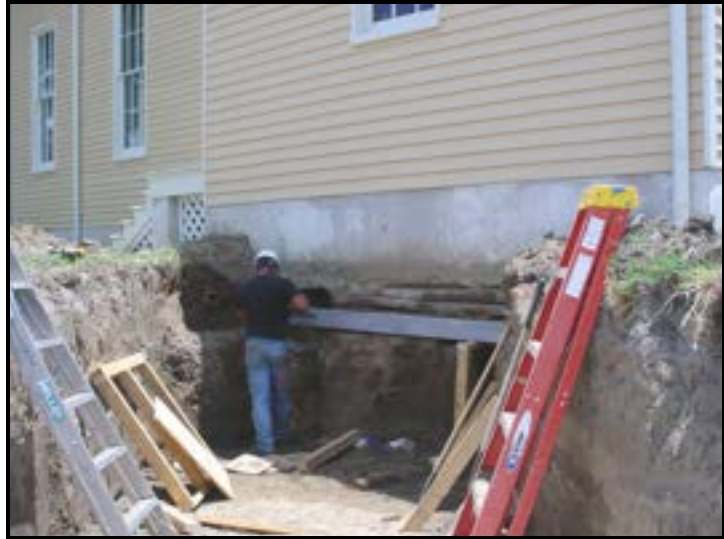
The photo at right shows a steel brace being constructed to support the footer while the cast iron pipes are being installed. A steel plate has been placed beneath the footer and L-braces are welded to each side of the plate. The braces will be supported at each end by concrete piers.

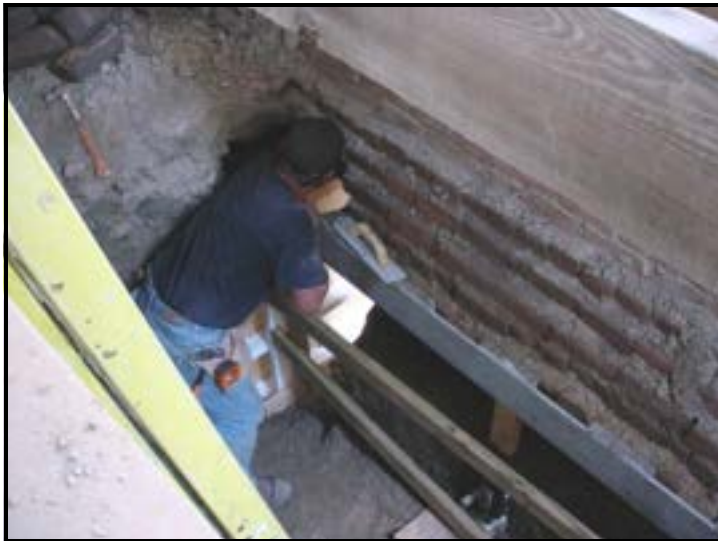
The photo at left shows construction of the steel brace from below the house. The large, cast iron pipes will enter Lakeport house beneath the footer of the cook's room. Part of the cook's room flooring has been removed to provide access to the footer from inside the house.

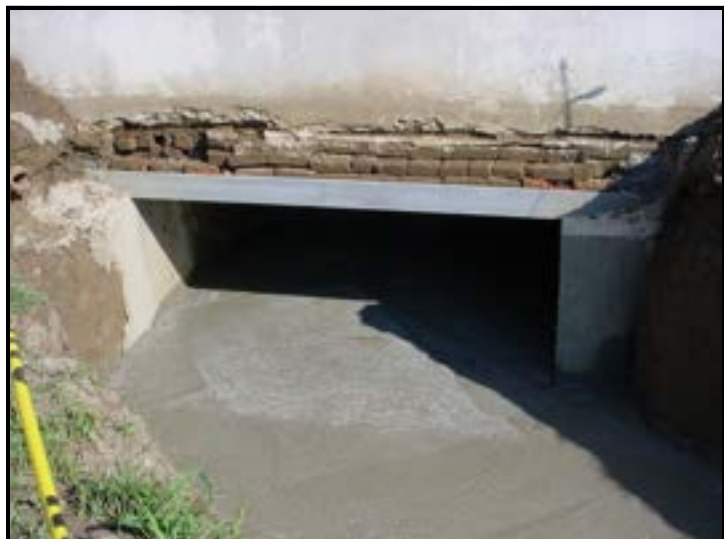
The photo at right shows the bracing completed. The concrete support is poured and ready for the large pipes to be laid. Once the pipes are laid, a cement fill will be used to provide permanent support.

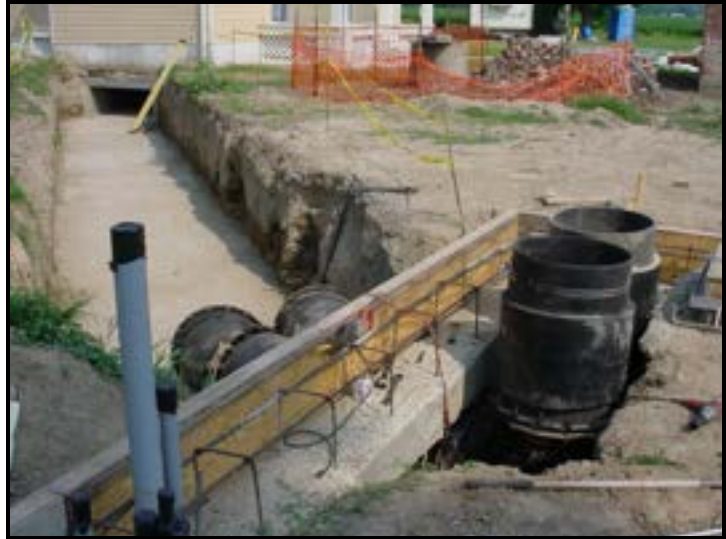
In the photo at right the large cast iron pipes have been run beneath the foundation of the new smokehouse. The pipes that are running upward will connect to the air handler inside the smokehouse.

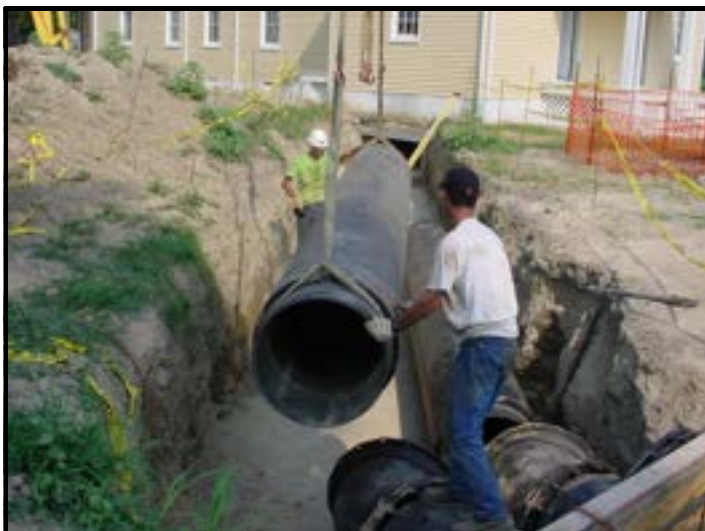
The photo at left shows the large cast-iron pipes being run from the smokehouse to Lakeport Plantation house. The large pipes are twenty-four inches in diameter.

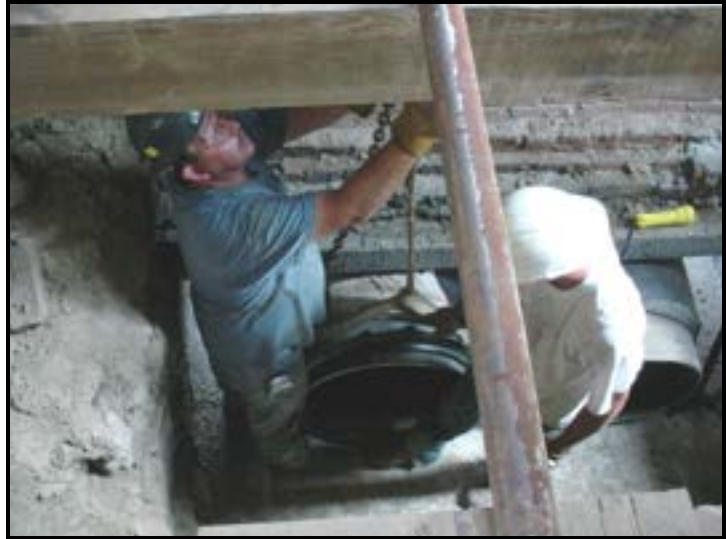
The photo at right was taken from inside the cook's room. In this photo the cast iron pipe can be seen as it enters below the footer of the house.

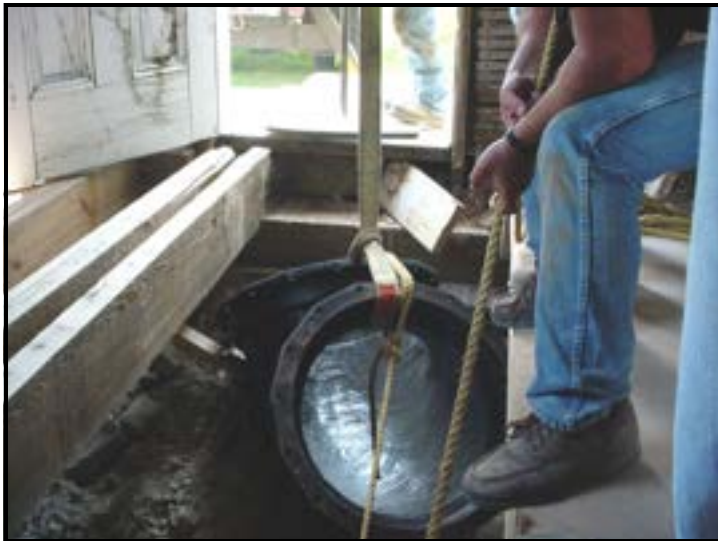
In the photo at left the cast iron elbow has been brought in through the east entrance of the cook's room and is being lowered to beneath the floor. It will connect to the pipe that enters from the exterior.

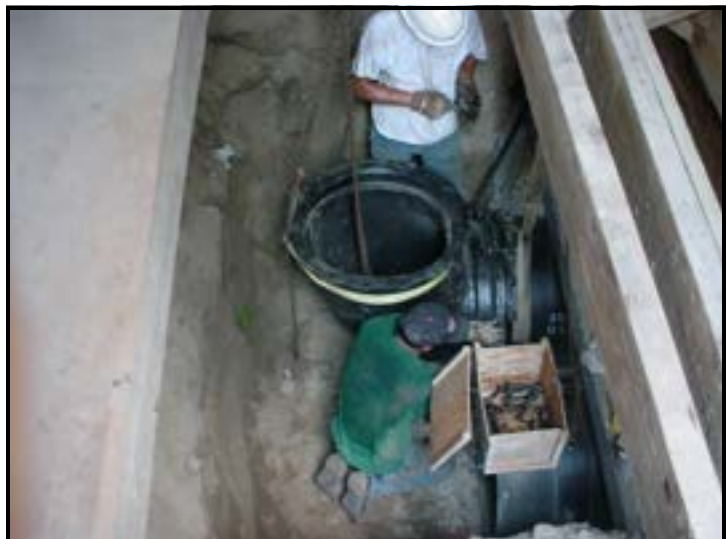
In the photo at right the elbow has been set in place. Below the house, the cast iron pipes will connect to custom fabricated metal ductwork that will run throughout the house.

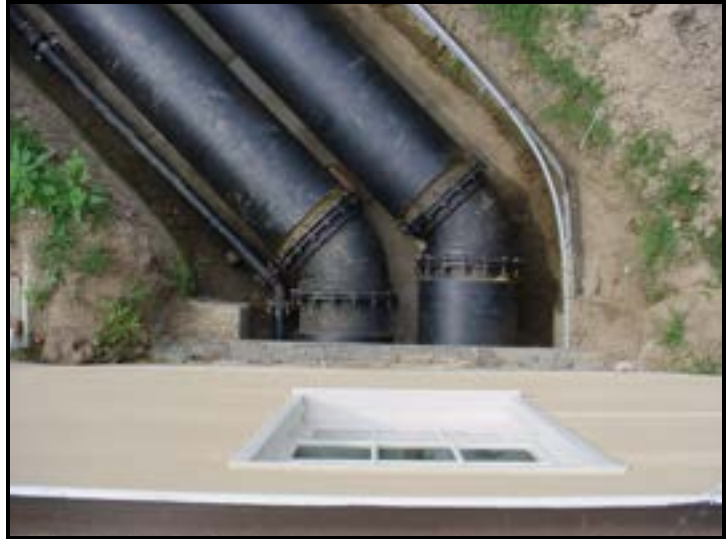
The photo at right is an aerial view of the mechanical pipes as they enter Lakeport Plantation house. The smaller cast iron pipe to the left is a dry-line pipe for the fire suppression system. The large cast iron pipes carry the supply and return air. The small pipe on the right carries the electrical conduit for the mechanical system.

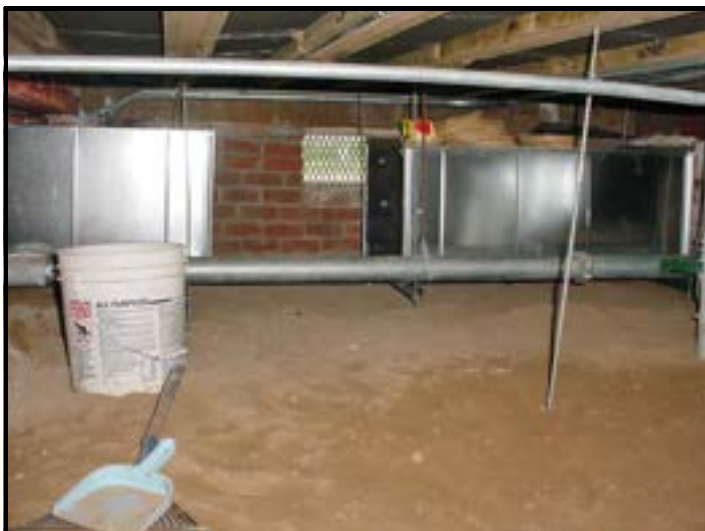
The photo at left shows two sections of the main ductwork that runs beneath the house. The main ductwork connects to the cast iron pipes as they enter the house. The two sections shown in this photo will be joined together.

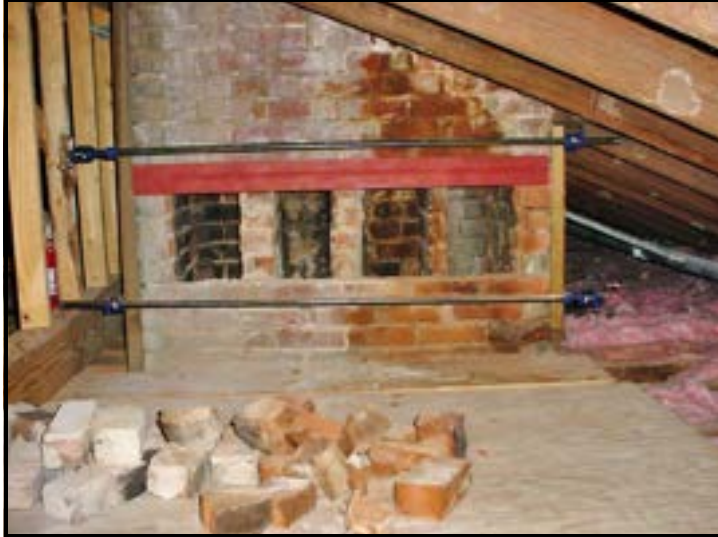
The photo at left shows one of the chimneys in the attic of Lakeport Plantation house. This chimney has four flues which serve the south parlor and dining room on the main floor and the southeast and southwest bedrooms on the second floor. The bricks have been removed to provide access to each of the four flues in preparation for the ductwork to be installed.

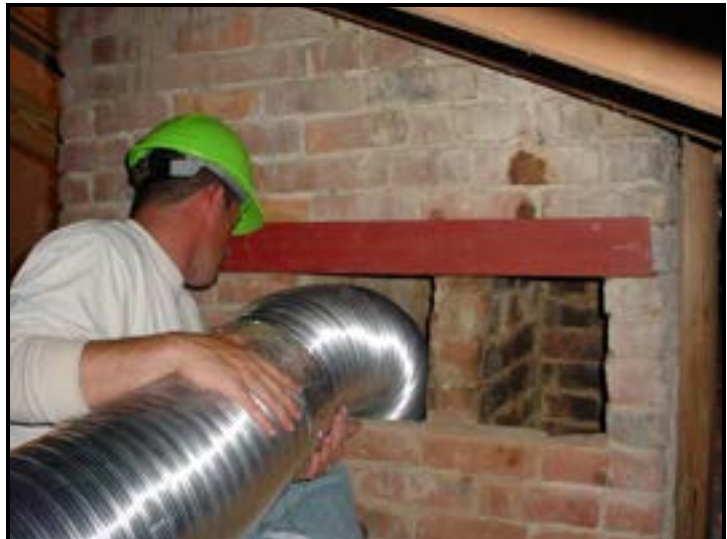
The photo at right shows the flexible, round metal ductwork being run down one of the chimney flues. This particular chimney has only two flues.

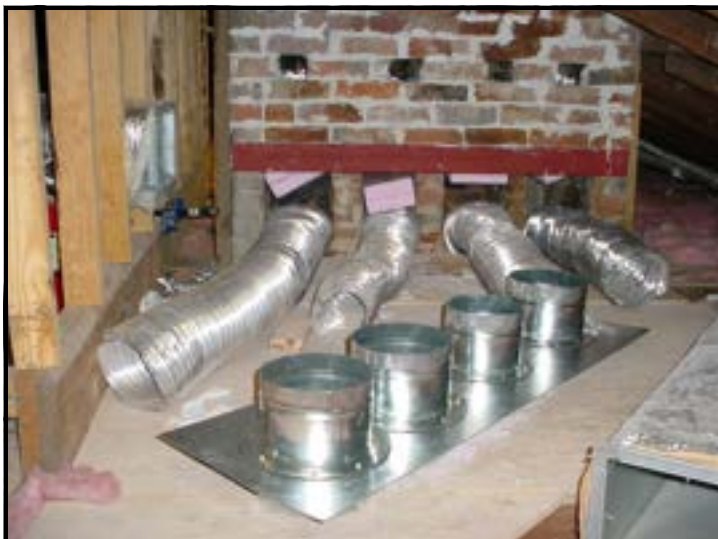
In the photo at left the ductwork has been run down the four chimney flues. The custom made collars that lay on the floor are ready to be attached to the chimney face. They will secure the ducts and ready them for attachment to the main supply ducts in the attic.

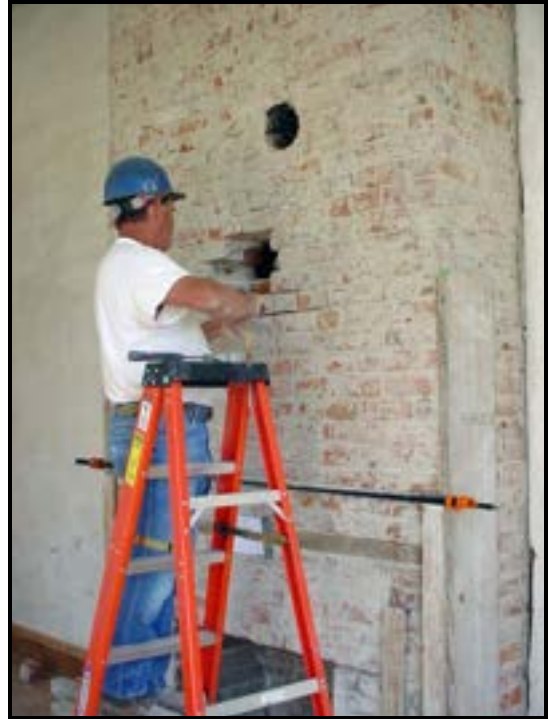
In the photo at right, bricks are being removed to provide access into the chimney flue. This will allow restoration workers to guide the ductwork down the flue. A special carbide-toothed handsaw is being used to remove the bricks. This type of saw blade will help to reduce damage to the bricks. Plans are to salvage the bricks for reuse.

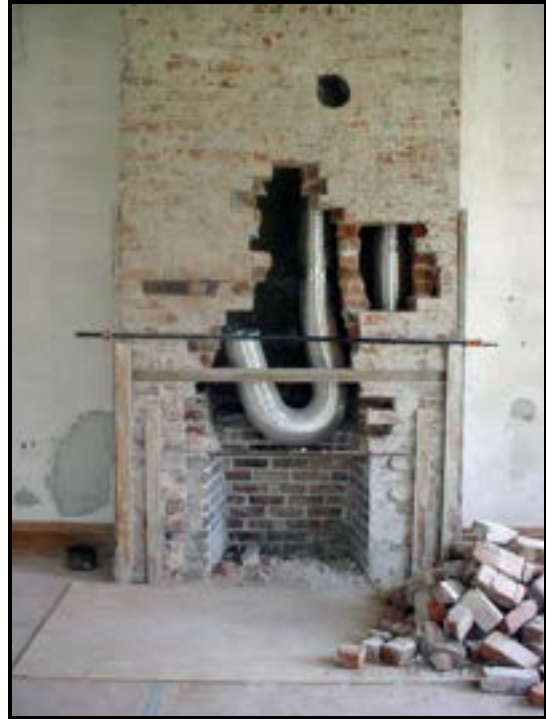
In the photo at left, the southwest bedroom fireplace has been opened up to allow access to the ductwork that has been run down the flues from the attic. The ductwork seen in the center of the chimney will serve this bedroom while the ductwork on the right in the photo continues on to the dining room fireplace below.

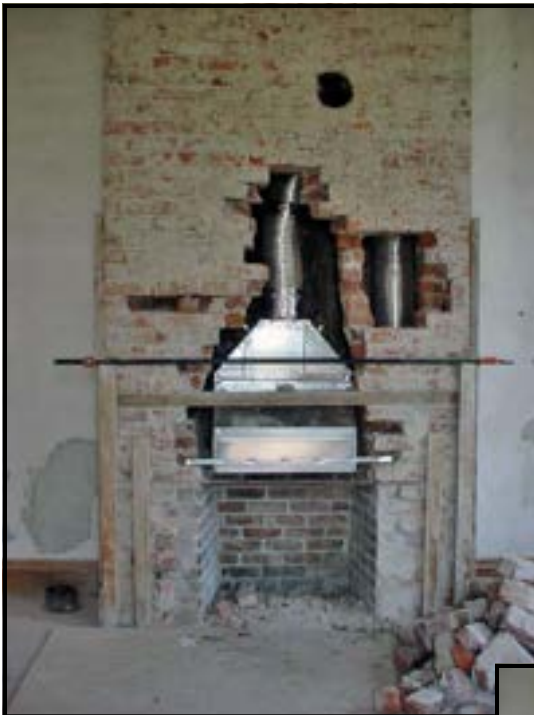
In the photo at right, more bricks have been removed to prepare for installation of the plenum and air diffuser.

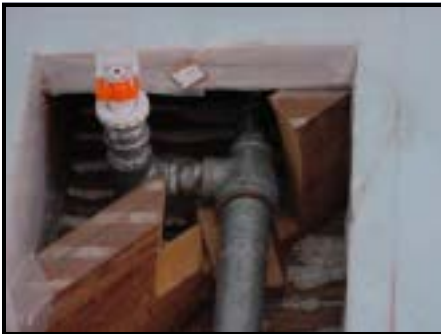
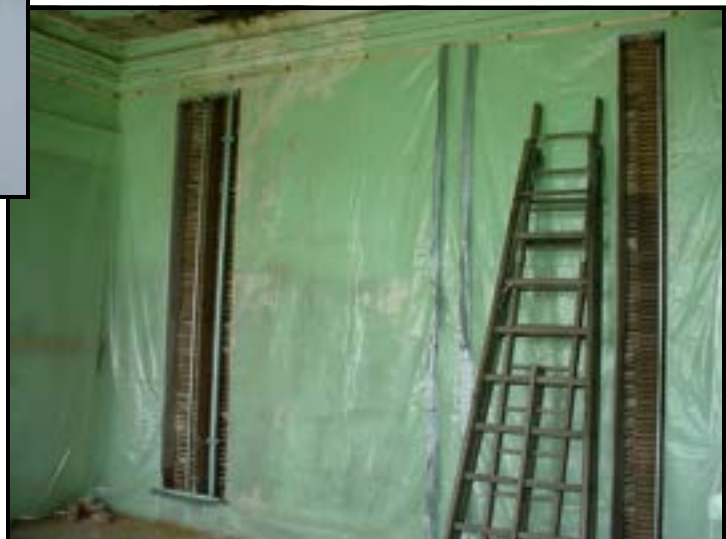
The photo at right shows two of the trenches that were cut in the walls of Lakeport house to run the pipes for the fire suppression and electrical systems. The photo above shows one of the fire sprinkler heads that will be left exposed inside the house.

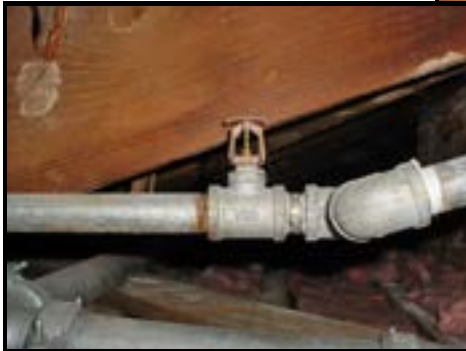
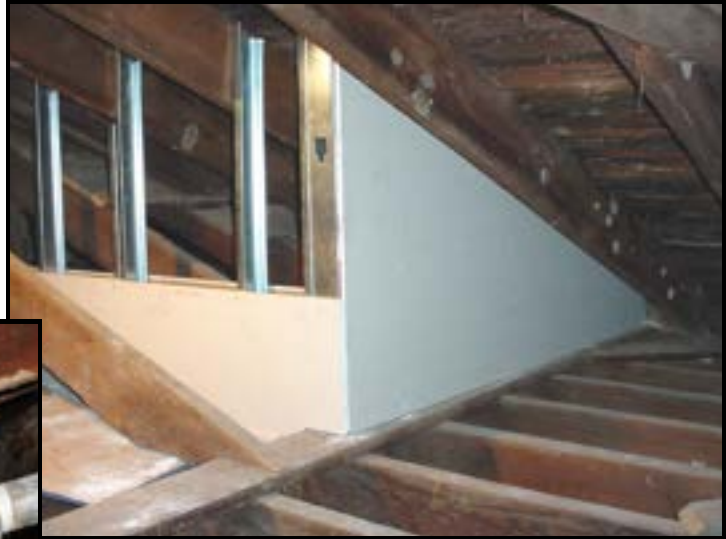
The photo at right shows metal stud framed partition walls, with fire retardant gypsum board, being built in the attic of Lakeport Plantation house. The purpose of the walls is to isolate areas of the attic to help contain a fire if one should one break out. The photo below shows a close-up of one of the fire sprinklers that were placed in the attic.

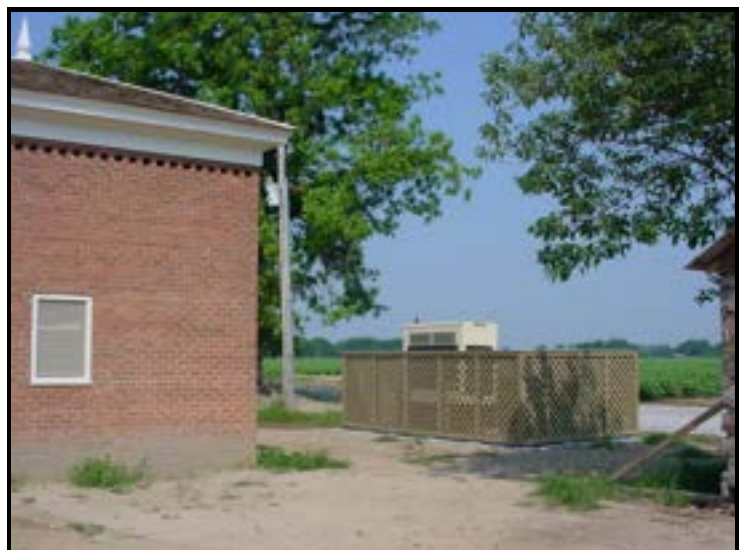
In the photo at right the transformer and generator are hidden behind the latticework fence. The purpose of the transformer is to reduce high voltage electricity down to a safe level for domestic use. The generator is used as a backup for the fire suppression system should there be an electrical outage.

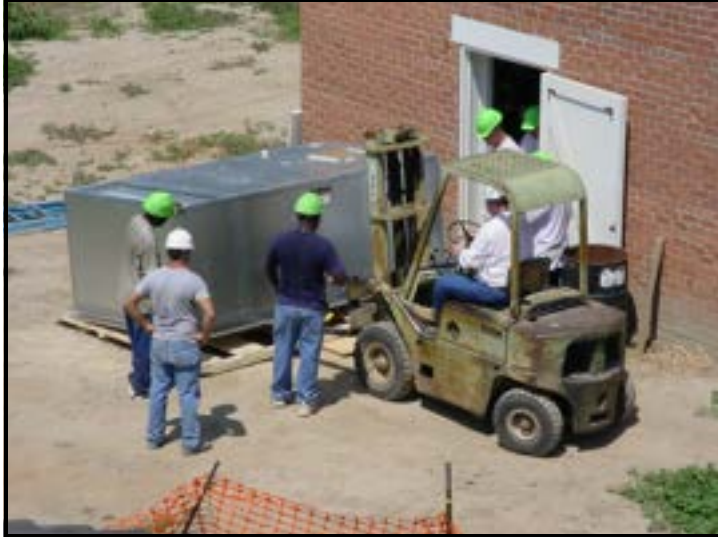
The photo at left shows the large air handler being maneuvered through the smokehouse door. Once inside, the air handler will be raised to the mezzanine floor where it will be installed.

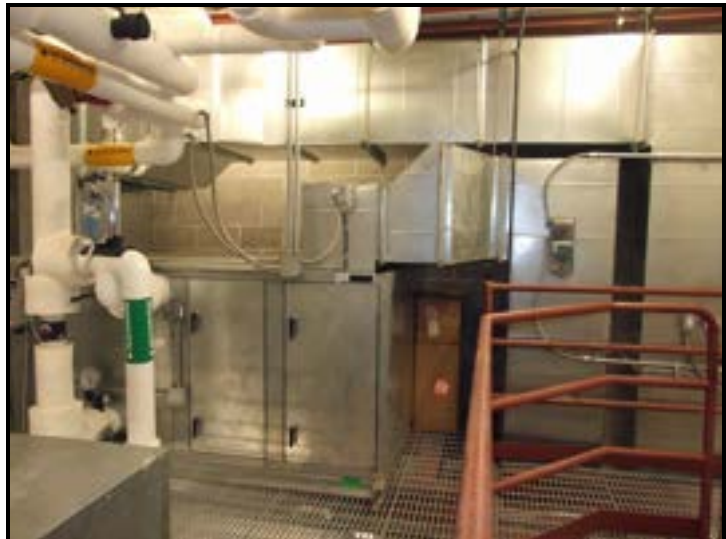
The large air handler can be seen in the photo at right setting on the mezzanine floor of the smokehouse. The supply and return air ductwork comes from the floor below to tie into the air handler.

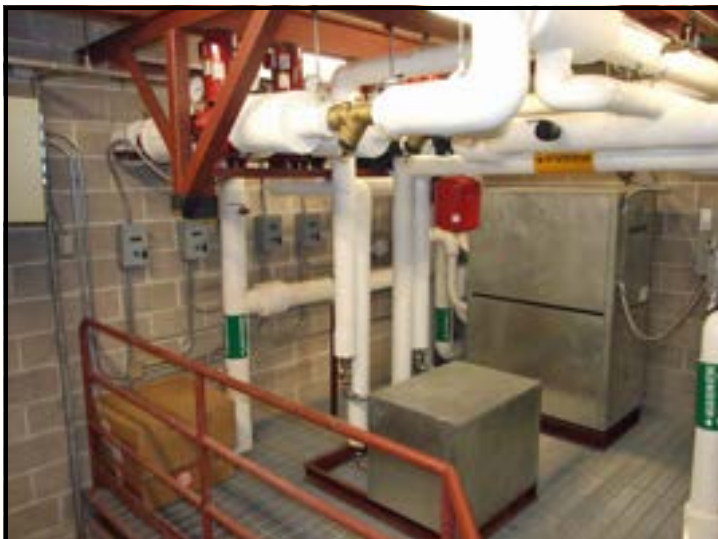
The photo at left shows the hydronic piping and pumps which direct the feed from the geothermal field to the mechanicals inside the smokehouse.

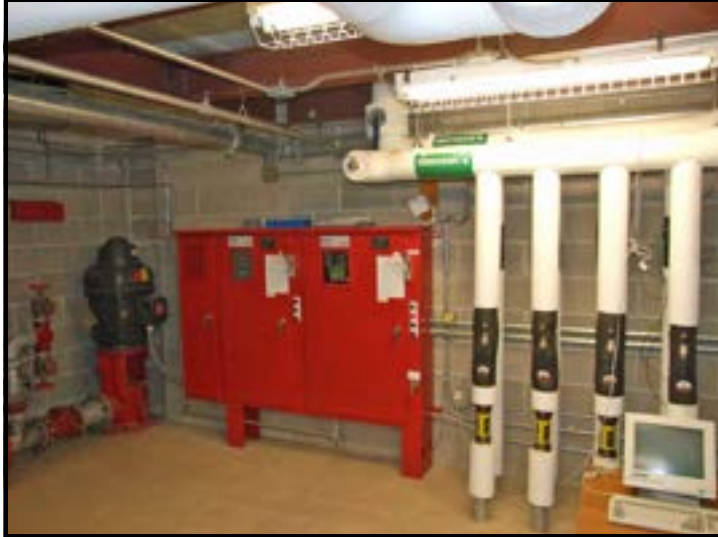
In this photo, the ground well and motor that will pump the water for the fire suppression system are to the left. To the right, the pipes that are coming through the concrete slab are joined to the ground loops as they enter the smokehouse from the outside. On the inside they will join the hydronic piping for the system.

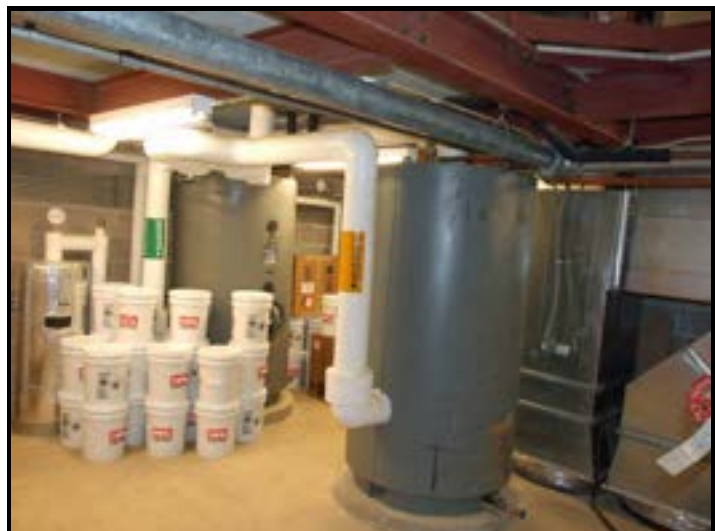
The two large tanks seen in this photo are the hot and cold water storage for the geothermal heat pump system. To the far right of the photo can be seen the supply and return air ducts. These ducts are connected to the large cast iron pipes that run underground to Lakeport Plantation house. Inside the smokehouse they go up and over to connect to the air handler.
